DEPARTMENT OF TRANSPORTATION

Contract #: 04-0120F4Cty: SF/ALA Rte: 80 PM: 13.2/13.9File #: 1.28**WELDING INSPECTION REPORT****Resident Engineer:** Casey, William**Address:** 333 Burma Road**City:** Oakland, CA 94607**Report No:** WIR-027813**Date Inspected:** 23-Jun-2012**Project Name:** SAS Superstructure**OSM Arrival Time:** 700**Prime Contractor:** American Bridge/Fluor Enterprises, a JV**OSM Departure Time:** 1530**Contractor:** American Bridge/Fluor Enterprises, a JV**Location:** Job Site

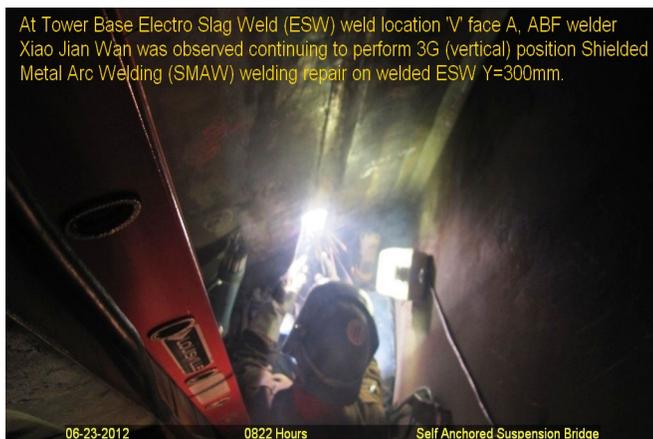
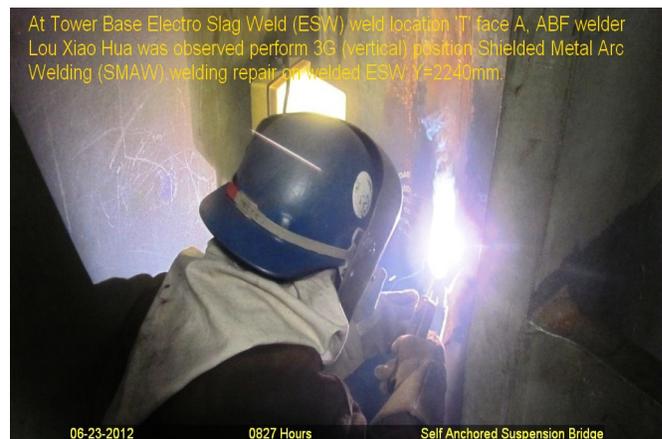
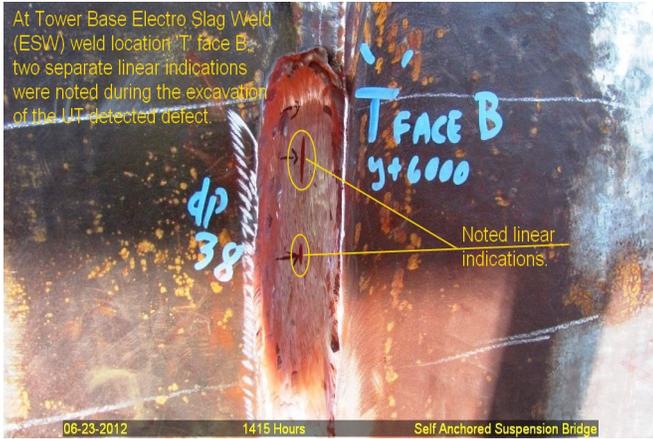
At Tower Base Electro Slag Welding (ESW) 100mm/80mm transition weld butt joint 'V' face A (S-042), QA randomly observed ABF/JV qualified welder Xiao Jian Wan continuing to perform CJP groove welding repair at Y=300mm to Y=580mm with excavation dimensions of 280mm long X 70mm wide x 55 mm deep per Caltrans approved Request for Welding Repair (RWR) #201206-42. The welder was observed welding in the 3G (vertical) position utilizing Shielded Metal Arc Welding (SMAW) with 3.2mm diameter E7018H4R electrode implementing welding procedure ABF-WPS-D15-1000-Repair Rev. 2. The repair excavation was preheated to more than 300 degree Fahrenheit using propane gas torch prior welding and then switch to Miller Proheat 35 Induction Heating System. During the shift, ABF QC Scott Kourtom was noted monitoring the welder with measured working current of 124 amperes during welding. At the end of the shift, the welding repair of weld joint mentioned above was still continuing and should remain tomorrow.

At Tower Base Electro Slag Welding (ESW) 100mm/80mm transition weld butt joint 'T' face A (S-043), QA randomly observed ABF/JV qualified welder Jin Pei Wang continuing to perform CJP groove welding repair at Y=8660mm to Y=8950mm with excavation dimensions of 290mm long X 60mm wide x 52 mm deep per Caltrans approved Request for Welding Repair (RWR) #201206-38. The welder was observed welding in the 3G (vertical) position utilizing Shielded Metal Arc Welding (SMAW) with 3.2mm diameter E7018H4R electrode implementing welding procedure ABF-WPS-D15-1000-Repair Rev. 2. The repair excavation was preheated to more than 300

degree Fahrenheit using propane gas torch prior welding. During the shift, ABF QC Scott Kourtom was noted monitoring the welder with measured working current of 126 amperes during welding. At the end of the shift, the welding repair of weld joint mentioned above was completed and so with the flush grinding on the weld cover.

At Tower Base Electro Slag Welding (ESW) 100mm/80mm transition weld butt joint 'T' face A (S-043), QA randomly observed ABF/JV qualified welder Lou Xiao Hua perform CJP groove welding repair at Y=2240mm to Y=2440mm with excavation dimensions of 200mm long X 50mm wide x 52 mm deep per Caltrans approved Request for Welding Repair (RWR) #201206-50. The welder was observed welding in the 3G (vertical) position utilizing Shielded Metal Arc Welding (SMAW) with 3.2mm diameter E7018H4R electrode implementing welding procedure ABF-WPS-D15-1000-Repair Rev. 2. The repair excavations was preheated to more than 300 degree Fahrenheit using propane gas torch prior welding and then switch to Miller Proheat 35 Induction Heating System. During the shift, ABF QC Scott Kourtom was noted monitoring the welder with measured working current of 124 amperes during welding. At the end of the shift, the welding repair of weld joint mentioned above was still continuing and should remain tomorrow.

At Tower Base Electro Slag Weld (ESW) 100mm/80mm transition weld butt joint 'T' face B (S-043) location Y=6000, ABF welder Jin Pei Wang was observed perform excavation on ESW welded joint due to UT detected defect. The excavation is being performed per Caltrans approved RWR #201206-055. The welder excavated the defect using carbon air arc gouging followed by die grinder. During the excavation at 32mm deep, there were two linear indications noted measuring 25mm long and 10mm long that was separated by approximately 30mm. The welder continued the excavation after the 32mm depth but due to time constraint of the work shift, the welder was not able to complete the excavation.
