Contract #: 04-0120F4Cty: SF/ALA Rte: 80 PM: 13.2/13.9File #: 1.28**WELDING INSPECTION REPORT****Resident Engineer:** Casey, William**Address:** 333 Burma Road**City:** Oakland, CA 94607**Report No:** WIR-027818**Date Inspected:** 22-Jun-2012**Project Name:** SAS Superstructure**OSM Arrival Time:** 700**Prime Contractor:** American Bridge/Fluor Enterprises, a JV**OSM Departure Time:** 1930**Contractor:** American Bridge/Fluor Enterprises, a JV**Location:** Job Site**CWI Name:** As noted below.**CWI Present:** Yes No**Inspected CWI report:** Yes No N/A**Rod Oven in Use:** Yes No N/A**Electrode to specification:** Yes No N/A**Weld Procedures Followed:** Yes No N/A**Qualified Welders:** Yes No N/A**Verified Joint Fit-up:** Yes No N/A**Approved Drawings:** Yes No N/A**Approved WPS:** Yes No N/A**Delayed / Cancelled:** Yes No N/A**Bridge No:** 34-0006**Component:** Tower Component**Summary of Items Observed:**

Electroslag Weld Excavation

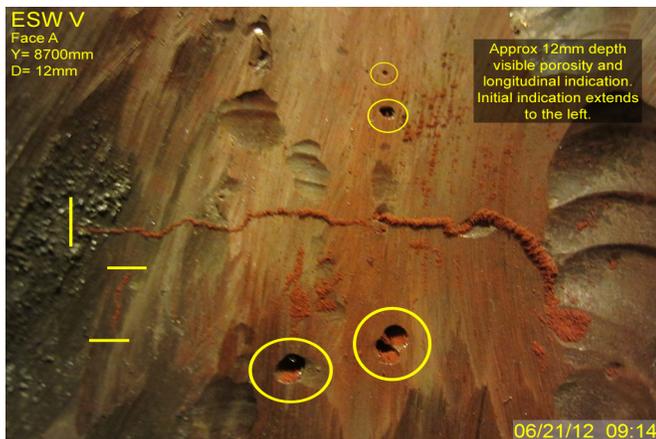
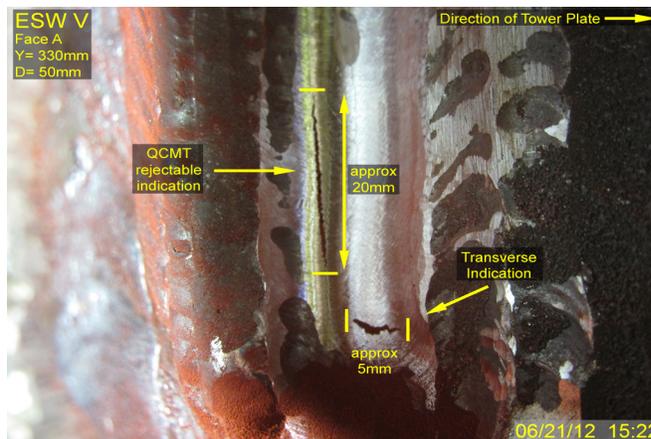
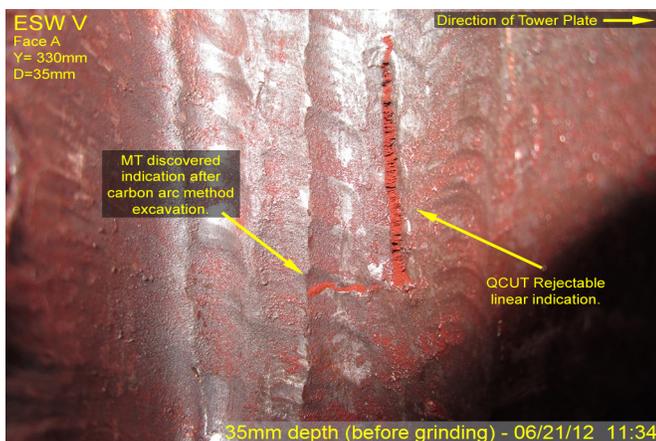
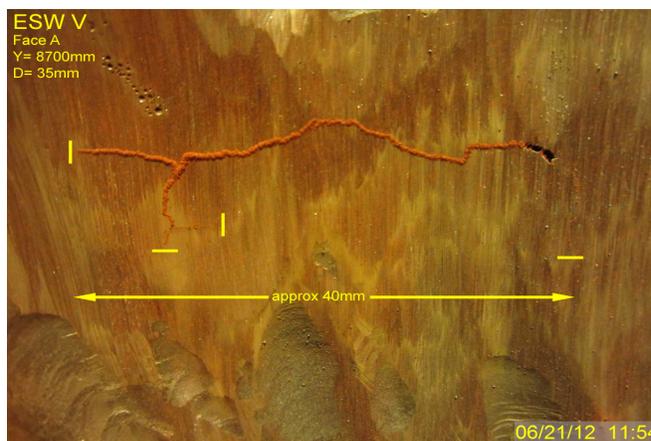
This QA observed ABF/JV welding personnel Xiao Jian Wan #9677 performing excavation of an Electroslag Weld (ESW) previously Ultrasonic Tested (UT) by Quality Control (QC) technicians.

The UT discovered indication was found to be oriented in the longitudinal position. The indication was found to be rejectable per AWS D1.5 Table 6.4).

The carbon arc gouging process, as well as machine grinding, were used to excavated approximately 2mm-5mm at a time. In between excavation passes both QA and QC performed Magnetic Particle Testing (MT) and photographed the discovered indications.

Throughout this excavation this QA observed and photographed several linear indications in both the transverse and longitudinal orientation.

This excavation is currently in-progress and final measurements have not been made. Please see attached photographs for more information.

Throughout this excavation this QA observed and photographed linear indications.
