DEPARTMENT OF TRANSPORTATION

Contract #: 04-0120F4Cty: SF/ALA Rte: 80 PM: 13.2/13.9File #: 1.28**WELDING INSPECTION REPORT****Resident Engineer:** Casey, William**Address:** 333 Burma Road**City:** Oakland, CA 94607**Report No:** WIR-027828**Date Inspected:** 26-Jun-2012**Project Name:** SAS Superstructure**OSM Arrival Time:** 700**Prime Contractor:** American Bridge/Fluor Enterprises, a JV**OSM Departure Time:** 1930**Contractor:** American Bridge/Fluor Enterprises, a JV**Location:** Job Site**CWI Name:** As noted below**CWI Present:** Yes No**Inspected CWI report:** Yes No N/A**Rod Oven in Use:** Yes No N/A**Electrode to specification:** Yes No N/A**Weld Procedures Followed:** Yes No N/A**Qualified Welders:** Yes No N/A**Verified Joint Fit-up:** Yes No N/A**Approved Drawings:** Yes No N/A**Approved WPS:** Yes No N/A**Delayed / Cancelled:** Yes No N/A**Bridge No:** 34-0006**Component:** SAS OBG**Summary of Items Observed:**

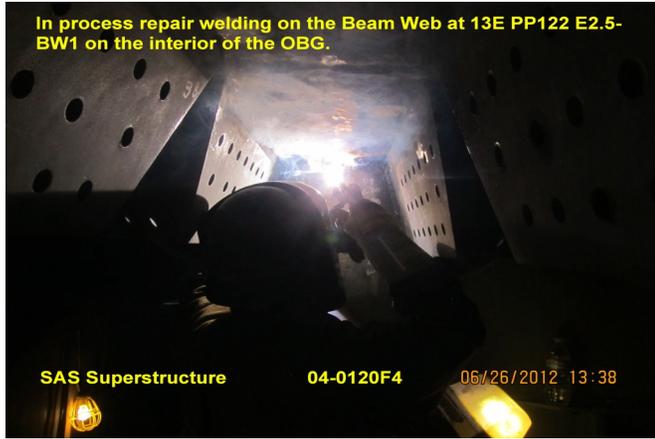
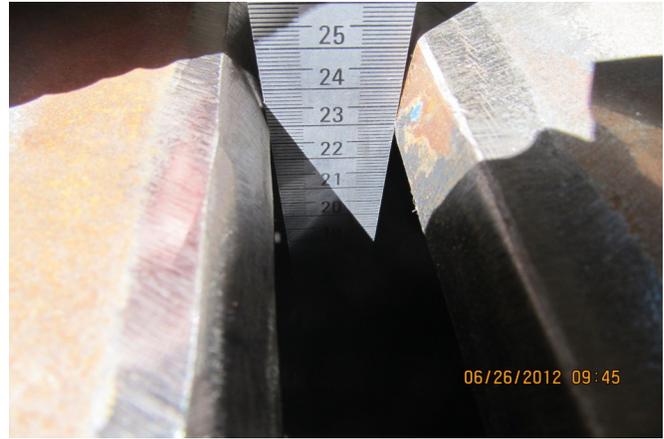
Lift 12 Corner Assembly

During this QA Inspectors' review of the fit-up operation being performed after the erection of Segment 12 East's Deck Corner Plate Drop-in, the following issue was observed: This QA Inspector observed that the root opening throughout the length of the joint was in excess of 20mm. The root opening averaged 22mm. This QA Inspector generated an Incident Report on this date and notified METS QA Lead Inspector Danny Reyes and METS QA Task Leader Bill Levell via email for review and disposition of the report due to the non-compliance with AWS D1.5-2002 - Section 3.3.4.2 - Assembly which states that Root openings larger than those allowed in 3.3.4.1 may be corrected by welding only with the approval of the Engineer. See attached photos for further details.

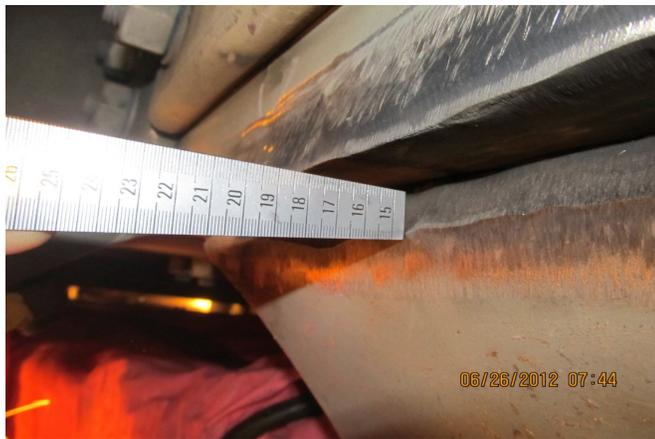
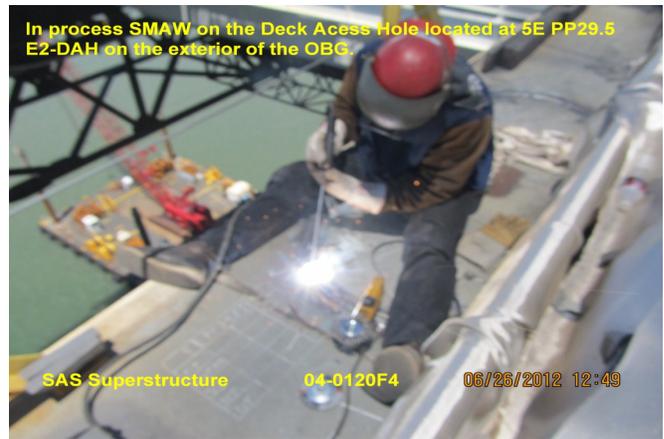
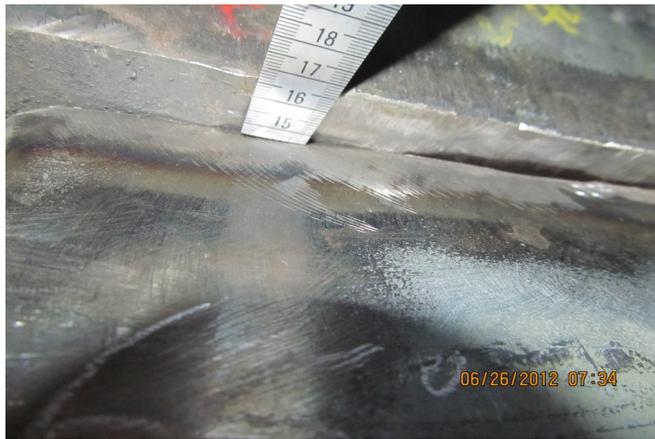
13E Drop-In Panel K Plate

During this QA Inspectors' review of the fit-up operation being performed of Segment 13 East's Drop-in Panel Plate "K", the following issue was observed: The joint was not pre-qualified, Excessive included angle and misalignment. This QA Inspector generated an Incident Report on this date and notified METS QA Lead Inspector Danny Reyes and METS QA Task Leader Bill Levell via email for review and disposition of the report due to the non-compliance with AWS D1.5-2002 - Section 3.3.3 - Assembly which states that; Measurement of offset shall be based upon the centerline of parts unless otherwise shown on the drawings. 2.12.1 Dimensional Tolerances. Dimensions of groove welds specified on design or detailed drawings may vary as shown in Figure 2.4. The joint does not comply with Figure 2.4 Joint designation B-U4b. See attached photos for further details.
