**DEPARTMENT OF TRANSPORTATION**

Contract #: 04-0120F4Cty: SF/ALA Rte: 80 PM: 13.2/13.9File #: 1.28**WELDING INSPECTION REPORT****Resident Engineer:** Casey, William**Address:** 333 Burma Road**City:** Oakland, CA 94607**Report No:** WIR-027839**Date Inspected:** 24-Jun-2012**Project Name:** SAS Superstructure**OSM Arrival Time:** 700**Prime Contractor:** American Bridge/Fluor Enterprises, a JV**OSM Departure Time:** 1930**Contractor:** American Bridge/Fluor Enterprises, a JV**Location:** Job site

# WELDING INSPECTION REPORT

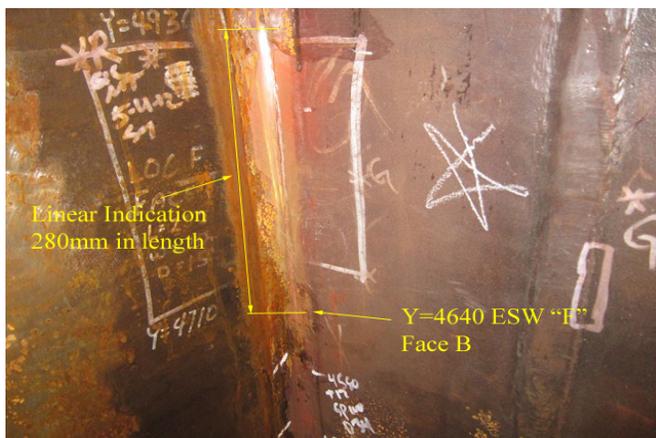
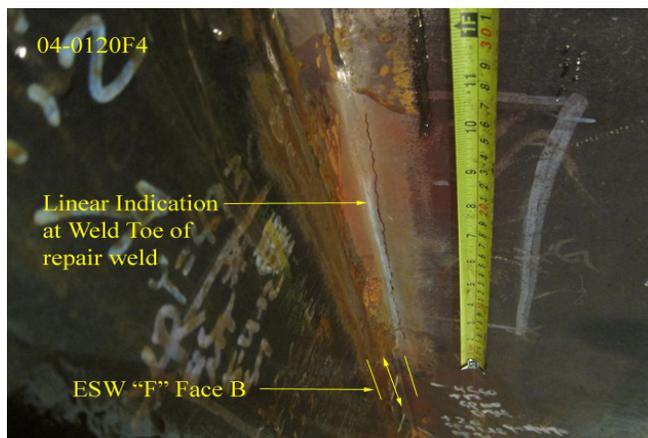
During the QA visual inspection while performing UT, a linear indication was observed on weld ESW "F" from face B at Y=4640 in way of a previous repair not noted on the provided UT report. The indication was then confirmed by MT to be approximately 280mm in length located at the toe of the repair weld. (See attached photographs.)
