DEPARTMENT OF TRANSPORTATION

Contract #: 04-0120F4Cty: SF/ALA Rte: 80 PM: 13.2/13.9File #: 1.28**WELDING INSPECTION REPORT****Resident Engineer:** Casey, William**Address:** 333 Burma Road**City:** Oakland, CA 94607**Report No:** WIR-027849**Date Inspected:** 25-Jun-2012**Project Name:** SAS Superstructure**OSM Arrival Time:** 700**Prime Contractor:** American Bridge/Fluor Enterprises, a JV**OSM Departure Time:** 1730**Contractor:** American Bridge/Fluor Enterprises, a JV**Location:** Job Site**CWI Name:** As noted below.**CWI Present:** Yes No**Inspected CWI report:** Yes No N/A**Rod Oven in Use:** Yes No N/A**Electrode to specification:** Yes No N/A**Weld Procedures Followed:** Yes No N/A**Qualified Welders:** Yes No N/A**Verified Joint Fit-up:** Yes No N/A**Approved Drawings:** Yes No N/A**Approved WPS:** Yes No N/A**Delayed / Cancelled:** Yes No N/A**Bridge No:** 34-0006**Component:** Tower Component**Summary of Items Observed:**

Electroslag Weld Excavation

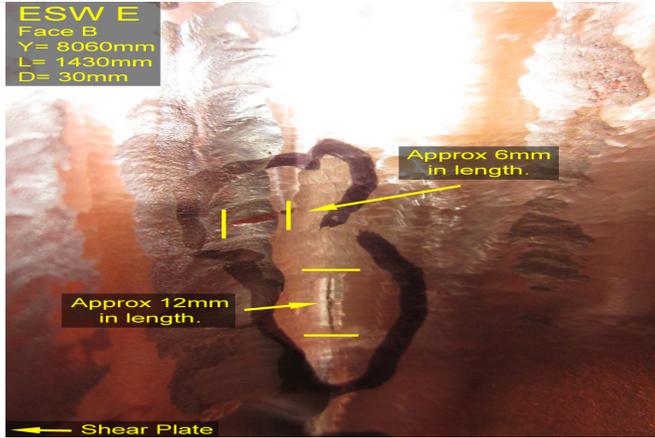
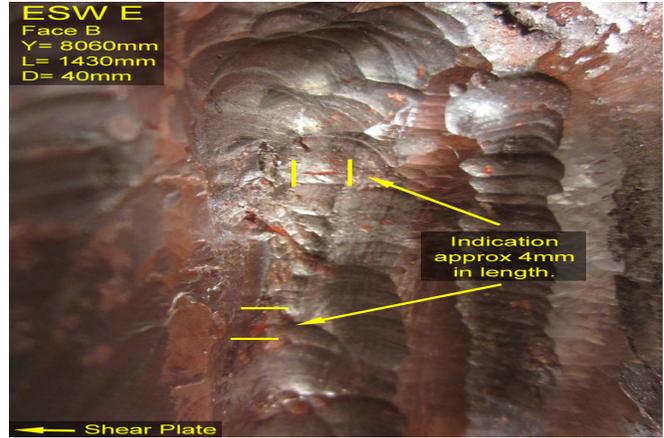
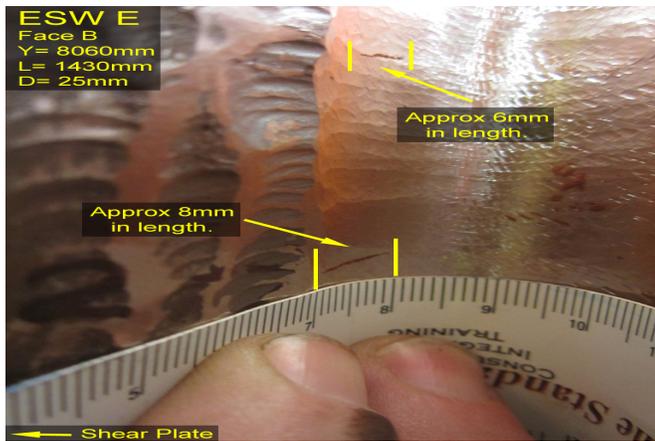
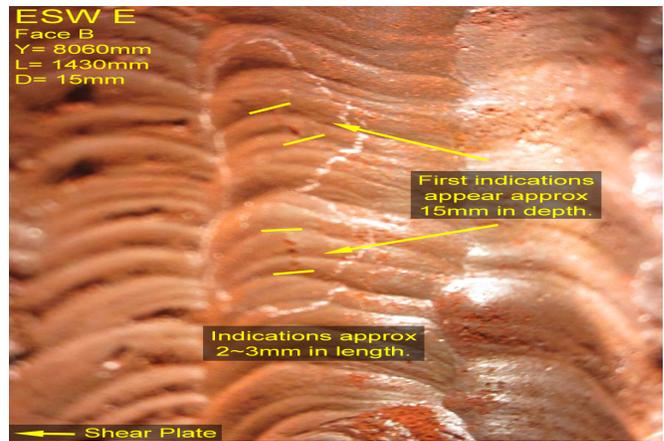
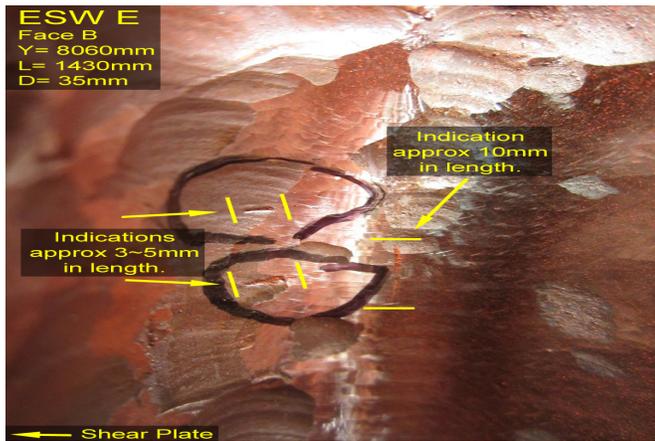
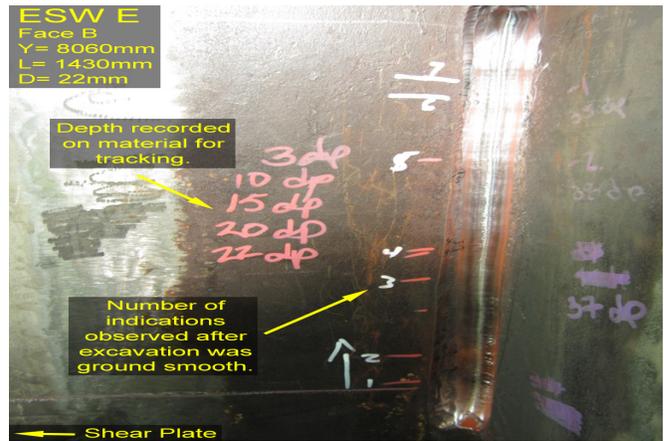
At approximately 15mm in depth longitudinal indications were observed. These indications were discovered both visually and through the Magnetic Particle Testing (MT) process.

The excavation was continued using a combination of carbon arc gouging and mechanical grinding. Several longitudinal and transverse indications were observed at varying lengths throughout.

Excavation was stopped at approximately 40mm in depth. Indications could still be observed at that time.

Please see photographs attached to this report for examples of indications observed
