Contract #: 04-0120F4Cty: SF/ALA Rte: 80 PM: 13.2/13.9File #: 1.28**WELDING INSPECTION REPORT**

Report No: WIR-027875
Date Inspected: 28-Jun-2012

Project Name: SAS Superstructure
Prime Contractor: American Bridge/Fluor Enterprises, a JV
Contractor: American Bridge/Fluor Enterprises, a JV

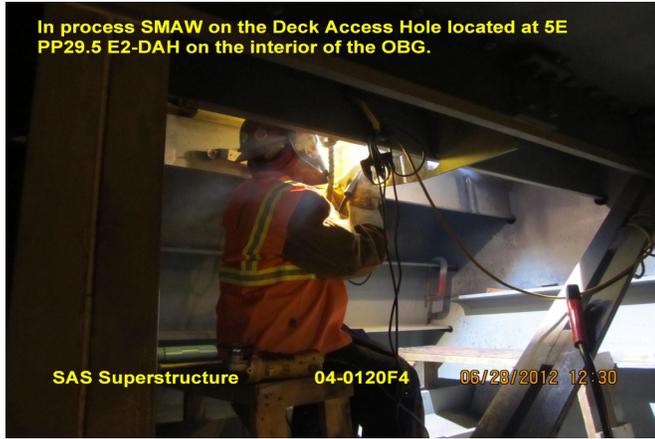
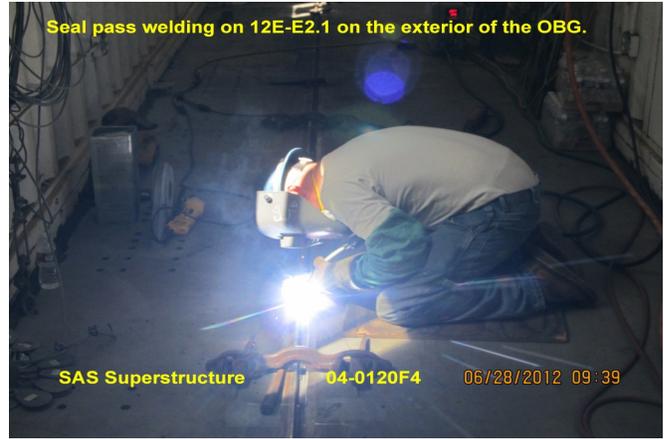
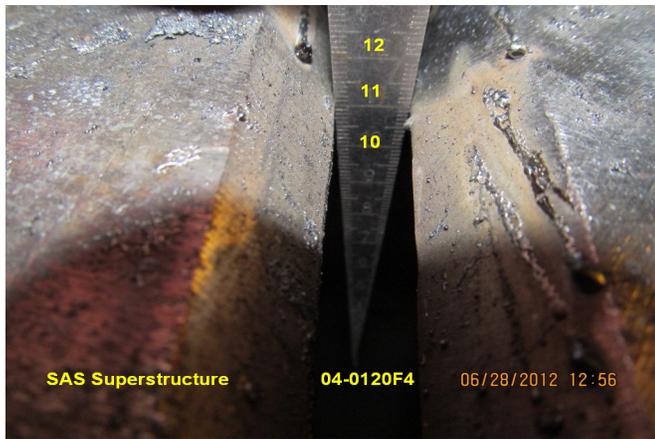
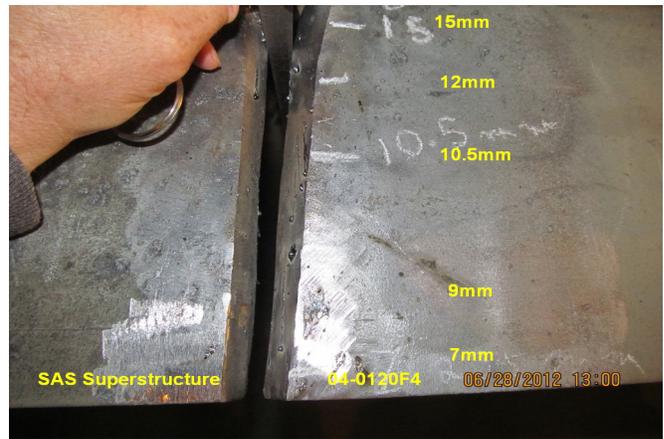
5E PP29.5 E2-DAH (Interior)

This QA Inspector conducted fit up operations and planar alignment measurements on the Longitudinal Stiffener West (LSW) on the Deck Access Hole at 5E PP20.5 E2-DAH on the interior of the OBG. This QA Inspector observed that the Root Opening varied from 7mm at the bottom of the joint to in excess of 15mm at the top of the joint. This QA Inspector generated an Incident Report on this date and notified METS QA Lead Inspector Danny Reyes and METS QA Task Leader Bill Levell via email for review and disposition of the report due to the non-compliance with AWS D1.5-2002 - Section 3.3 - Assembly 3.3.4.2 Root openings larger than those allowed in 3.3.4.1 may be corrected by welding only with the approval of the Engineer. See attached photos for further details.

This QA Inspector discussed the disposition of the Longitudinal Stiffener West (LSW) at 5E PP29.5 E2-DAH with Quality Control Manager Bonifacio Daquinag Jr. QC will be submitting an RWR.
