**DEPARTMENT OF TRANSPORTATION**

Contract #: 04-0120F4Cty: SF/ALA Rte: 80 PM: 13.2/13.9File #: 1.28**WELDING INSPECTION REPORT****Resident Engineer:** Casey, William**Address:** 333 Burma Road**City:** Oakland, CA 94607**Report No:** WIR-027876**Date Inspected:** 30-Jun-2012**Project Name:** SAS Superstructure**OSM Arrival Time:** 700**Prime Contractor:** American Bridge/Fluor Enterprises, a JV**OSM Departure Time:** 1530**Contractor:** American Bridge/Fluor Enterprises, a JV**Location:** Job Site**CWI Name:** As noted below**CWI Present:** Yes No**Inspected CWI report:** Yes No N/A**Rod Oven in Use:** Yes No N/A**Electrode to specification:** Yes No N/A**Weld Procedures Followed:** Yes No N/A**Qualified Welders:** Yes No N/A**Verified Joint Fit-up:** Yes No N/A**Approved Drawings:** Yes No N/A**Approved WPS:** Yes No N/A**Delayed / Cancelled:** Yes No N/A**Bridge No:** 34-0006**Component:** SAS OBG**Summary of Items Observed:**

# WELDING INSPECTION REPORT

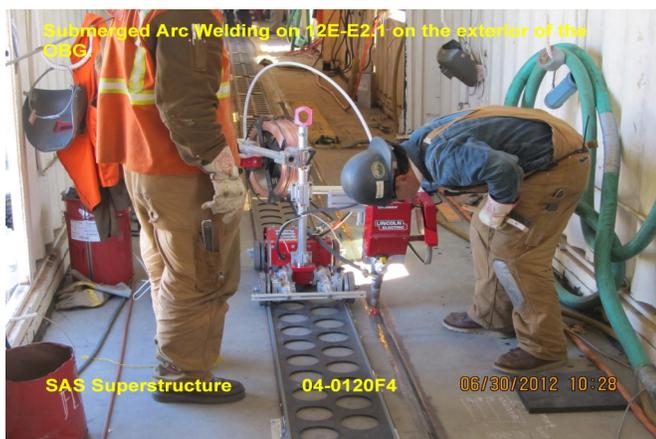
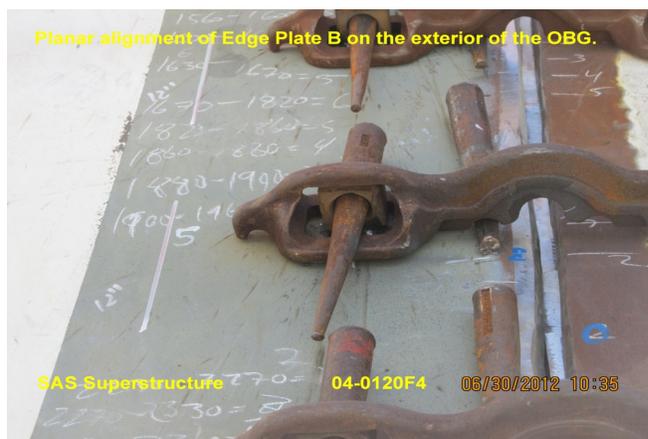
This QA Inspector randomly conducted fit up and measurement of the 12E Corner Drop-In Panel on the interior of the OBG. QC Inspector Salvador Merino utilized a Bridge Cam gauge to measure the planar offset of the 12E-E2. 1-C seam located on Bottom Plate "D" where the existing Plate thickness averaged 22mm to the 18mm Drop-In Plate. Work was also performed on Edge Plate "B" on the exterior of the OBG. (see photo below) The work at this location is in progress and appeared to be in general conformance with the contract specifications.

This QA Inspector randomly observed Submerged Arc Welding (SAW) of the Corner Drop-In Plate at 12E-E2.1 on the exterior of the OBG. This QA Inspector observed heat induction blankets to provide pre-heat for the single bevel joint and verified the temperature was the required minimum of 150° F. It was also noted that the remote oven for the ESAB EN 760 Flux was in the on position with the dial set at 250° F as ABF welding personnel employed a flux recycling vacuum hose to empty the feeder hopper of the SAW unit. This QA Inspector observed the removal of the electrode spool which was discarded and replaced with a new F7A2-EM12KH8 electrode spool. QC Inspector Fred Michels measured the parameters for amperage, volts, travel speed and the heat input as ABF

welder James Zhen (ID 6001) adjusted the controls on the Lincoln track mounted wire feeder. Upon approval for conformity with WPS-D1.5-4042B-1, Mr. Zhen commenced welding operations on the joint in the 1G flat position. On a subsequent observation, this QA Inspector observed ABF welding personnel recycle the flux utilizing a vacuum hose and cleaning the edge of the work with a chipping hammer between passes. Mr. Zhen was observed adjusting the path of the feeder prior to each consecutive pass during the ongoing process and inspected each completed pass for indications and workmanship. QC was present to monitor the welding and the parameters so they remain within the requirements of the WPS. This QA Inspector made subsequent observations throughout the shift to monitor quality and noted that the work was in process and appeared to be in general conformance with the contract specifications.
