**DEPARTMENT OF TRANSPORTATION**

Contract #: 04-0120F4Cty: SF/ALA Rte: 80 PM: 13.2/13.9File #: 1.28**WELDING INSPECTION REPORT****Resident Engineer:** Casey, William**Address:** 333 Burma Road**City:** Oakland, CA 94607**Report No:** WIR-027881**Date Inspected:** 29-Jun-2012**Project Name:** SAS Superstructure**OSM Arrival Time:** 700**Prime Contractor:** American Bridge/Fluor Enterprises, a JV**OSM Departure Time:** 1930**Contractor:** American Bridge/Fluor Enterprises, a JV**Location:** Job Site

**Bridge No:** 34-0006**Component:** SAS Tower**Summary of Items Observed:**

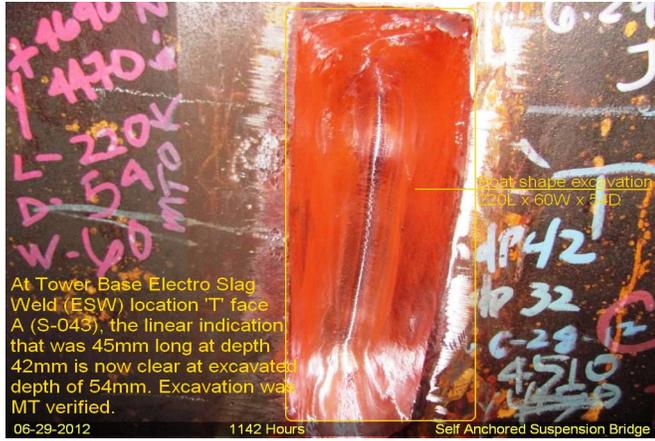
At Tower Base Electro Slag Weld (ESW), this QA observed ABF welder Lou Xiao Hua continuing to perform repair excavation at location 'T' face A (S-043) Y=4510mm due to Ultrasonic Testing (UT) detected defect. The repair excavation is being undertaken per Caltrans approved Request for Weld Repair (RWR) #201206-053. The welder was noted using carbon air arc gouging followed by grinding using a die grinder. During the excavation, one linear indication was noted at depth 32mm and was measured 27mm long. This was confirmed using Magnetic Particle Testing (MT). The welder continued the excavation at depth 42mm and the indication has increased to 45mm long. The welder continued the excavation at approximate depth 48mm and the remaining linear indication was noted 20mm at the bottom and 10mm at the top of the original 45mm long indication. The welder continued the excavation at 50mm deep and the bottom indication was gone while the top indication has reduced to 12mm. At 54mm deep excavation, the 12mm top indication has already gone and ABF QC Jesse Cayabyab instructed the welder to grind smooth the excavation in preparation for QC and QA visual test (VT) and Magnetic Particle Test (MT). ABF QC Jesse Cayabyab has performed the VT and MT on the boat shape repair excavation and noted no relevant indication during the tests. This QA also performed the same VT and MT on the same excavation and found same result.

After the VT and MT acceptance of the repair excavation just mentioned above, the same welder started another excavation at the same weld location but Y=5170mm. The repair excavation is being undertaken per Caltrans

approved Request for Weld Repair (RWR) #201206-054. The welder was noted using carbon air arc gouging followed by grinding using a die grinder. During the excavation, one linear indication was noted at depth 30mm and was measured 30mm long. This was confirmed using Magnetic Particle Testing (MT). The welder continued the excavation at depth 35mm and the indication has increased to 50mm long. The welder continued the excavation at approximate depth 43mm and the linear indication was reduced to 40mm. The welder continued the excavation at 53mm deep when the linear indication has disappeared and ABF QC Jesse Cayabyab instructed the welder to grind smooth the excavation in preparation for QC and QA visual test (VT) and Magnetic Particle Test (MT). ABF QC Jesse Cayabyab has performed the VT and MT on the boat shape repair excavation and noted no relevant indication during the tests. This QA also performed the same VT and MT on the same excavation and found same result.
