DEPARTMENT OF TRANSPORTATION

Contract #: 04-0120F4Cty: SF/ALA Rte: 80 PM: 13.2/13.9File #: 1.28**WELDING INSPECTION REPORT****Resident Engineer:** Casey, William**Address:** 333 Burma Road**City:** Oakland, CA 94607**Report No:** WIR-027882**Date Inspected:** 30-Jun-2012**Project Name:** SAS Superstructure**OSM Arrival Time:** 700**Prime Contractor:** American Bridge/Fluor Enterprises, a JV**OSM Departure Time:** 1530**Contractor:** American Bridge/Fluor Enterprises, a JV**Location:** Job Site**CWI Name:** Jesse Cayabyab**CWI Present:** Yes No**Inspected CWI report:** Yes No N/A**Rod Oven in Use:** Yes No N/A**Electrode to specification:** Yes No N/A**Weld Procedures Followed:** Yes No N/A**Qualified Welders:** Yes No N/A**Verified Joint Fit-up:** Yes No N/A**Approved Drawings:** Yes No N/A**Approved WPS:** Yes No N/A**Delayed / Cancelled:** Yes No N/A**Bridge No:** 34-0006**Component:** SAS Tower**Summary of Items Observed:**

WELDING INSPECTION REPORT

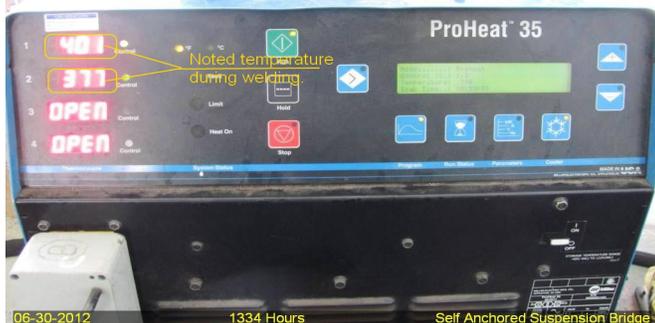
At Tower Base Electro Slag Weld (ESW) location 'T' face A (S-043) Y= 4510mm and 'V' face A (W-643) Y=3300 to 4330mm, ABF personnel were noted using the Miller Proheat 35 Induction Heating System to preheat and maintain the required temperature of 350 degrees Fahrenheit during welding of the two (2) repairs.

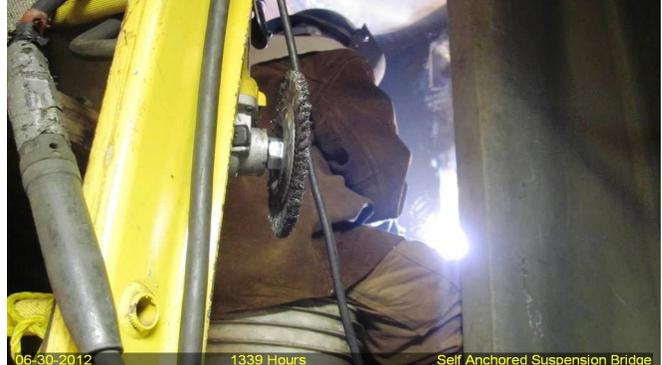
At Tower Base Electro Slag Weld (ESW) location 'T' face A (S-043) ABF welder Lou Xiao Hua was observed performing 3G (vertical) position Shielded Metal Arc Welding (SMAW) welding repair at Y=4510.
