DEPARTMENT OF TRANSPORTATION

Contract #: 04-0120F4Cty: SF/ALA Rte: 80 PM: 13.2/13.9File #: 1.28**WELDING INSPECTION REPORT****Resident Engineer:** Casey, William**Address:** 333 Burma Road**City:** Oakland, CA 94607**Report No:** WIR-027901**Date Inspected:** 04-Jul-2012**Project Name:** SAS Superstructure**OSM Arrival Time:** 700**Prime Contractor:** American Bridge/Fluor Enterprises, a JV**OSM Departure Time:** 1730**Contractor:** American Bridge/Fluor Enterprises, a JV**Location:** Job Site**CWI Name:** Bernie Docena**CWI Present:** Yes No**Inspected CWI report:** Yes No N/A**Rod Oven in Use:** Yes No N/A**Electrode to specification:** Yes No N/A**Weld Procedures Followed:** Yes No N/A**Qualified Welders:** Yes No N/A**Verified Joint Fit-up:** Yes No N/A**Approved Drawings:** Yes No N/A**Approved WPS:** Yes No N/A**Delayed / Cancelled:** Yes No N/A**Bridge No:** 34-0006**Component:** SAS Tower**Summary of Items Observed:**

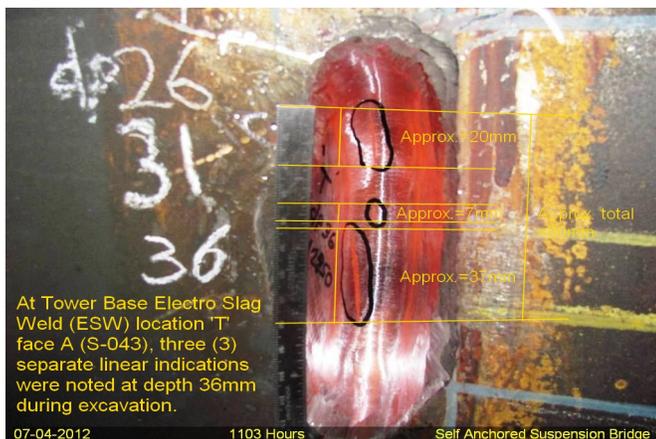
07-04-2012 1103 Hours Self Anchored Suspension Bridge

At Tower Base Electro Slag Weld (ESW), this QA observed ABF welder Lou Xiao Hua continuing to perform repair excavation at location 'T' face A (S-043) Y=2850mm due to Ultrasonic Testing (UT) detected defect. The repair excavation is being undertaken per Caltrans approved Request for Weld Repair (RWR) #201206-051. The welder was noted using carbon arc gouging followed by grinding using a die grinder. During the excavation, one linear indication measuring 20mm long was noted at depth 26mm. This was confirmed using Magnetic Particle Testing (MT). The welder continued the excavation at depth 31mm and the indication has increased to 45mm long. The welder continued the excavation at approximate depth 36mm and noted three (3) separate indications measuring 20mm at the top, 7mm at the middle and 37mm at the bottom. The welder continued the excavation at 42mm deep and the top and middle indications were noted removed but the bottom indication has increased to 50mm At 47mm deep excavation, the bottom indication was reduced to 30mm long and ABF QC Bernie Docena instructed the welder to go one more excavation then grind smooth the excavation in preparation

for QC and QA visual test (VT) and Magnetic Particle Test (MT). At 52mm deep excavation, ABF QC Bernie Docena has performed the VT and MT on the boat shape repair excavation and noted the bottom indication is gone and there is no more relevant indication during the tests. This QA also performed the same VT and MT on the same excavation and found same result.

At Tower Base Electro Slag Weld (ESW) location 'T' face A (S-043), three (3) separate linear indications were noted at depth 36mm during excavation.

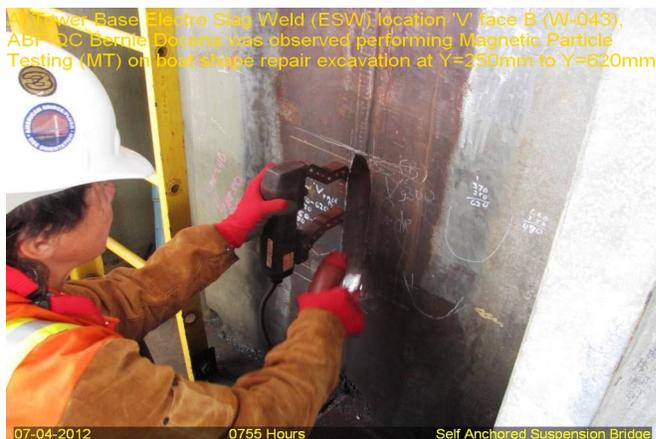
07-04-2012 0755 Hours Self Anchored Suspension Bridge

At Tower Base Electro Slag Weld (ESW) location 'V' face B (W-043), ABF QC Bernie Docena was observed performing Magnetic Particle Testing (MT) on boat shape repair excavation at Y=250mm to Y=620mm.

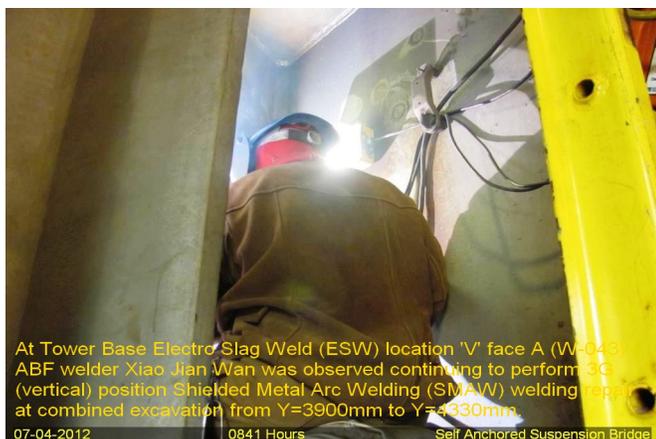
07-04-2012 0841 Hours Self Anchored Suspension Bridge

At Tower Base Electro Slag Weld (ESW) location 'V' face A (W-043), QA randomly observed ABF/JV qualified welder Xiao Jian Wan continuing to perform CJP groove welding repair. The welder was observed manually welding in the 3G (vertical) position utilizing Shielded Metal Arc Welding (SMAW) with 3.2mm diameter E7018H4R electrode and implementing Caltrans approved Welding Procedure Specification (WPS) ABF-WPS-D15-1000 Repair Rev. 2. The repair welding is being undertaken per Caltrans approved Request for Weld Repair (RWR)#201206-044 and #201206-045 in a combined repair excavations at Y=3950mm and Y=4270mm respectively. The repair excavation was preheated and continuously maintained to more than 350 degree Fahrenheit using Miller Proheat 35 Induction Heating System prior/during welding. The ESW repair being welded is located at ESW 'V' face A, Y=3900mm having dimensions of 560mm long X 70mm wide X 53mm deep. During the shift, ABF QC Bernie Docena was noted monitoring the welder with measured working current of 124 amperes. At the end of the shift, 3G SMAW repair welding at location mentioned above was still continuing and should remain tomorrow. The welder held the same preheat of 350°F on the combined excavation repair for three hours after welding as required.

At Tower Base Electro Slag Weld (ESW) location 'V' face A (W-043), ABF welder Xiao Jian Wan was observed continuing to perform 3G (vertical) position Shielded Metal Arc Welding (SMAW) welding repair at combined excavation from Y=3900mm to Y=4330mm.

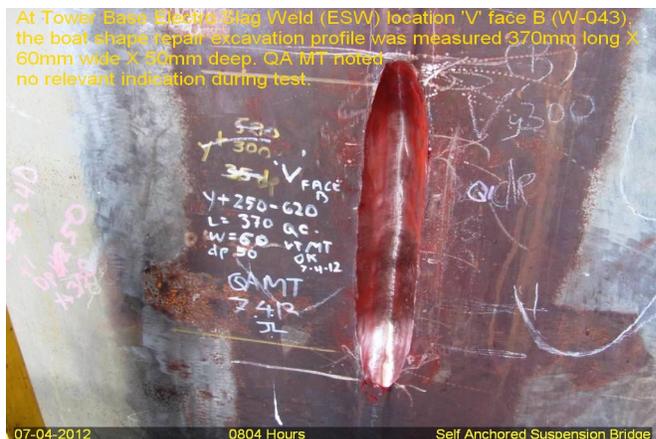
07-04-2012 0804 Hours Self Anchored Suspension Bridge

At Tower Base Electro Slag Weld (ESW) location 'V' face B (W-043), QA randomly observed ABF/JV qualified welder Han Wen Yu perform CJP groove welding repair. The welder was observed manually welding in the 3G (vertical) position utilizing Shielded Metal Arc Welding (SMAW) with 3.2mm diameter E7018H4R electrode and implementing Caltrans approved Welding Procedure Specification (WPS) ABF-WPS-D15-1000 Repair Rev. 2. The repair excavation was preheated and continuously maintained to more than 350 degree Fahrenheit using Miller Proheat 35 Induction Heating System prior/during welding. The ESW repair being welded is located at ESW 'V' face B, Y=250mm to Y=620mm was having dimensions of 370mm long X 60mm wide X 50mm deep is a continuation repair from face A due to linear indication that was left during previous MT. This repair has been approved per Request for Welding Repair (RWR) #201206-042. During the shift, ABF QC Bernie Docena was noted monitoring the welder with measured working current of 128 amperes. At the end of the shift, repair welding at location mentioned above was still continuing and should remain tomorrow. The welder held the same preheat of 350°F on the repair for three hours after welding as required.

At Tower Base Electro Slag Weld (ESW) location 'V' face B (W-043), the boat shape repair excavation profile was measured 370mm long X 60mm wide X 50mm deep. QA MT noted no relevant indication during test.
