**DEPARTMENT OF TRANSPORTATION**

Contract #: 04-0120F4Cty: SF/ALA Rte: 80 PM: 13.2/13.9File #: 1.28**WELDING INSPECTION REPORT****Resident Engineer:** Casey, William**Address:** 333 Burma Road**City:** Oakland, CA 94607**Report No:** WIR-027903**Date Inspected:** 02-Jul-2012**Project Name:** SAS Superstructure**OSM Arrival Time:** 700**Prime Contractor:** American Bridge/Fluor Enterprises, a JV**OSM Departure Time:** 1930**Contractor:** American Bridge/Fluor Enterprises, a JV**Location:** Job site

**Ultrasonic Testing (Tower ESW-E-045- "B" from Y=3800~5890 Face B)**

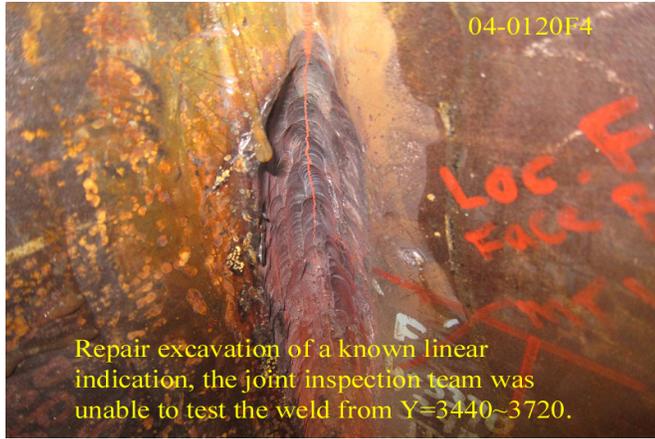
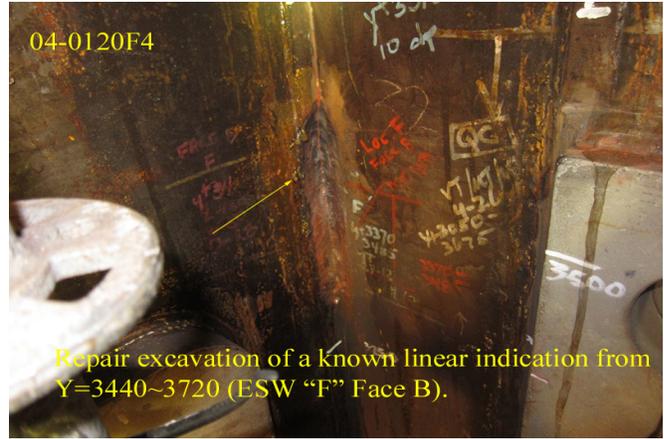
This QAI performed 100% Joint Ultrasonic Testing (UT), together with ABF QC inspector John Pagliero, on the Tower Complete Joint Penetration (CJP) butt joint shear plate connection designated as ESW-E-045- "B" from Face B. The QA/QC joint inspection team did not observe transverse indications from Y=3800~5890 from Face B at the time of inspection.

**Ultrasonic Testing (Tower ESW- E-045 #24 "F" from Y=0~4200 Face B)**

This QAI performed 100% Joint Ultrasonic Testing (UT), together with ABF QC inspector John Pagliero, on the Tower Complete Joint Penetration (CJP) Tee joint shear plate connection designated as ESW- E-045 #24 "F" from Face B. Due to a repair excavation of a known linear indication, the joint inspection team was unable to test the weld from Y=3440~3720.

Y=3920, X= -35, Sound Path=197, Depth From A=9mm, Length 65mm, -3 db Rating
