Contract #: 04-0120F4Cty: SF/ALA Rte: 80 PM: 13.2/13.9File #: 1.28**WELDING INSPECTION REPORT****Resident Engineer:** Casey, William**Address:** 333 Burma Road**City:** Oakland, CA 94607**Report No:** WIR-027904**Date Inspected:** 03-Jul-2012**Project Name:** SAS Superstructure**OSM Arrival Time:** 700**Prime Contractor:** American Bridge/Fluor Enterprises, a JV**OSM Departure Time:** 1930**Contractor:** American Bridge/Fluor Enterprises, a JV**Location:** Job site

Ultrasonic Testing (Tower ESW- E-045 #24 "F" from Y=4200~5890 Face B)

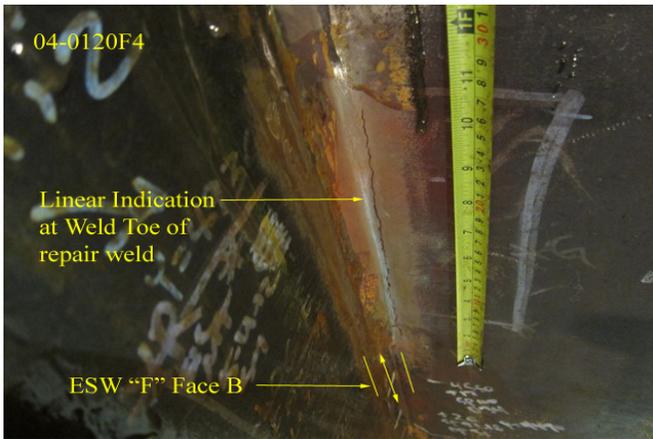
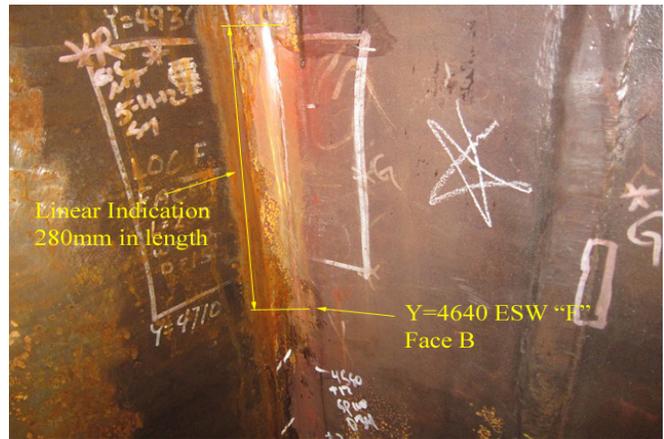
This QAI performed 100% Joint Ultrasonic Testing (UT), together with ABF QC inspector John Pagliero, on the Tower Complete Joint Penetration (CJP) Tee joint shear plate connection designated as ESW- E-045 #24 "F" from Face B. Due to a known linear indication in way of the weld toe of a previous repair, the joint inspection team was unable to accept the weld from Y=4660~4940.

A Grouping of multiple transverse indications was observed at Y=5260, 5270, 5300 and 5325.
Unless otherwise noted, all work observed on this date appeared to generally comply with applicable contract documents.
