Contract #: 04-0120F4Cty: SF/ALA Rte: 80 PM: 13.2/13.9File #: 1.28**WELDING INSPECTION REPORT**

Report No: WIR-027918
Date Inspected: 05-Jul-2012

Project Name: SAS Superstructure
Prime Contractor: American Bridge/Fluor Enterprises, a JV
Contractor: American Bridge/Fluor Enterprises, a JV

CWI Name:	Bernie Docena	CWI Present:	Yes	No
Inspected CWI report:	Yes No N/A	Rod Oven in Use:	Yes	No N/A
Electrode to specification:	Yes No N/A	Weld Procedures Followed:	Yes	No N/A
Qualified Welders:	Yes No N/A	Verified Joint Fit-up:	Yes	No N/A
Approved Drawings:	Yes No N/A	Approved WPS:	Yes	No N/A
		Delayed / Cancelled:	Yes	No N/A
Bridge No:	34-0006	Component:	SAS Tower

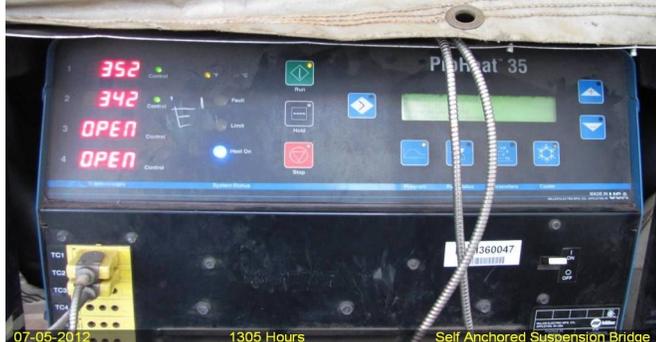
07-05-2012 1305 Hours Self Anchored Suspension Bridge

At Tower Base Electro Slag Weld (ESW) location 'E' face A (N-045), ABF personnel were noted using the Miller Preheat Induction Heating System to preheat and maintain the required temperature during repair welding from Y=7850mm to 9850mm.

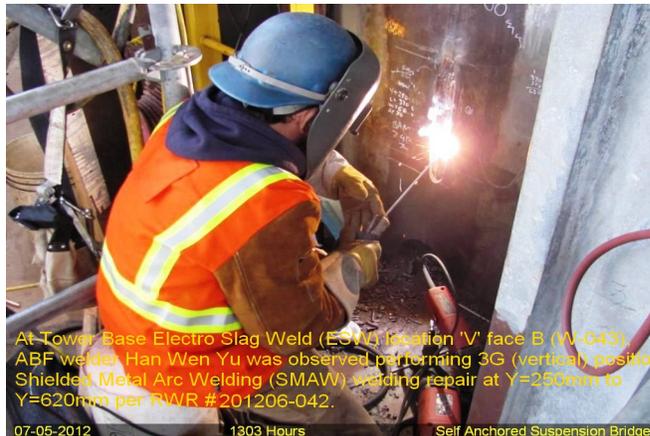
07-05-2012 1303 Hours Self Anchored Suspension Bridge

At Tower Base Electro Slag Weld (ESW) location 'V' face B (N-043), ABF welder Han Wen Yu was observed performing 3G (vertical) position Shielded Metal Arc Welding (SMAW) welding repair at Y=250mm to Y=620mm per RWR #201206-042.

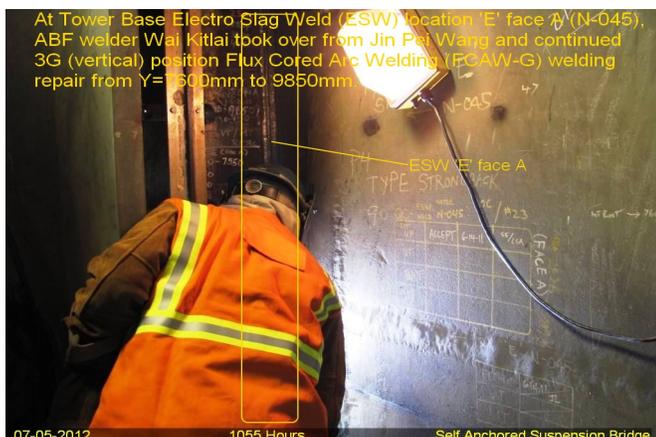
07-05-2012 1055 Hours Self Anchored Suspension Bridge

At Tower Base Electro Slag Weld (ESW) location 'E' face A (N-045), ABF welder Wai Kitlai took over from Jin Pei Wang and continued 3G (vertical) position Flux Cored Arc Welding (FCAW-G) welding repair from Y=1500mm to 9850mm.

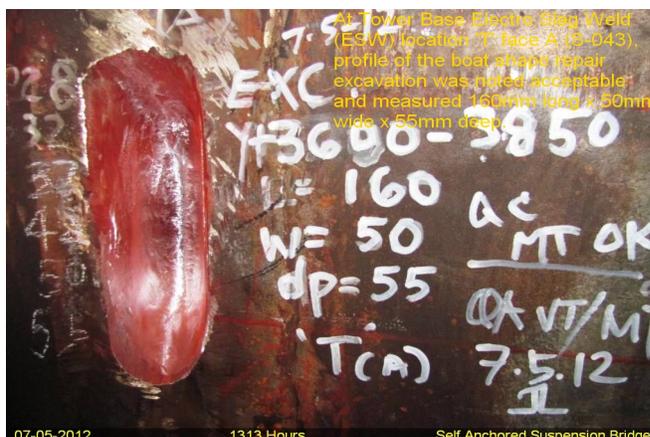
07-05-2012 1313 Hours Self Anchored Suspension Bridge

At Tower Base Electro Slag Weld (ESW) location 'T' face A (N-043), profile of the boat shape repair excavation was noted, acceptable; and measured 160mm long x 50mm wide x 55mm deep.
