**DEPARTMENT OF TRANSPORTATION**

Contract #: 04-0120F4Cty: SF/ALA Rte: 80 PM: 13.2/13.9File #: 1.28**WELDING INSPECTION REPORT****Resident Engineer:** Casey, William**Address:** 333 Burma Road**City:** Oakland, CA 94607**Report No:** WIR-027924**Date Inspected:** 09-Jul-2012**Project Name:** SAS Superstructure**OSM Arrival Time:** 700**Prime Contractor:** American Bridge/Fluor Enterprises, a JV**OSM Departure Time:** 1730**Contractor:** American Bridge/Fluor Enterprises, a JV**Location:** Job Site**CWI Name:** Bernie Docena**CWI Present:** Yes No**Inspected CWI report:** Yes No N/A**Rod Oven in Use:** Yes No N/A**Electrode to specification:** Yes No N/A**Weld Procedures Followed:** Yes No N/A**Qualified Welders:** Yes No N/A**Verified Joint Fit-up:** Yes No N/A**Approved Drawings:** Yes No N/A**Approved WPS:** Yes No N/A**Delayed / Cancelled:** Yes No N/A**Bridge No:** 34-0006**Component:** SAS Tower**Summary of Items Observed:**

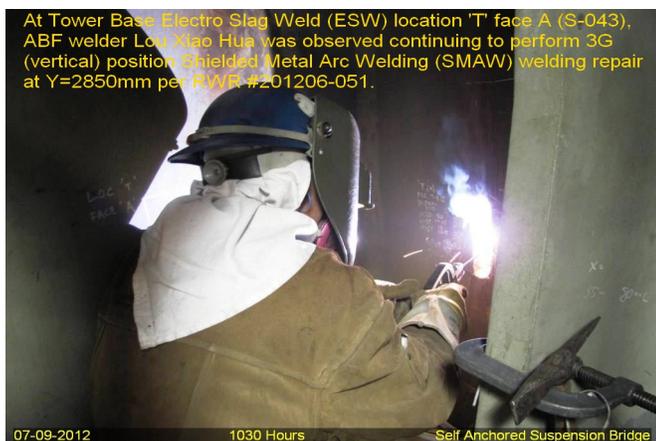
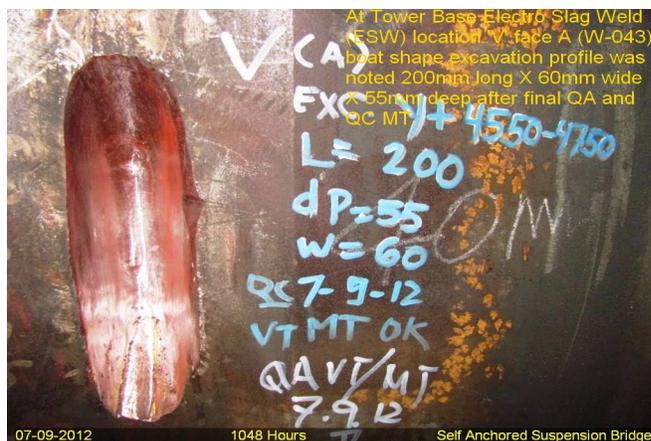
At Tower Base Electro Slag Weld (ESW) location ‘T’ face A (S-043), QA randomly observed ABF/JV qualified welder Lou Xiao Hua continuing to perform CJP groove welding repair. The welder was observed manually welding in the 3G (vertical) position utilizing Shielded Metal Arc Welding (SMAW) with 3.2mm diameter E7018H4R electrode and implementing Caltrans approved Welding Procedure Specification (WPS) ABF-WPS-D15-1000 Repair Rev. 2. The repair excavation was preheated and continuously maintained to more than 350 degree Fahrenheit using Miller Proheat 35 Induction Heating System prior/during welding. The ESW repair being welded is located at ESW ‘T’ face A, Y=2850mm having dimensions of 200mm long X 50mm wide X 52mm deep has been approved per Request for Welding Repair (RWR) #201206-051. During the shift, ABF QC Bernie Docena was noted monitoring the welder with measured working current of 115 amperes. At the end of the shift, repair welding of the weld joint/location mentioned above was completed and the welder held the same preheat of 350°F on the repair for three hours after welding as required.

Location	Weld No.	Y-dim.	Length	Width	Depth	Remarks
2. 'T'	S-043	2850mm	200mm	50mm	52mm	Completed

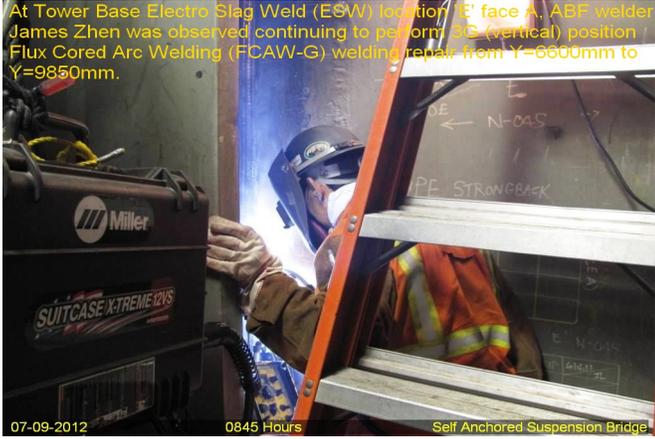
At Tower Base Electro Slag Weld (ESW) location 'E' face A, ABF welder James Zhen was observed continuing to perform 10B (vertical) position Flux Cored Arc Welding (FCAW-G) welding repair from Y=6600mm to Y=9850mm.
