Contract #: 04-0120F4Cty: SF/ALA Rte: 80 PM: 13.2/13.9File #: 1.28**WELDING INSPECTION REPORT****Resident Engineer:** Casey, William**Address:** 333 Burma Road**City:** Oakland, CA 94607**Report No:** WIR-027930**Date Inspected:** 06-Jul-2012**Project Name:** SAS Superstructure**OSM Arrival Time:** 700**Prime Contractor:** American Bridge/Fluor Enterprises, a JV**OSM Departure Time:** 1930**Contractor:** American Bridge/Fluor Enterprises, a JV**Location:** Job site**CWI Name:** Steve McConnell**CWI Present:** Yes No**Inspected CWI report:** Yes No N/A**Rod Oven in Use:** Yes No N/A**Electrode to specification:** Yes No N/A**Weld Procedures Followed:** Yes No N/A**Qualified Welders:** Yes No N/A**Verified Joint Fit-up:** Yes No N/A**Approved Drawings:** Yes No N/A**Approved WPS:** Yes No N/A**Delayed / Cancelled:** Yes No N/A**Bridge No:** 34-0006**Component:** Tower**Summary of Items Observed:**

Electroslag Weld Excavations

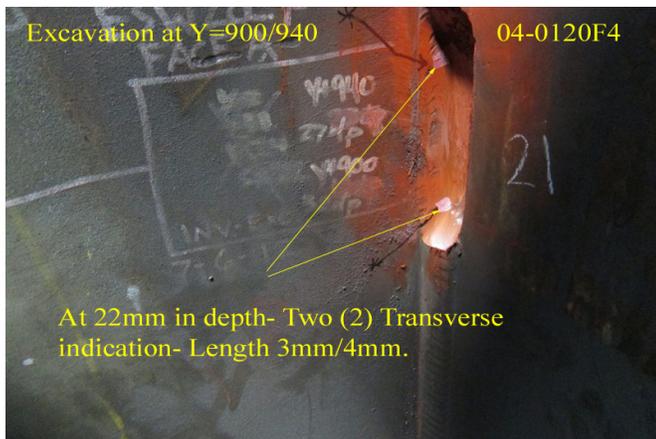
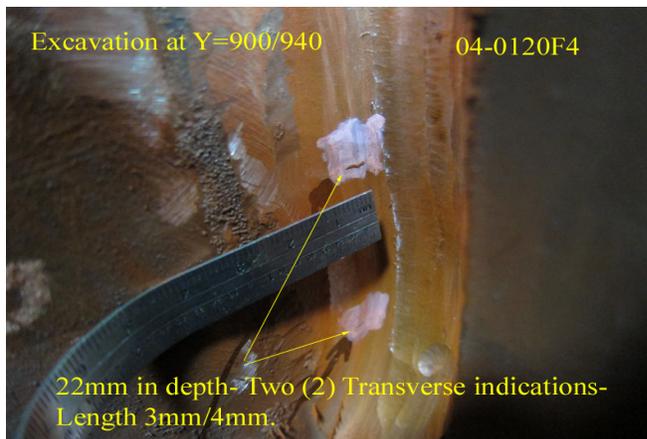
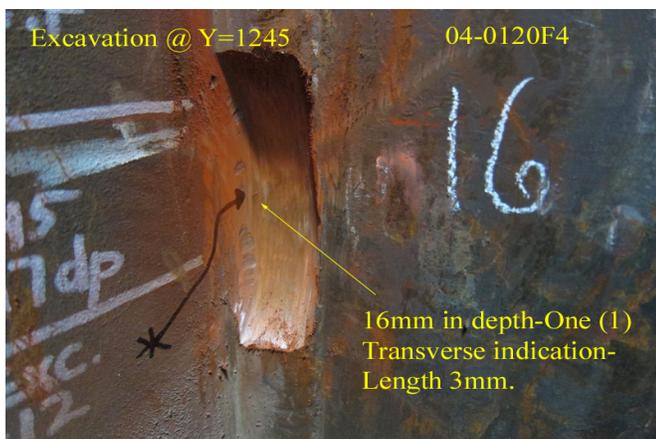
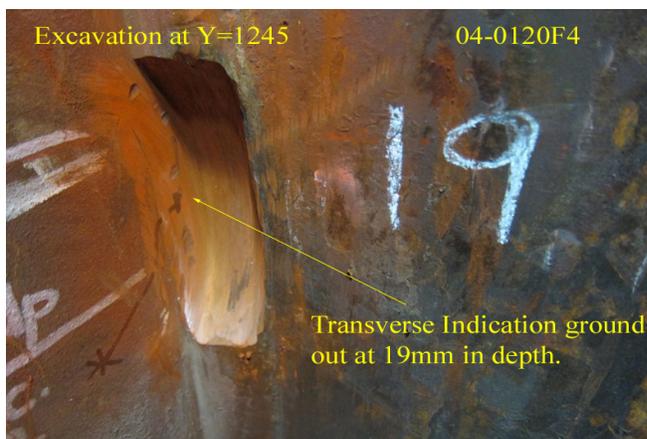
ESW "F" Face A from Y=1180~1330 for a transverse indication ultrasonically detected at approximately Y=1245 (+4 AWS db rating.)

14mm in depth-No Indications found
16mm in depth-One (1) Transverse indication- Length 3mm.
19mm in depth-No Indications found.
22mm in depth-No Indications found.

The transverse indication observed appeared to be in a location not detected during ultrasonic testing. After exploratory ultrasonic testing at the end of the QAI's shift, the sought indication still showed the same ultrasonic response. It was determined that the transverse indications "X" location was approximately 2mm wider than what was currently excavated. The QAI informed the QC inspector that the excavation would need to be widened on the following shift.

ESW "F" Face A from Y=790~960 for a transverse indication ultrasonically detected at approximately Y=900/940 (+16 and +23 AWS db rating.)

Initial Excavation 21mm in depth- one (1) Transverse indication- Length 3mm.
22mm in depth- Two (2) Transverse indication- Length 3mm/4mm.
24mm in depth- one (1) Transverse indication- Length 2mm.
27mm in depth-No Indications found.
28mm in depth-No Indications found.
31mm in depth-No Indications found.

Two (2) of the three (3) indications observed appeared to be in locations not detected during ultrasonic testing.

Indications observed at Y=940 appeared to be in the approximate location detected during ultrasonic testing. The sought depth of the transverse indication at Y=900 was not accomplished during the QAI's shift and further excavation will be needed at a later date.

Please see attached photographs for representative samples of indications observed.
