DEPARTMENT OF TRANSPORTATION

Contract #: 04-0120F4Cty: SF/ALA Rte: 80 PM: 13.2/13.9File #: 1.28**WELDING INSPECTION REPORT****Resident Engineer:** Casey, William**Address:** 333 Burma Road**City:** Oakland, CA 94607**Report No:** WIR-027939**Date Inspected:** 09-Jul-2012**Project Name:** SAS Superstructure**OSM Arrival Time:** 700**Prime Contractor:** American Bridge/Fluor Enterprises, a JV**OSM Departure Time:** 1930**Contractor:** American Bridge/Fluor Enterprises, a JV**Location:** Job site**CWI Name:** John Pagliero**CWI Present:** Yes No**Inspected CWI report:** Yes No N/A**Rod Oven in Use:** Yes No N/A**Electrode to specification:** Yes No N/A**Weld Procedures Followed:** Yes No N/A**Qualified Welders:** Yes No N/A**Verified Joint Fit-up:** Yes No N/A**Approved Drawings:** Yes No N/A**Approved WPS:** Yes No N/A**Delayed / Cancelled:** Yes No N/A**Bridge No:** 34-0006**Component:** Tower**Summary of Items Observed:**

Electroslag Weld Excavations

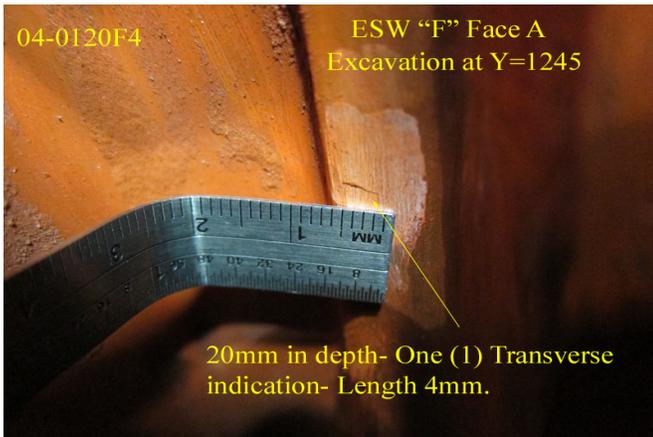
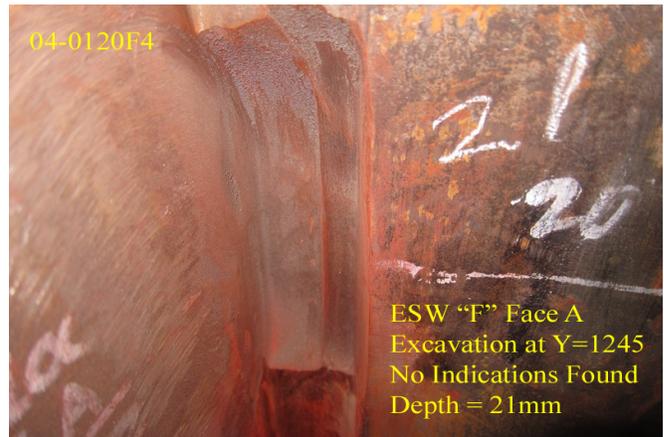
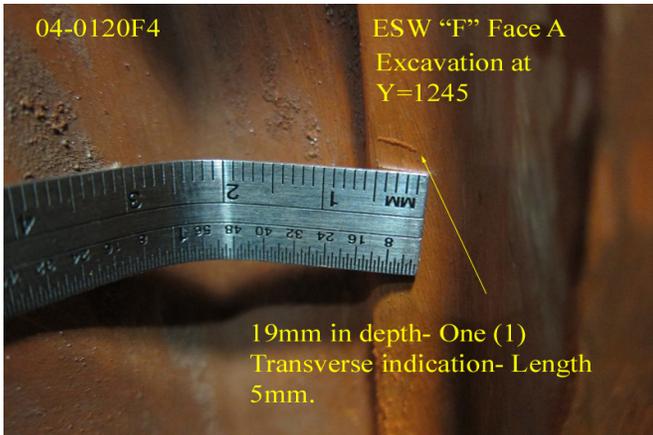
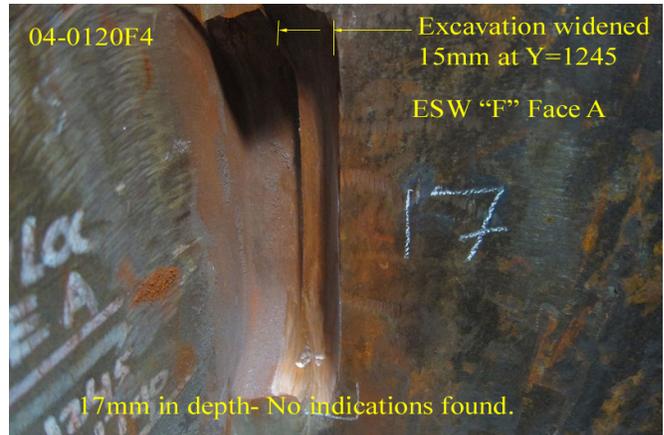
ESW "F" Face A from Y=1180~1330 for a transverse indication ultrasonically detected at approximately Y=1245 (+4 AWS db rating.) The existing excavation was widened by 15mm at the beginning of the shift.

- 15mm in depth-No Indications found
- 17mm in depth- No Indications found
- 19mm in depth- One (1) Transverse indication- Length 5mm.
- 20mm in depth- One (1) Transverse indication- Length 4mm.
- 21mm in depth-No Indications found.

Please see attached photographs for representative samples of indications observed.
