Contract #: 04-0120F4Cty: SF/ALA Rte: 80 PM: 13.2/13.9File #: 1.28**WELDING INSPECTION REPORT**

Report No: WIR-027940
Date Inspected: 10-Jul-2012

Project Name: SAS Superstructure
Prime Contractor: American Bridge/Fluor Enterprises, a JV
Contractor: American Bridge/Fluor Enterprises, a JV

Electroslag Weld Excavations

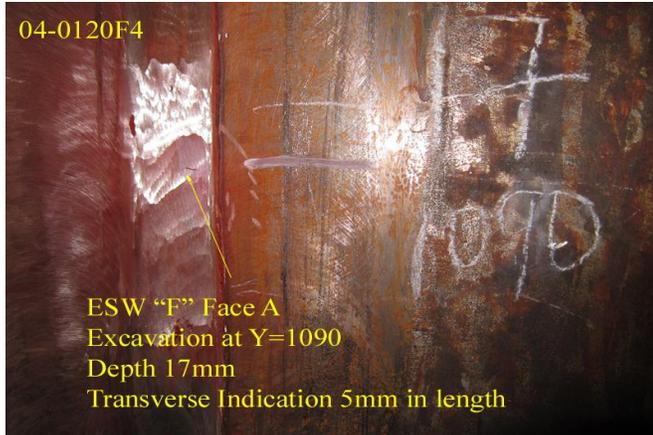
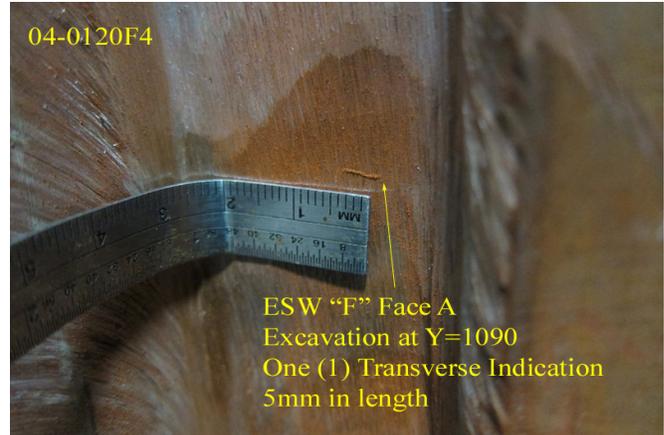
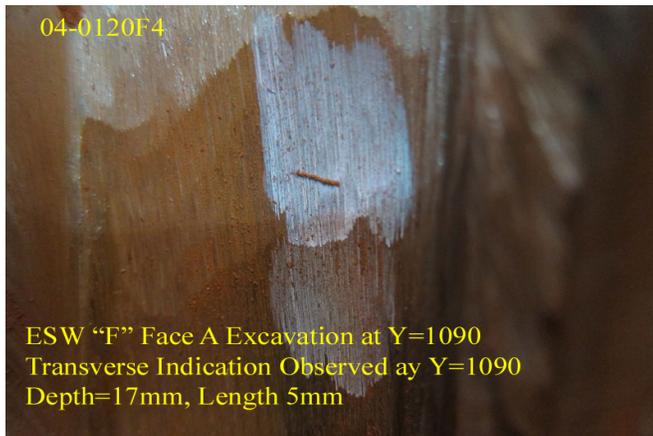
This QA observed ABF/JV welding personnel Wai Kitlai #2953 performing an exploratory excavation of an Electroslag Weld ESW "F" from face A. The exploratory excavation was performed to determine the presence of transverse indications observed during the joint Ultrasonic Testing (UT) performed by the QAI and ABF QC inspector John Pagliero. Due to the presence of weld reinforcement the QAI was unable to size the length and measure the "X" location on the welds in way of the indications observed that were oriented transverse to the weld.

ESW "F" Face A from Y=960~1180 for a transverse indication ultrasonically detected at approximately Y=1090 (+10 AWS db rating.)

17mm in depth- One (1) Transverse indication- Length 5mm.

20mm in depth- One (1) Transverse indication- Length 4mm.

21mm in depth- No Indications found.

Please see attached photographs for representative samples of indications observed.
