Contract #: 04-0120F4Cty: SF/ALA Rte: 80 PM: 13.2/13.9File #: 1.28**WELDING INSPECTION REPORT**

Report No: WIR-027980
Date Inspected: 14-Jul-2012

Project Name: SAS Superstructure
Prime Contractor: American Bridge/Fluor Enterprises, a JV
Contractor: American Bridge/Fluor Enterprises, a JV

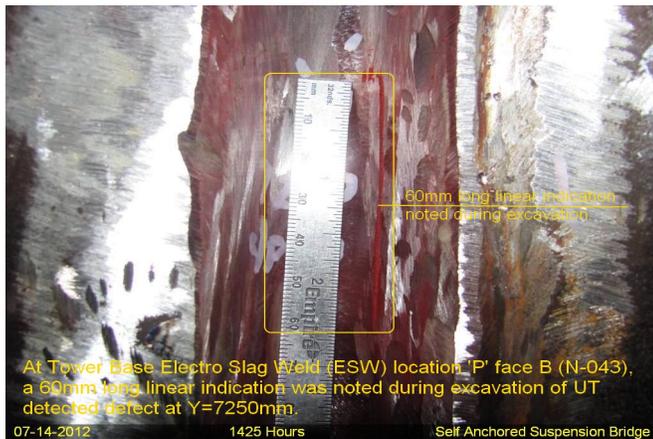
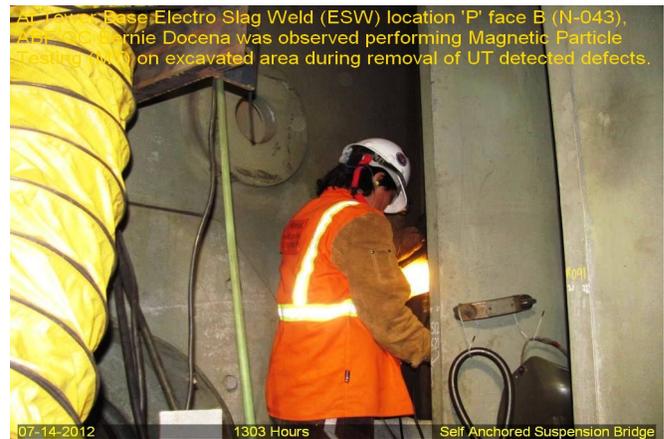
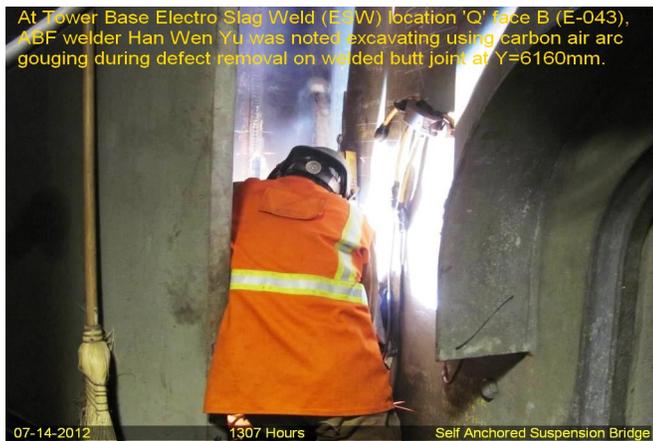
At Tower Base Electro Slag Weld (ESW), this QA observed ABF welder Lou Xiao Hua continuing to perform repair excavation at location 'P' face B (N-043) Y=7860mm and Y=7250mm due to Ultrasonic Testing (UT) detected defect. The repair excavation is being undertaken per Caltrans approved Request for Weld Repair (RWR) #201206-076 and RWR #201206-075 respectively. The welder was noted using carbon air arc gouging followed

by grinding using a die grinder. The excavation was alternately gouged and ground then Magnetic Particle Testing (MT) tested by ABF QC Bernie Docena and this QA until all the defects are removed. The following excavation events were noted during the repair excavation;

ESW location	Y-dim	Depth of excavation	Noted defect
1. 'P' (B)	7860mm	25mm	No relevant indication noted.
2. 'P' (B)	7860mm	35mm	1-35mm & 2-8mm long linear indications.
3. 'P' (B)	7860mm	45mm	1-35mm, 1-12mm & 1-3mm long linear ind.
4. 'P' (B)	7860mm	50mm	All linear indications removed.
5. 'P' (B)	7250mm	30mm	1-60mm long linear indication noted. .
6. 'P' (B)	7250mm	>30mm	Excavation in progress.
