Contract #: 04-0120F4Cty: SF/ALA Rte: 80 PM: 13.2/13.9File #: 1.28**WELDING INSPECTION REPORT****Resident Engineer:** Casey, William**Address:** 333 Burma Road**City:** Oakland, CA 94607**Report No:** WIR-027988**Date Inspected:** 16-Jul-2012**Project Name:** SAS Superstructure**OSM Arrival Time:** 700**Prime Contractor:** American Bridge/Fluor Enterprises, a JV**OSM Departure Time:** 1900**Contractor:** American Bridge/Fluor Enterprises, a JV**Location:** Job site**CWI Name:** Jesse Cayabyab**CWI Present:** Yes No**Inspected CWI report:** Yes No N/A**Rod Oven in Use:** Yes No N/A**Electrode to specification:** Yes No N/A**Weld Procedures Followed:** Yes No N/A**Qualified Welders:** Yes No N/A**Verified Joint Fit-up:** Yes No N/A**Approved Drawings:** Yes No N/A**Approved WPS:** Yes No N/A**Delayed / Cancelled:** Yes No N/A**Bridge No:** 34-0006**Component:** Tower**Summary of Items Observed:**

Electroslag Weld Excavations

WELDING INSPECTION REPORT

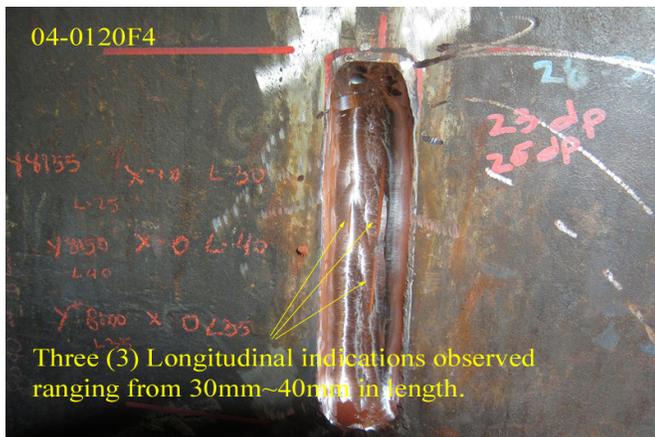
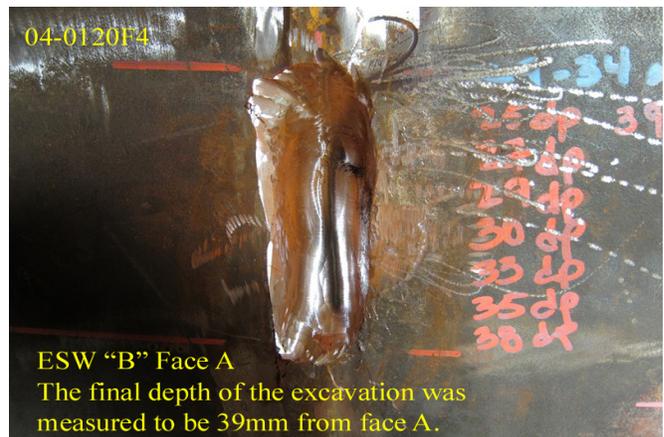
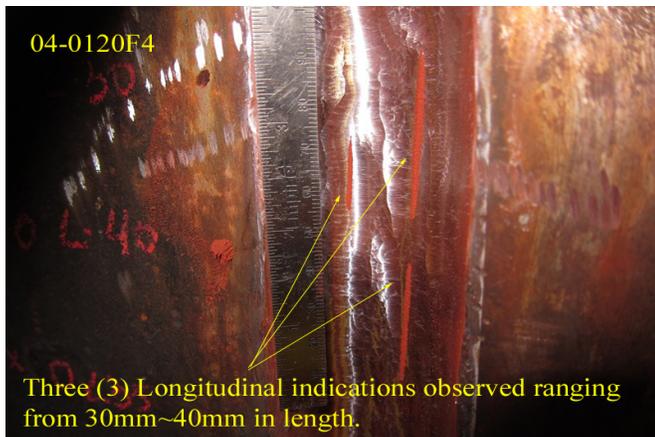
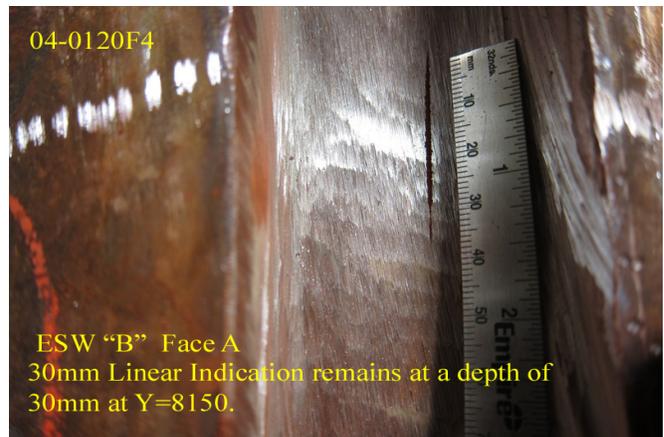
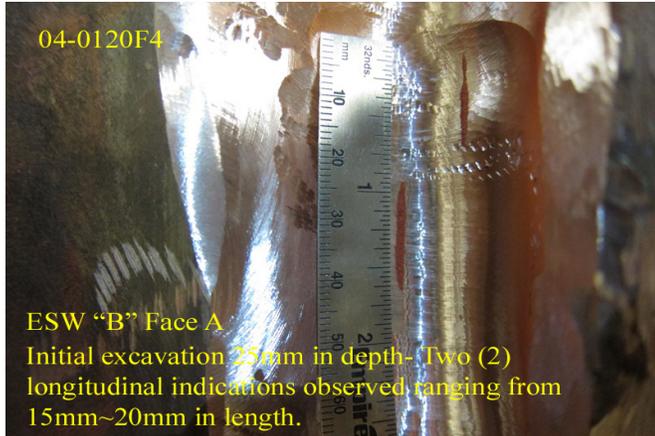
ESW "B" Face A from Y=8340~8480 for a longitudinal recordable indication ultrasonically detected at approximately Y=8390 (+7 AWS db rating.)

Initial excavation 25mm in depth- Two (2) longitudinal indications observed ranging from 15mm~20mm in length. The two indications were ground until the QA/QC team was unable to detect with magnetic particle inspection. The final depth of the excavation was measured to be 39mm from face A.

ESW "B" Face A from Y=8030~8250 for a longitudinal recordable indication ultrasonically detected at approximately Y=8090 (+6 AWS db rating.

)
Initial excavation 23mm in depth- Three (3) Longitudinal indications observed ranging from 30mm~40mm in length. Two indications were ground until the QA/QC team was unable to detect with magnetic particle inspection at a depth of 29mm. The depth of the excavation at the end of the QAI's shift was measured to be 33mm with one (1) remaining 25mm linear indication.

Please see attached photographs for representative samples of indications observed.
