**DEPARTMENT OF TRANSPORTATION**

Contract #: 04-0120F4Cty: SF/ALA Rte: 80 PM: 13.2/13.9File #: 1.28**WELDING INSPECTION REPORT****Resident Engineer:** Casey, William**Address:** 333 Burma Road**City:** Oakland, CA 94607**Report No:** WIR-027989**Date Inspected:** 17-Jul-2012**Project Name:** SAS Superstructure**OSM Arrival Time:** 700**Prime Contractor:** American Bridge/Fluor Enterprises, a JV**OSM Departure Time:** 1900**Contractor:** American Bridge/Fluor Enterprises, a JV**Location:** Job site**CWI Name:** Jesse Cayabyab**CWI Present:** Yes No**Inspected CWI report:** Yes No N/A**Rod Oven in Use:** Yes No N/A**Electrode to specification:** Yes No N/A**Weld Procedures Followed:** Yes No N/A**Qualified Welders:** Yes No N/A**Verified Joint Fit-up:** Yes No N/A**Approved Drawings:** Yes No N/A**Approved WPS:** Yes No N/A**Delayed / Cancelled:** Yes No N/A**Bridge No:** 34-0006**Component:** Tower**Summary of Items Observed:**

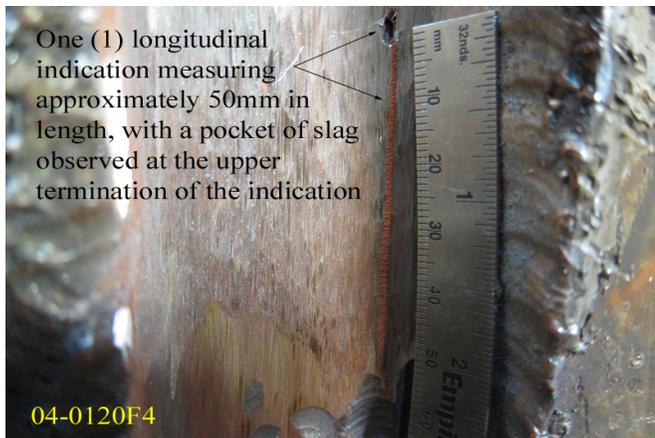
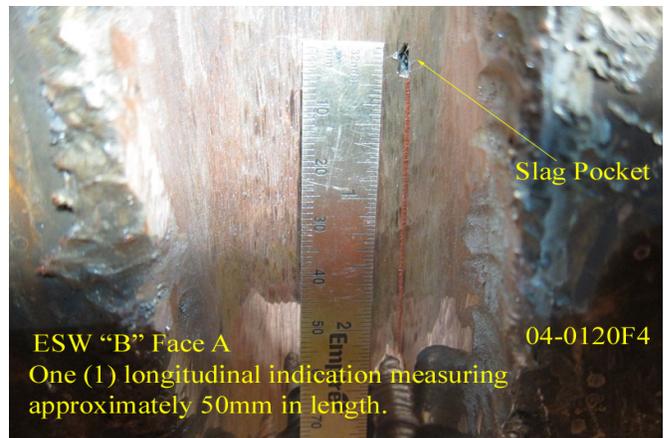
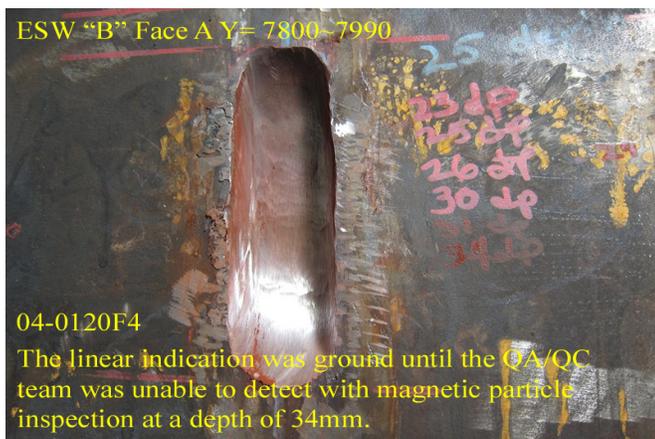
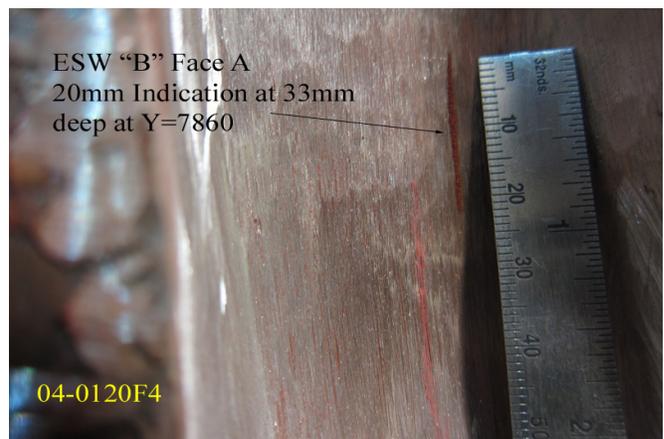
This QA observed ABF/JV welding personnel Wen Han Yu #6317 performing an exploratory excavation of an Electroslag Weld ESW "B" from face A. The exploratory excavation was performed to compare the AWS decibel rating to the actual indication observed due to the attenuation of sound in the coarse grained welds. The indications that were excavated were discovered by the joint QA/QC inspection team on a previous shift. The joint inspection team utilized the supplemental UT procedure SE-UT-D1.5-CT-108-ESW-R5 for the inspection of electroslag welds; however the use of the pitch-catch ultrasonic testing has not been utilized to date.

The carbon arc gouging process as well as grinding was used to excavate approximately 2mm at a time once near the indications depth. In between excavation passes both QAI and QC inspector Jesse Cayabyab performed Magnetic Particle Testing (MT) and photographed any observed indications found at the achieved depth. The weld ESW "B" was excavated at the following Y locations on this date. The details of the QA/QC findings were recorded on a joint inspection form for ESW weld excavations and are as follows;

ESW "B" Face A from Y=8030~8250 for a longitudinal recordable indication ultrasonically detected at approximately Y=8090 (+6 AWS db rating.)

Existing excavation from the previous shift- One (1) longitudinal indication observed, measured to be 25mm in length. The indication was ground until the QA/QC team was unable to detect with magnetic particle inspection at a depth of 39mm.

ESW "B" Face A from Y=7800~7990 for a longitudinal recordable indication ultrasonically detected at approximately Y=7860 (+5 AWS db rating.)

Initial excavation 23mm in depth- One (1) longitudinal indication measuring approximately 50mm in length, with a pocket of slag observed at the upper termination of the indication. The linear indication was ground until the QA/QC team was unable to detect with magnetic particle inspection at a depth of 34mm. The QA/QC team was unable to photo document the excavation at 2mm intervals due to over grinding by ABF personnel between 25mm~29mm in depth.
