Contract #: 04-0120F4Cty: SF/ALA Rte: 80 PM: 13.2/13.9File #: 1.28**WELDING INSPECTION REPORT**

**Report No:** WIR-028003  
**Date Inspected:** 18-Jul-2012

**Project Name:** SAS Superstructure  
**Prime Contractor:** American Bridge/Fluor Enterprises, a JV  
**Contractor:** American Bridge/Fluor Enterprises, a JV

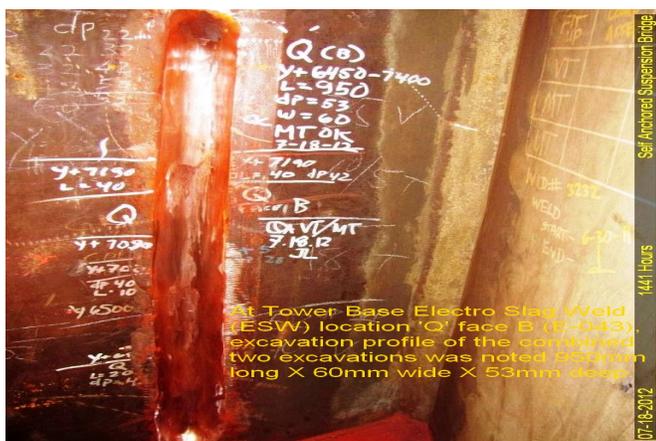
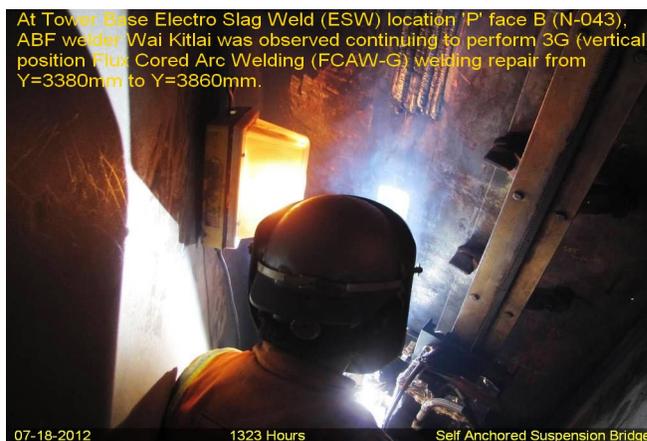
At Tower Base Electro Slag Weld (ESW), this QA observed ABF welder Lou Xiao Hua continuing to perform repair excavation at location 'Q' face B (E-043) Y=6500mm and Y=6980mm due to Ultrasonic Testing (UT) detected defect. The repair excavation is being undertaken per Caltrans approved Request for Weld Repair RWR #201206-085 and #201206-086 respectively. The welder was noted using carbon air arc gouging followed by grinding using a die grinder. The excavation was alternately gouged and ground then Magnetic Particle Testing (MT) tested by ABF QC Bernie Docena and this QA. The following excavation events were noted during the repair excavation;

ESW location	Y-dim	Depth of excavation	Noted defect
1. 'Q' (B)	6500/6980mm	50mm	1-5mm transverse & 3-4mm long linear indications noted.
2. 'Q' (B)	6500/6980mm	52mm	All transverse/linear indications removed.
