Contract #: 04-0120F4Cty: SF/ALA Rte: 80 PM: 13.2/13.9File #: 1.28**WELDING INSPECTION REPORT**

**Report No:** WIR-028011  
**Date Inspected:** 19-Jul-2012

**Project Name:** SAS Superstructure  
**Prime Contractor:** American Bridge/Fluor Enterprises, a JV  
**Contractor:** American Bridge/Fluor Enterprises, a JV

<b>CWI Name:</b>	As noted below.	<b>CWI Present:</b>	Yes	No
<b>Inspected CWI report:</b>	Yes No N/A	<b>Rod Oven in Use:</b>	Yes No N/A	
<b>Electrode to specification:</b>	Yes No N/A	<b>Weld Procedures Followed:</b>	Yes No N/A	
<b>Qualified Welders:</b>	Yes No N/A	<b>Verified Joint Fit-up:</b>	Yes No N/A	
<b>Approved Drawings:</b>	Yes No N/A	<b>Approved WPS:</b>	Yes No N/A	
		<b>Delayed / Cancelled:</b>	Yes No N/A	
<b>Bridge No:</b>	34-0006	<b>Component:</b>	Tower Component

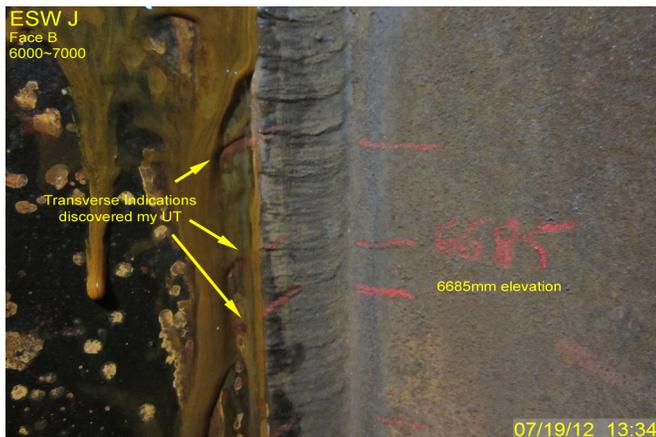
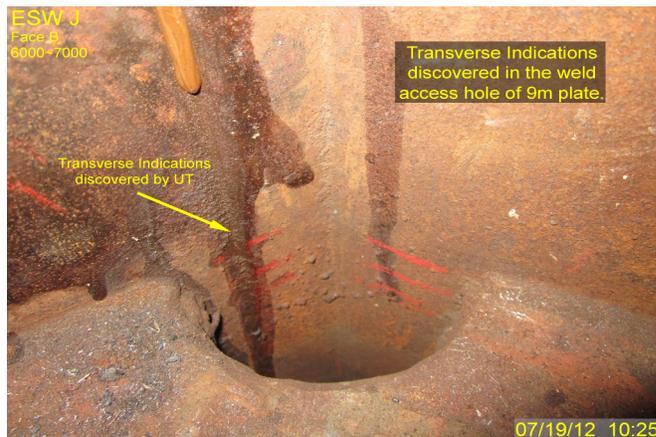
ESW J, Face B:

This QA performed Ultrasonic Testing (UT) on approximately 1050mm of Tower Electroslag Complete Joint Penetration (CJP) shear plate weld designated as "ESW J" face B. Location (Y=6000~7050) of this weld was inspected using this testing method.

This QA observed no planar recordable indications at the time of testing.
