Contract #: 04-0120F4Cty: SF/ALA Rte: 80 PM: 13.2/13.9File #: 1.28**WELDING INSPECTION REPORT****Resident Engineer:** Casey, William**Address:** 333 Burma Road**City:** Oakland, CA 94607**Report No:** WIR-028023**Date Inspected:** 20-Jul-2012**Project Name:** SAS Superstructure**OSM Arrival Time:** 700**Prime Contractor:** American Bridge/Fluor Enterprises, a JV**OSM Departure Time:** 1530**Contractor:** American Bridge/Fluor Enterprises, a JV**Location:** Job site

Bridge No: 34-0006**Component:** Tower**Summary of Items Observed:**

Electroslag Weld Excavations

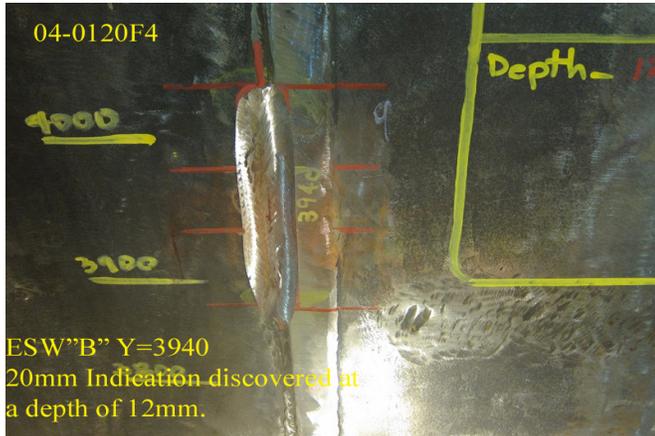
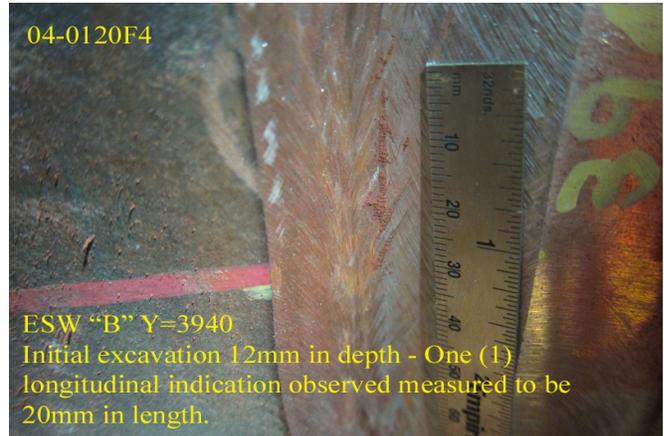
ESW "B" Face A from Y=3880~4020 for a longitudinal recordable indication ultrasonically detected at approximately Y=3940 (+3 AWS db rating.)

Initial excavation 12mm in depth - One (1) longitudinal indication observed measured to be 20mm in length. The QAI and QC inspector Jesse Cayabyab were instructed by QA and QC management during this shift to terminate the exploratory excavations until further notice. Additional grinding of the indication will be required on a later shift.
