DEPARTMENT OF TRANSPORTATION

Contract #: 04-0120F4Cty: SF/ALA Rte: 80 PM: 13.2/13.9File #: 1.28**WELDING INSPECTION REPORT****Resident Engineer:** Casey, William**Address:** 333 Burma Road**City:** Oakland, CA 94607**Report No:** WIR-028044**Date Inspected:** 24-Jul-2012**Project Name:** SAS Superstructure**OSM Arrival Time:** 900**Prime Contractor:** American Bridge/Fluor Enterprises, a JV**OSM Departure Time:** 1930**Contractor:** American Bridge/Fluor Enterprises, a JV**Location:** Job site**CWI Name:** Salvador Merino**CWI Present:** Yes No**Inspected CWI report:** Yes No N/A**Rod Oven in Use:** Yes No N/A**Electrode to specification:** Yes No N/A**Weld Procedures Followed:** Yes No N/A**Qualified Welders:** Yes No N/A**Verified Joint Fit-up:** Yes No N/A**Approved Drawings:** Yes No N/A**Approved WPS:** Yes No N/A**Delayed / Cancelled:** Yes No N/A**Bridge No:** 34-0006**Component:** OBG**Summary of Items Observed:**

Ultrasonic Testing (OBG Deck)

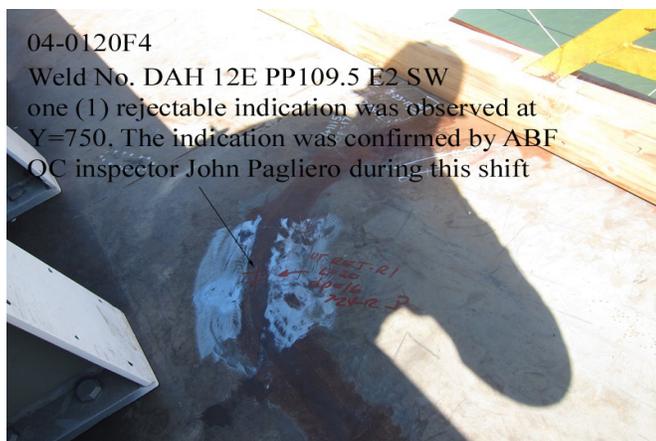
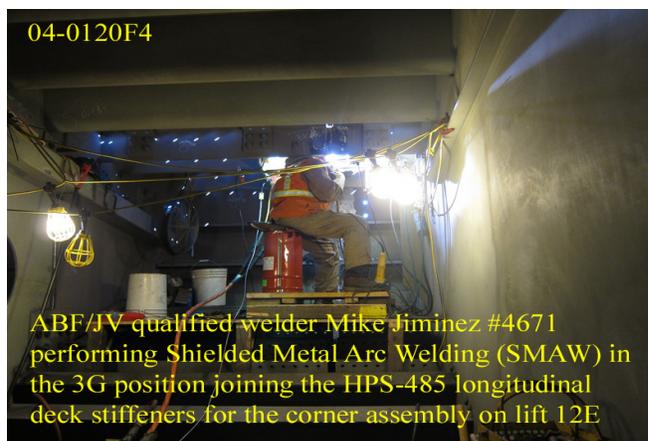
This QA inspector periodically observed ABF/JV qualified welder Mike Jiminez #4671 performing Shielded Metal Arc Welding (SMAW) in the 3G position implementing Caltrans approved Welding Procedure Specification (WPS) ABF-WPS-D1.5-1012 Rev3. The weld is a Complete Joint Penetration (CJP) butt weld, joining the HPS-485 longitudinal deck stiffeners for the corner assembly on lift 12E. The weld is designated as 12E-PP111.1-LS2. The weld surface and surrounding area was brought to temperature the use of induction heaters and the preheat temperature was confirmed by ABF Quality Control (QC) prior to welding. The Quality Control (QC) inspector Salvador Merino was observed monitoring the welding parameters at the beginning of welding. The QAI spent a portion of this shift reviewing and documenting the status and completion of various production welding tracking logs for lift 13E/14E drop-in deck work currently in-process. The QA recorded the information on the OBG tracking log.

This QA inspector observed at random intervals ABF/JV qualified welder Richard Garcia #5892 performing Shielded Metal Arc Welding (SMAW) in the 2G position implementing Caltrans approved Welding Procedure Specification (WPS) ABF-WPS-D1.5-1072. The weld is a Complete Joint Penetration (CJP) butt weld, joining the HPS-485 longitudinal deck stiffener to the K-plate. The weld surface and surrounding area was brought to temperature the use of induction heaters and the preheat temperature was confirmed by ABF Quality Control (QC) prior to welding. The Quality Control (QC) inspector Salvador Merino was observed monitoring the welding parameters at the beginning of the shift.
