DEPARTMENT OF TRANSPORTATION

Quality Assurance and Source Inspection

Contract #: 04-0120F4Cty: SF/ALA Rte: 80 PM: 13.2/13.9File #: 1.28**WELDING INSPECTION REPORT****Resident Engineer:** Casey, William**Address:** 333 Burma Road**City:** Oakland, CA 94607**Report No:** WIR-028059**Date Inspected:** 25-Jul-2012**Project Name:** SAS Superstructure**OSM Arrival Time:** 900**Prime Contractor:** American Bridge/Fluor Enterprises, a JV**OSM Departure Time:** 1930**Contractor:** American Bridge/Fluor Enterprises, a JV**Location:** Job site**CWI Name:** Salvador Merino**CWI Present:** Yes No**Inspected CWI report:** Yes No N/A**Rod Oven in Use:** Yes No N/A**Electrode to specification:** Yes No N/A**Weld Procedures Followed:** Yes No N/A**Qualified Welders:** Yes No N/A**Verified Joint Fit-up:** Yes No N/A**Approved Drawings:** Yes No N/A**Approved WPS:** Yes No N/A**Delayed / Cancelled:** Yes No N/A**Bridge No:** 34-0006**Component:** OBG**Summary of Items Observed:**

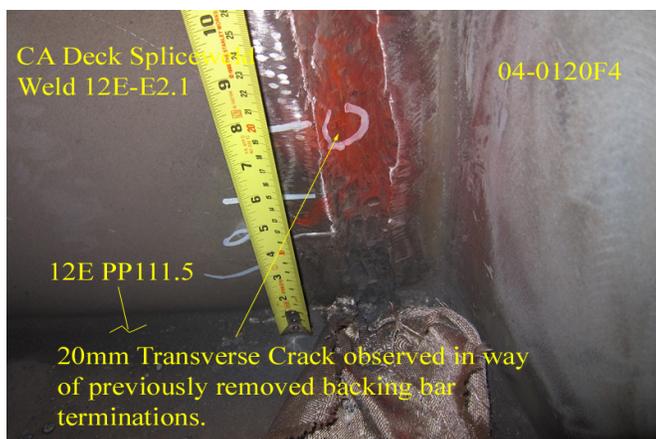
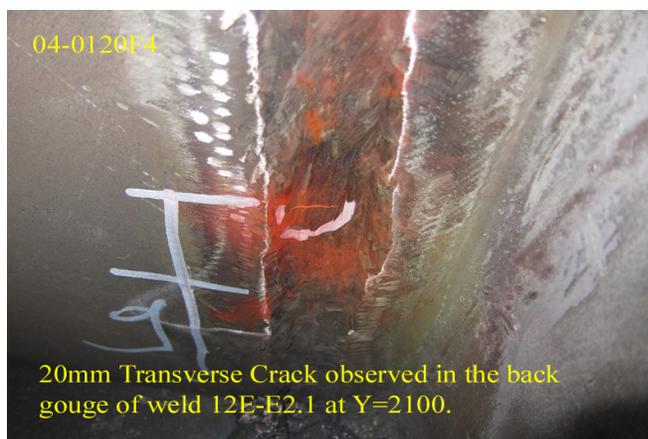
During the QA verification Magnetic Particle Testing (MT) of the back gouged weld designated as 12E-E2.1, a total of one (1) transverse crack was observed at Y=2100 that measured to be a total of 20mm in length. The transverse crack was located at an area marked by QA as a termination of non-continuous backing on a previous shift. Subsequent exploratory Ultrasonic Testing of the weld was performed by QA, utilizing scanning pattern D on the weld face in way of the previously marked backing terminations appeared to show similar weld defects at approximately 2.4 meter intervals (typical length of backing used).
