Contract #: 04-0120F4Cty: SF/ALA Rte: 80 PM: 13.2/13.9File #: 1.28**WELDING INSPECTION REPORT**

**Report No:** WIR-028081  
**Date Inspected:** 31-Jul-2012

**Project Name:** SAS Superstructure  
**Prime Contractor:** American Bridge/Fluor Enterprises, a JV  
**Contractor:** American Bridge/Fluor Enterprises, a JV

**Electroslag Weld Excavation / Repair**

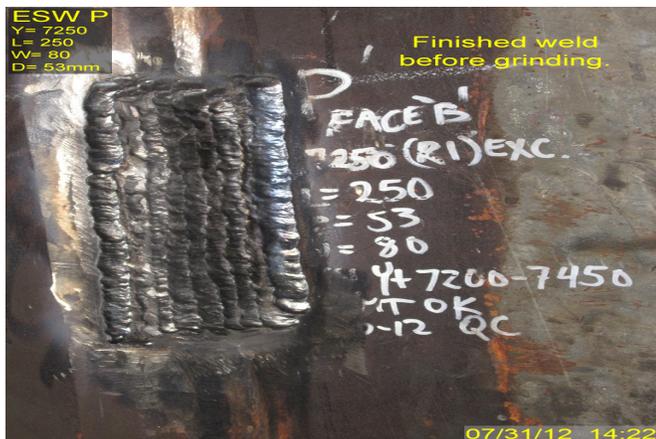
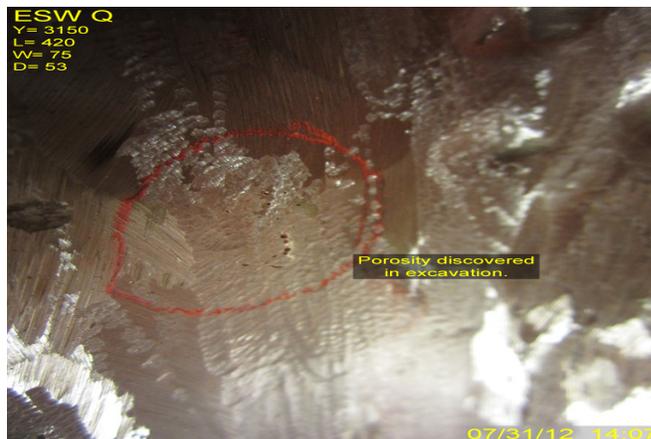
Both QA and QC performed Magnetic Particle Testing (MT) and photographed discovered indications.

Near completion of this excavation this QA observed and photographed one (1) grouping of porosity located at the side wall.
