Contract #: 04-0120F4Cty: SF/ALA Rte: 80 PM: 13.2/13.9File #: 1.28**WELDING INSPECTION REPORT****Resident Engineer:** Casey, William**Address:** 333 Burma Road**City:** Oakland, CA 94607**Report No:** WIR-028091**Date Inspected:** 01-Aug-2012**Project Name:** SAS Superstructure**OSM Arrival Time:** 700**Prime Contractor:** American Bridge/Fluor Enterprises, a JV**OSM Departure Time:** 1930**Contractor:** American Bridge/Fluor Enterprises, a JV**Location:** Job site**CWI Name:** Julian Razo**CWI Present:** Yes No**Inspected CWI report:** Yes No N/A**Rod Oven in Use:** Yes No N/A**Electrode to specification:** Yes No N/A**Weld Procedures Followed:** Yes No N/A**Qualified Welders:** Yes No N/A**Verified Joint Fit-up:** Yes No N/A**Approved Drawings:** Yes No N/A**Approved WPS:** Yes No N/A**Delayed / Cancelled:** Yes No N/A**Bridge No:** 34-0006**Component:** OBG**Summary of Items Observed:**

Lift 14W In-Process Inspection

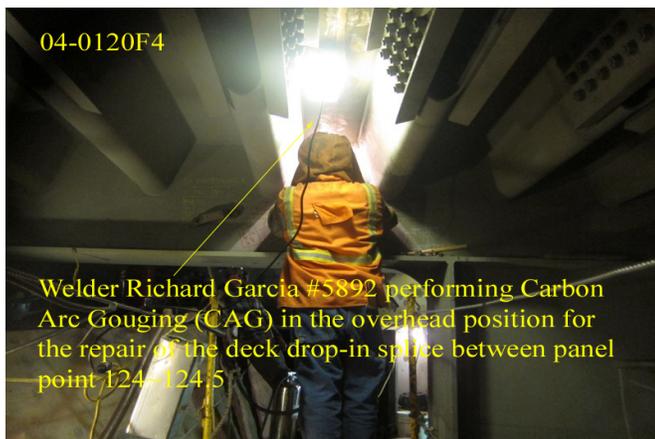
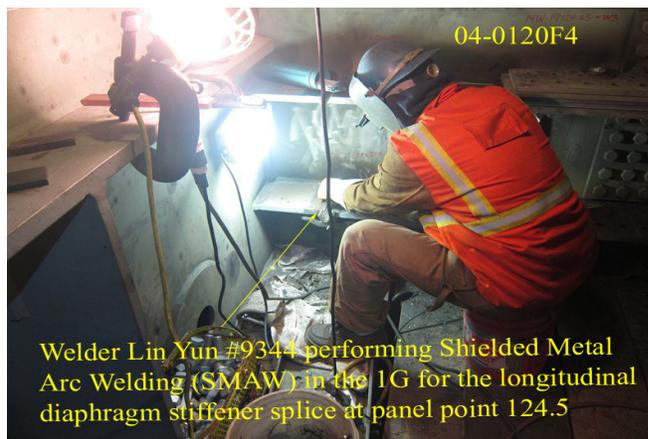
Carbon Arc Gouging (CAG) in the overhead position for the repair of the deck drop-in splice between panel point 124~124.5 designated as 13W-W2.8. The weld surface and surrounding area was brought to temperature by the use of induction heaters prior to gouging. The weld is being re-gouged 100% to 10mm in depth from face B, due to the amount of indications found during the ABF QC final Ultrasonic Testing inspection. The repairs at this location are being conducted in accordance with RWR-201208-001.

The QA inspector noted and periodically observed ABF/JV qualified welder Rick Clayborn #2773 performing Shielded Metal Arc Welding (SMAW) in the 4G position utilizing the Caltrans approved Welding Procedure Specification ABF-WPS-D1.5-1004-Repair. The welding is being performed for the repair of the deck drop-in splice between panel point 122~122.5 designated as 13W-W2.1. The weld surface and surrounding area was brought to temperature by the use of induction heaters prior to welding. The weld will be re-gouged in sections, throughout the entire length to 12mm in depth from face B, due to the amount of indications found during the ABF QC final Ultrasonic Testing inspection. The repairs at this location are being conducted in accordance with RWR-201207-016.
