DEPARTMENT OF TRANSPORTATION

Contract #: 04-0120F4Cty: SF/ALA Rte: 80 PM: 13.2/13.9File #: 1.28**WELDING INSPECTION REPORT****Resident Engineer:** Casey, William**Address:** 333 Burma Road**City:** Oakland, CA 94607**Report No:** WIR-028100**Date Inspected:** 03-Aug-2012**Project Name:** SAS Superstructure**OSM Arrival Time:** 700**Prime Contractor:** American Bridge/Fluor Enterprises, a JV**OSM Departure Time:** 1930**Contractor:** American Bridge/Fluor Enterprises, a JV**Location:** Job Site**CWI Name:** Julian Razo**CWI Present:** Yes No**Inspected CWI report:** Yes No N/A**Rod Oven in Use:** Yes No N/A**Electrode to specification:** Yes No N/A**Weld Procedures Followed:** Yes No N/A**Qualified Welders:** Yes No N/A**Verified Joint Fit-up:** Yes No N/A**Approved Drawings:** Yes No N/A**Approved WPS:** Yes No N/A**Delayed / Cancelled:** Yes No N/A**Bridge No:** 34-0006**Component:** SAS Tower**Summary of Items Observed:**

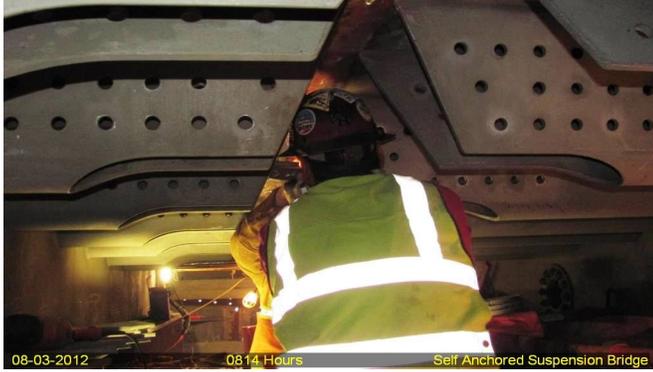
At OBG 13W/14W-A1 drop-in top deck plate splice butt joint inside, ABF QC Julian Razo was observed performing Magnetic Particle Testing (MT) on the excavation of defect removal at Y=4405mm.

The same welder was tasked to perform welding repair at OBG 13W/14W top deck plate A1. At this repair location, the welder has excavated UT detected defect at Y=4405mm with boat shape dimensions 90mm long X 20mm wide X 9mm deep. The defect removal excavation was tested by ABF QC Julian Razo using Magnetic Particle Testing (MT) and it was verified by this QA. The repair area was preheated to more than 325°F using Miller Proheat 35 Induction Heating System prior and during welding. After the completion of the repair, the welder performed Post Weld Heat Treated (PWHT) at 450°F for one hour as required.

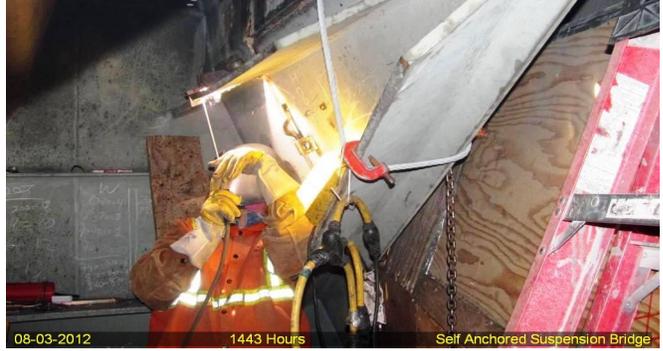
At OBG 13W-WK-S1 K-plate stiffener #1 splice butt joint inside, ABF welder Chau Tran was observed performing 4G (overhead) position Shielded Metal Arc Welding (SMAW) welding root pass to fill pass on butt joint.
