**DEPARTMENT OF TRANSPORTATION**

Contract #: 04-0120F4Cty: SF/ALA Rte: 80 PM: 13.2/13.9File #: 1.28**WELDING INSPECTION REPORT****Resident Engineer:** Casey, William**Address:** 333 Burma Road**City:** Oakland, CA 94607**Report No:** WIR-028126**Date Inspected:** 07-Aug-2012**Project Name:** SAS Superstructure**OSM Arrival Time:** 800**Prime Contractor:** American Bridge/Fluor Enterprises, a JV**OSM Departure Time:** 1930**Contractor:** American Bridge/Fluor Enterprises, a JV**Location:** Job Site**CWI Name:** Julian Razo**CWI Present:** Yes No**Inspected CWI report:** Yes No N/A**Rod Oven in Use:** Yes No N/A**Electrode to specification:** Yes No N/A**Weld Procedures Followed:** Yes No N/A**Qualified Welders:** Yes No N/A**Verified Joint Fit-up:** Yes No N/A**Approved Drawings:** Yes No N/A**Approved WPS:** Yes No N/A**Delayed / Cancelled:** Yes No N/A**Bridge No:** 34-0006**Component:** SAS Tower**Summary of Items Observed:**

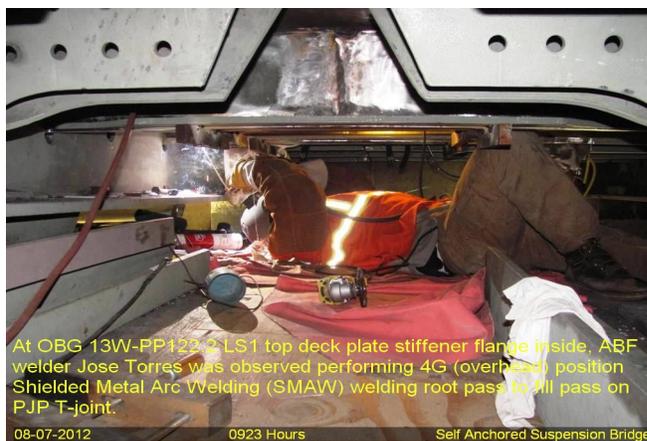
At OBG 13W-PP122.2-LS1 deck stiffener flange inside, QA randomly observed ABF/JV qualified welder Jose Torres perform PJP groove welding root pass to fill pass on the deck stiffener flange T-joint. The welder was observed perform manual welding in the 4G (overhead) position utilizing a Shielded Metal Arc Welding (SMAW) with 3.2mm diameter E9018H4R electrode and implementing Caltrans approved Welding Procedure Specification (WPS) ABF-WPS-D15-1162-4. The stiffener flange plate has a bevel groove being welded PJP T-joint to the longitudinal stiffener. The plates were preheated to more than 200 degree Fahrenheit using Miller Proheat 35 Induction Heating System. During welding, ABF Quality Control (QC) Julian Razo was noted monitoring the

welding parameters of the welder with measured working current of 124 amperes on the 3.2mm E9018H4R. At the end of the shift, fill pass welding was still continuing and should remain tomorrow. The welder held the same preheat of >200 degree Fahrenheit for three hours after welding as required.
