**DEPARTMENT OF TRANSPORTATION**

Contract #: 04-0120F4Cty: SF/ALA Rte: 80 PM: 13.2/13.9File #: 1.28**WELDING INSPECTION REPORT****Resident Engineer:** Casey, William**Address:** 333 Burma Road**City:** Oakland, CA 94607**Report No:** WIR-028128**Date Inspected:** 07-Aug-2012**Project Name:** SAS Superstructure**OSM Arrival Time:** 700**Prime Contractor:** American Bridge/Fluor Enterprises, a JV**OSM Departure Time:** 1930**Contractor:** American Bridge/Fluor Enterprises, a JV**Location:** Job site**CWI Name:** Salvador Merino**CWI Present:** Yes No**Inspected CWI report:** Yes No N/A**Rod Oven in Use:** Yes No N/A**Electrode to specification:** Yes No N/A**Weld Procedures Followed:** Yes No N/A**Qualified Welders:** Yes No N/A**Verified Joint Fit-up:** Yes No N/A**Approved Drawings:** Yes No N/A**Approved WPS:** Yes No N/A**Delayed / Cancelled:** Yes No N/A**Bridge No:** 34-0006**Component:** OBG**Summary of Items Observed:**

# WELDING INSPECTION REPORT

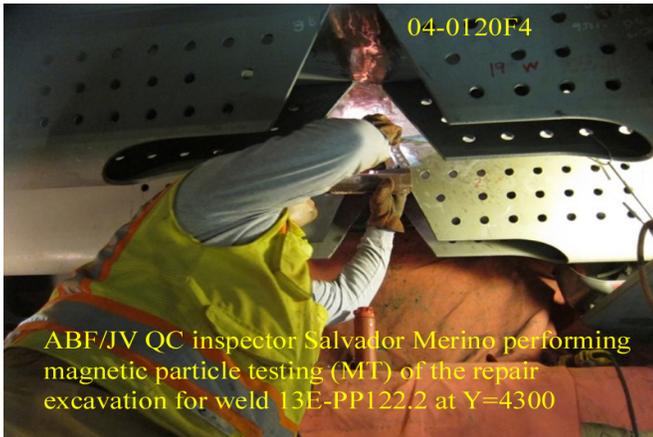
This QAI randomly observed ABF/JV QC inspector Salvador Merino performing magnetic particle testing (MT) of the repair excavation for weld 13E-PP122.2 at Y=4300 as seen in the attached photograph.

After the (MT) was performed the QAI observed ABF/JV qualified welder Wai Kitlai #2953 performing Shielded Metal Arc Welding (SMAW) in the 4G position utilizing the Caltrans approved Welding Procedure Specification ABF-WPS-D1.5-1004-Repair. The welding observed was for repairs to the deck panel drop-in weld designated as 13E-PP122.2. The weld surface and surrounding area was brought to temperature by the use of an induction heater and the preheat temperature was confirmed ABF personnel prior to welding. Due to the first time repair at this
