**DEPARTMENT OF TRANSPORTATION**

Contract #: 04-0120F4Cty: SF/ALA Rte: 80 PM: 13.2/13.9File #: 1.28**WELDING INSPECTION REPORT****Resident Engineer:** Casey, William**Address:** 333 Burma Road**City:** Oakland, CA 94607**Report No:** WIR-028136**Date Inspected:** 08-Aug-2012**Project Name:** SAS Superstructure**OSM Arrival Time:** 700**Prime Contractor:** American Bridge/Fluor Enterprises, a JV**OSM Departure Time:** 1930**Contractor:** American Bridge/Fluor Enterprises, a JV**Location:** Job Site**CWI Name:** Julian Razo**CWI Present:** Yes No**Inspected CWI report:** Yes No N/A**Rod Oven in Use:** Yes No N/A**Electrode to specification:** Yes No N/A**Weld Procedures Followed:** Yes No N/A**Qualified Welders:** Yes No N/A**Verified Joint Fit-up:** Yes No N/A**Approved Drawings:** Yes No N/A**Approved WPS:** Yes No N/A**Delayed / Cancelled:** Yes No N/A**Bridge No:** 34-0006**Component:** SAS OBG**Summary of Items Observed:**

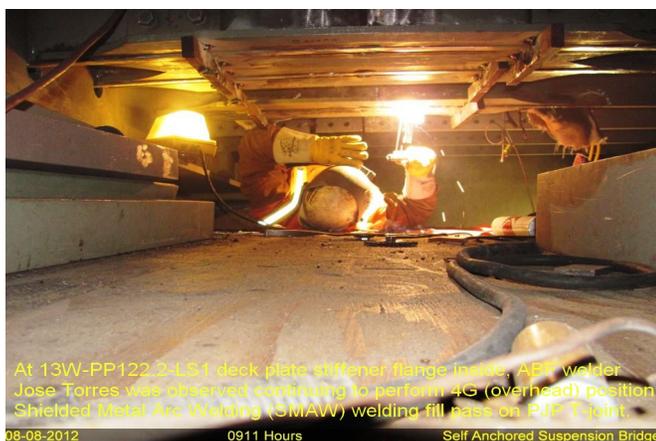
08-08-2012 0911 Hours Self Anchored Suspension Bridge

At OBG 13W-PP122.2-LS1 deck stiffener flange inside, QA randomly observed ABF/JV qualified welder Jose Torres perform PJP groove welding root pass to fill pass on the deck stiffener flange T-joint. The welder was observed perform manual welding in the 4G (overhead) position utilizing a Shielded Metal Arc Welding (SMAW) with 3.2mm diameter E9018H4R electrode and implementing Caltrans approved Welding Procedure Specification (WPS) ABF-WPS-D15-1162-4. The stiffener flange plate has a bevel groove being welded PJP T-joint to the longitudinal stiffener. The plates were preheated to more than 200 degree Fahrenheit using Miller Proheat 35 Induction Heating System. During welding, ABF Quality Control (QC) Julian Razo was noted monitoring the welding parameters of the welder with measured working current of 125 amperes on the 3.2mm E9018H4R. At the end of the shift, fill pass welding was still continuing and should remain tomorrow. The welder held the same preheat of >200 degree Fahrenheit for three hours after welding as required.

At 13W-PP122 2-LS1 deck plate stiffener flange inside, ABF welder Jose Torres was observed continuing to perform 4G (overhead) position Shielded Metal Arc Welding (SMAW) welding fill pass on PJP T-joint.

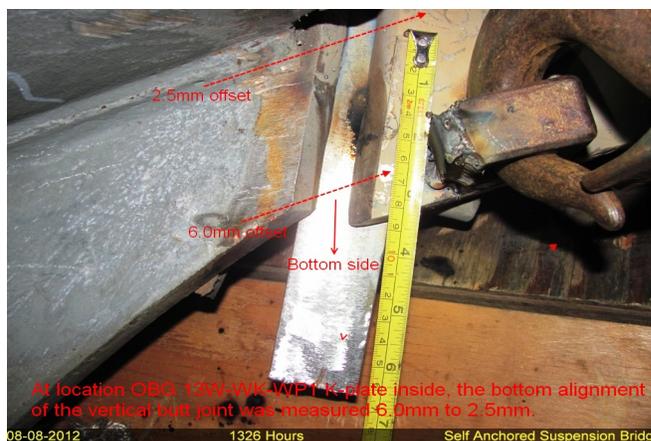
08-08-2012 1326 Hours Self Anchored Suspension Bridge

At OBG 13W-WK- WP1 K-plate inside, QA randomly observed ABF/JV qualified welder Chau Tran continuing to perform CJP groove welding root pass fill pass on the K plate butt joint. Prior welding, ABF foreman Rick Clayborn performed the fit up of the 18mm thick single V butt joint. After the completion of the fit up, ABF QC Julian Razo performed the fit up check and noted an offset of 6.0mm maximum at the bottom of the joint. According to Mr. Razo, he will map up the misalignment and submit it to ABF for review. This QA performed the verification and noted the same. Due to misalignment that was out of tolerance, this QA has generated an Incident Report.

At location OBG 13W-WK WP1 K-plate inside, the bottom alignment of the vertical butt joint was measured 6.0mm to 2.5mm.
