DEPARTMENT OF TRANSPORTATION

Contract #: 04-0120F4Cty: SF/ALA Rte: 80 PM: 13.2/13.9File #: 1.28**WELDING INSPECTION REPORT****Resident Engineer:** Casey, William**Address:** 333 Burma Road**City:** Oakland, CA 94607**Report No:** WIR-028151**Date Inspected:** 12-Aug-2012**Project Name:** SAS Superstructure**OSM Arrival Time:** 700**Prime Contractor:** American Bridge/Fluor Enterprises, a JV**OSM Departure Time:** 1530**Contractor:** American Bridge/Fluor Enterprises, a JV**Location:** Job Site**CWI Name:** Bernie Docena**CWI Present:** Yes No**Inspected CWI report:** Yes No N/A**Rod Oven in Use:** Yes No N/A**Electrode to specification:** Yes No N/A**Weld Procedures Followed:** Yes No N/A**Qualified Welders:** Yes No N/A**Verified Joint Fit-up:** Yes No N/A**Approved Drawings:** Yes No N/A**Approved WPS:** Yes No N/A**Delayed / Cancelled:** Yes No N/A**Bridge No:** 34-0006**Component:** SAS OBG**Summary of Items Observed:**

WELDING INSPECTION REPORT

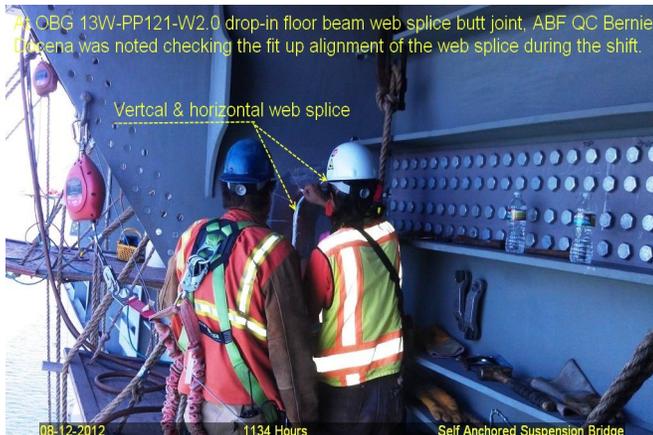
At OBG 13W-PP121-W2 floor beam web inside, QA randomly observed ABF/JV qualified welder Mike Jimenez perform root pass back on the Complete Joint Penetration (CJP) butt joint. The welder was observed manually welding in the 3G (vertical) position utilizing a Shielded Metal Arc Welding (SMAW) with 3.2mm diameter E7018H4R electrode and implementing Caltrans approved Welding Procedure Specification (WPS) ABF-WPS-D15-1040C Revision 1. The joint being welded has a single V-groove butt joint welded with steel backing bar. Prior welding, ABF QC Bernie Docena was observed checking the fit up of the horizontal and vertical butt joint. The misalignment was measured 0mm to 2mm while the root opening was measured 6.0mm to 12.5mm which appears in conformance to the contract requirements. ABF Quality Control (QC) Bernie Docena was noted monitoring the welding parameters of the welder. QA randomly monitored the welding parameter with measured working current of 134 amperes on the 3.2mm diameter E7018H4R electrode which appears in compliance to the WPS. At the end of the shift, SMAW root pass welding was still continuing and should remain tomorrow.

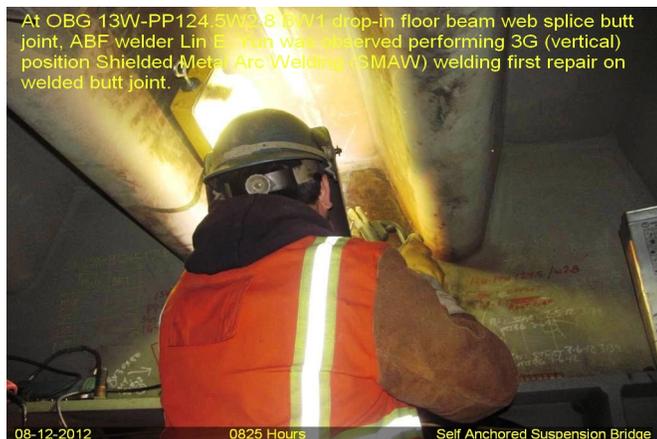
At OBG 13W-PP124.5-W2.8 BW1 drop-in floor beam inside, QA randomly observed ABF/JV qualified welder Lin E. Yun perform CJP groove first time welding repair. The welder was observed welding the floor beam web butt joint in 3G (vertical) position utilizing Shielded Metal Arc Welding (SMAW) with 3.2mm diameter E7018H4R electrode implementing welding procedure ABF-WPS-D15-1004-Repairs. The repair excavation located at Y=315mm and having boat shape excavation dimensions of 50mm long x 30mm wide x 8mm deep was preheated to more than 325°F using propylene gas torch prior welding. During the shift, ABF QC Bernie Docena was noted monitoring the welder with measured working current of 128 amperes on the 3.2mm E7018H4R electrode. After the completion of the welding repair, the welder performed the Post Weld Heat Treatment (PWHT) of more than 450°F using the same propylene gas torch for one hour after welding as required.

During the shift, the same welder was noted welding repair at the same floor beam flange butt joint at Y=0mm. The boat shape repair excavation was having dimensions of 25mm long x 20mm wide x 14mm deep. The welder was noted welding repair at 1G (flat) position using the same process but implementing Caltrans approved welding procedure ABF-WPS-D15-1001-Repairs. Repair at this location was also completed during the shift.
