Contract #: 04-0120F4Cty: SF/ALA Rte: 80 PM: 13.2/13.9File #: 1.28**WELDING INSPECTION REPORT**

**Report No:** WIR-028159  
**Date Inspected:** 10-Aug-2012

**Project Name:** SAS Superstructure  
**Prime Contractor:** American Bridge/Fluor Enterprises, a JV  
**Contractor:** American Bridge/Fluor Enterprises, a JV

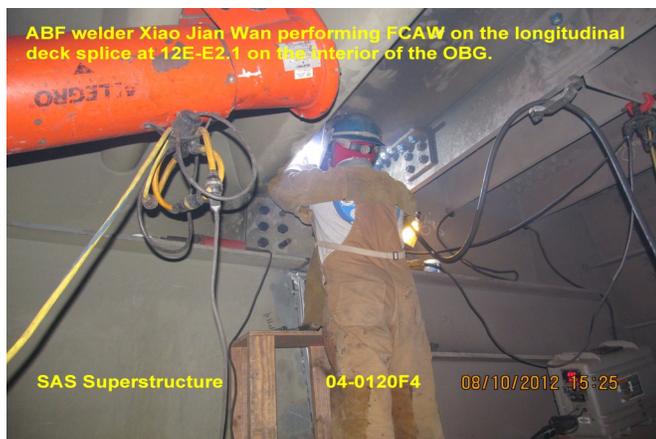
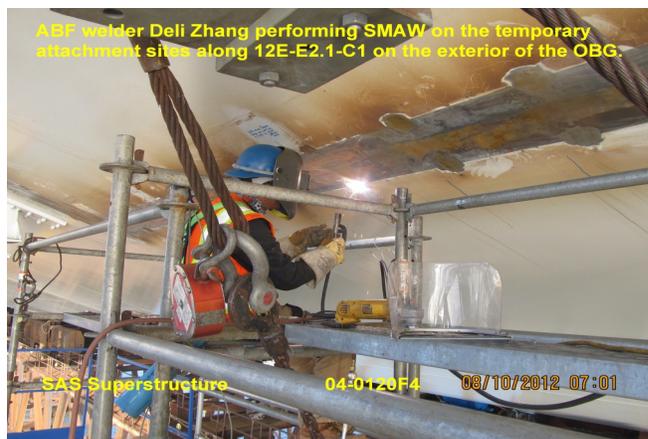
This QA Inspector randomly monitored the in process Shielded Metal Arc Welding (SMAW) of temporary attachment sites along the weld seam at 12E-E2.1-C1 on the exterior of the OBG. ABF/JV qualified welder Deli Zhang #4735 was observed grinding the areas and backfilling the 2mm-3mm deep sites and then ground flush utilizing a small disc grinder. Prior to welding QC Inspector Salvador Merino was observed monitoring the pre-heating of the joint and the parameters as they pertain to ABF-WPS-D1.5-1004-Repair. This QA Inspector verified that the 3.2mm electrodes were stored in an electrically heated thermostatically controlled oven after removal from the sealed containers. The exposure limits of the electrodes appeared to comply with the minimum storage oven temperature of 120 degrees Celsius as per the contract documents. The welding parameters and surface temperatures were verified by the QC inspector's utilizing a Fluke 337 clamp meter to measure the electrical welding parameters. The welder was observed grinding and blending the start/stop edges of the work utilizing a small disc grinder and compressed air in between passes as QC measured the inter-pass temperatures with an infra-red temperature gun. This QA Inspector made subsequent observations throughout the shift to monitor quality and noted that the production welding at this location was in progress and appeared to be in general conformance with the contract documents.

This QA Inspector randomly observed ABF/JV qualified welder Xiao Jian Wan #9677 continuing to perform production welding using the Flux Core Arc Welding (FCAW) process in the 4G overhead position on the A deck joint at 12E-E2.1 on the interior of the OBG. The splice joint was preheated to greater than 200 degrees Fahrenheit using Miller Proheat 35 Induction Heating System with the heater blanket located at the opposite side of the deck prior/during welding. This QA Inspector observed QC Inspector Salvador Merino verify prior to the start of welding operations, that the minimum preheat temperature as per the approved WPS was established; and afterwards verified that the welding parameters were in accordance with ABF-WPS-D1.5-1-3110-4. This QA Inspector made subsequent observations throughout the shift to monitor quality and noted the work at this location is in progress and appeared to be in general conformance with the contract specifications.

This QA Inspector randomly observed QC Inspectors Pat Swain and Fred Michels at 12E PP111.1-C1 performing Ultrasonic Testing (UT) on the exterior of the OBG. The QC Inspectors were observed scanning from each side of the weld and the scanning pattern as described in D1.5 6.24. The QC Inspectors were noted as identifying rejectable indications and the work at these locations is ongoing and appeared to be in general conformance with the contract documents and SE-UT-D1.5-CT-100-Revision 4.
