DEPARTMENT OF TRANSPORTATION

Contract #: 04-0120F4Cty: SF/ALA Rte: 80 PM: 13.2/13.9File #: 1.28**WELDING INSPECTION REPORT**

Report No: WIR-028166
Date Inspected: 10-Aug-2012

Project Name: SAS Superstructure
Prime Contractor: American Bridge/Fluor Enterprises, a JV
Contractor: American Bridge/Fluor Enterprises, a JV

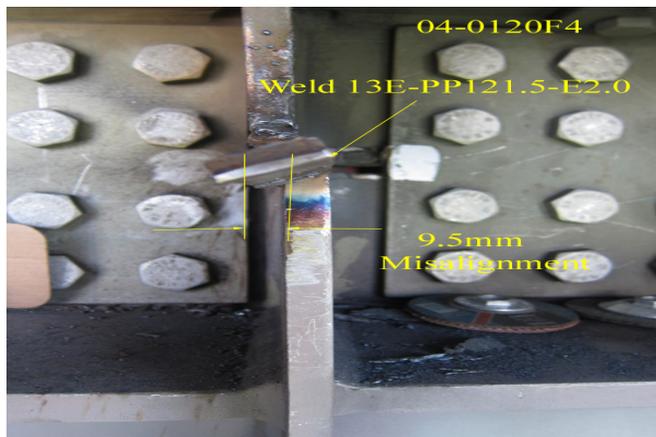
During the Quality Assurance (QA) random in-process visual inspection of the welding operations in lift 13E, this QA observed ABF personnel welding the web splice at panel point 121.5 with planar misalignment measuring up to 9.5mm. The web thickness at this connection is 14mm and the weld is designated as 13E-PP121.5-E2.0. The QA task leader was notified in writing of the non-compliant issue for further discussion with the Caltrans Structural Materials Representative (SMR) and ABF Management.
