**DEPARTMENT OF TRANSPORTATION**

Contract #: 04-0120F4Cty: SF/ALA Rte: 80 PM: 13.2/13.9File #: 1.28**WELDING INSPECTION REPORT****Resident Engineer:** Casey, William**Address:** 333 Burma Road**City:** Oakland, CA 94607**Report No:** WIR-028177**Date Inspected:** 13-Aug-2012**Project Name:** SAS Superstructure**OSM Arrival Time:** 700**Prime Contractor:** American Bridge/Fluor Enterprises, a JV**OSM Departure Time:** 1930**Contractor:** American Bridge/Fluor Enterprises, a JV**Location:** Job site**CWI Name:** Salvador Merino**CWI Present:** Yes No**Inspected CWI report:** Yes No N/A**Rod Oven in Use:** Yes No N/A**Electrode to specification:** Yes No N/A**Weld Procedures Followed:** Yes No N/A**Qualified Welders:** Yes No N/A**Verified Joint Fit-up:** Yes No N/A**Approved Drawings:** Yes No N/A**Approved WPS:** Yes No N/A**Delayed / Cancelled:** Yes No N/A**Bridge No:** 34-0006**Component:** OBG**Summary of Items Observed:**

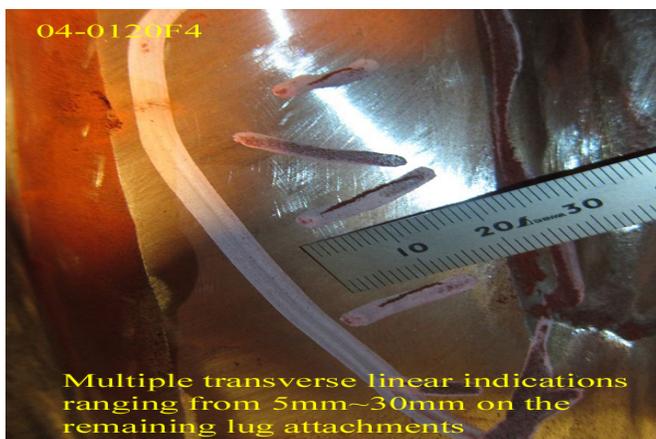
### Panel Point 119.5 E3 longitudinal diaphragm

The QA visual inspection at the lifting lug removal area was performed at this location and measurements taken on the required 3/1 slope of the removal area did not comply with ABF-RFI-001151R00 and Magnetic particle testing of the removal areas had not been performed at this location. The ABF/JV QC inspector Salvador Merino then proceeded to perform magnetic particle testing (MT) of the lifting lug removal area and observed multiple transverse linear indications ranging from 5mm~30mm on the remaining lug attachments. Further repair and inspection will be required at this location at a later date.

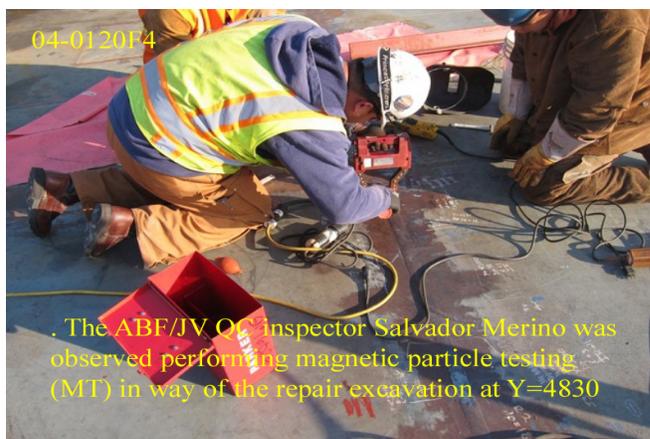
The QAI observed ABF/JV qualified welder Wai Kitlai #2953 performing Carbon Arc Gouging (CAG) for the repair of the deck panel drop-in splice designated as 13E-PP122.2. The ABF/JV QC inspector Salvador Merino was observed performing magnetic particle testing (MT) in way of the repair excavation at the following locations, Y=4830 third time repair.

The ABF qualified welder was observed later in the shift performing Shielded Metal Arc Welding (SMAW) in the 4G position utilizing the Caltrans approved Welding Procedure Specifications ABF-WPS-D1.5-1004-Repair. The weld and surrounding area was brought to temperature by the use of inductions heaters and maintained throughout welding. The third time repairs at Y=4830 were performed without the prior approval of the engineer. The QA task leader was notified in writing of the non-compliant issue for further discussion with the Caltrans Structural Materials Representative (SMR) and ABF Management.
