DEPARTMENT OF TRANSPORTATION

Office of Structural Materials

Contract #: 04-0120F4Cty: SF/ALA Rte: 80 PM: 13.2/13.9File #: 1.28**WELDING INSPECTION REPORT****Resident Engineer:** Casey, William**Address:** 333 Burma Road**City:** Oakland, CA 94607**Report No:** WIR-028181**Date Inspected:** 14-Aug-2012**Project Name:** SAS Superstructure**OSM Arrival Time:** 700**Prime Contractor:** American Bridge/Fluor Enterprises, a JV**OSM Departure Time:** 1930**Contractor:** American Bridge/Fluor Enterprises, a JV**Location:** Job Site**CWI Name:** Andrew Keach**CWI Present:** Yes No**Inspected CWI report:** Yes No N/A**Rod Oven in Use:** Yes No N/A**Electrode to specification:** Yes No N/A**Weld Procedures Followed:** Yes No N/A**Qualified Welders:** Yes No N/A**Verified Joint Fit-up:** Yes No N/A**Approved Drawings:** Yes No N/A**Approved WPS:** Yes No N/A**Delayed / Cancelled:** Yes No N/A**Bridge No:** 34-0006**Component:** SAS OBG**Summary of Items Observed:**

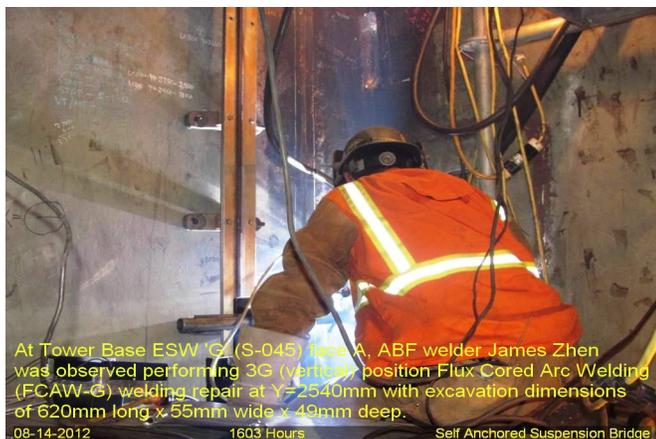
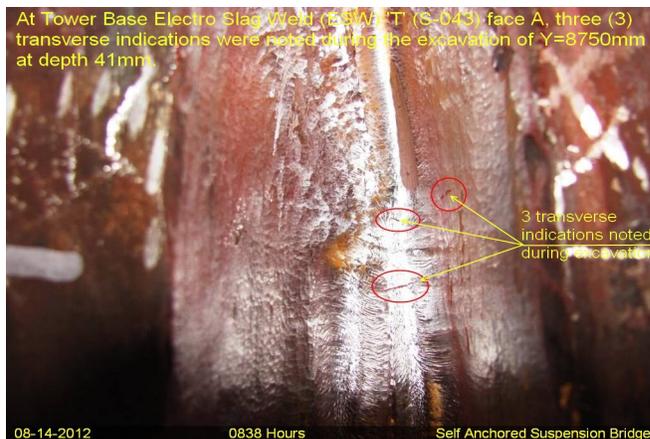
At Tower Base Electro Slag Weld (ESW), QA randomly observed ABF/JV qualified welder James Zhen perform CJP groove welding repair. The welder was observed manually welding in the 3G (vertical) position utilizing the dual shielded Flux Cored Arc Welding (FCAW-G) with E71T-1M, 1/16" diameter wire electrode and implementing Caltrans approved Welding Procedure Specification (WPS) ABF-WPS-D15-3001-3 repair. The repair excavation was preheated and continuously maintained to more than 325 degree Fahrenheit using Miller Proheat 35 Induction Heating System prior/during welding. The ESW repair being welded is located at ESW 'G' face A, Y=2540mm has no Caltrans approved Request for Weld Repair (RWR) and excavated beyond the excavation depth of 2/3 thickness. Due to these two infractions committed by ABF, an Incident Report was generated.

During the shift, ABF QC Andrew Keach was noted monitoring the welder with measured working current of 235 amperes, 23.5 volts which appears in compliance to the contract requirements. At the end of the shift, 3G FCAW-G repair welding at location mentioned above was still continuing and should remain tomorrow. Listed below was the first time repair being welded during the shift;

Location	Weld No.	Y-dim.	Length	Width	Depth	Remarks
ESW 'G'	S-045	2540mm	260mm	55mm	49mm	In progress.

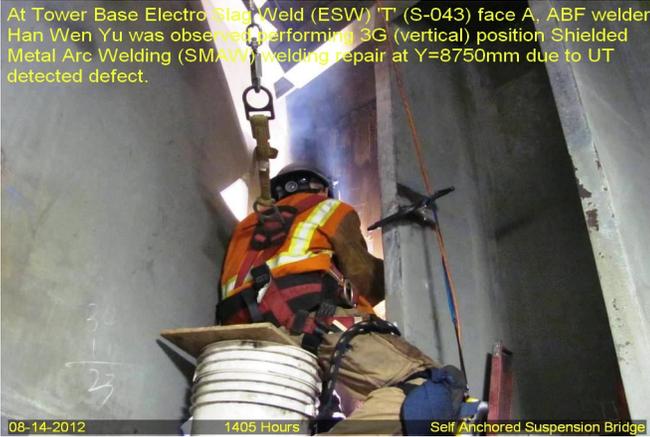
At Tower Base Electro Slag Weld (ESW) 'T' (S-043) face A, ABF welder Han Wen Yu was observed performing 3G (vertical) position Shielded Metal Arc Welding (SMAW) welding repair at Y=8750mm due to UT detected defect.

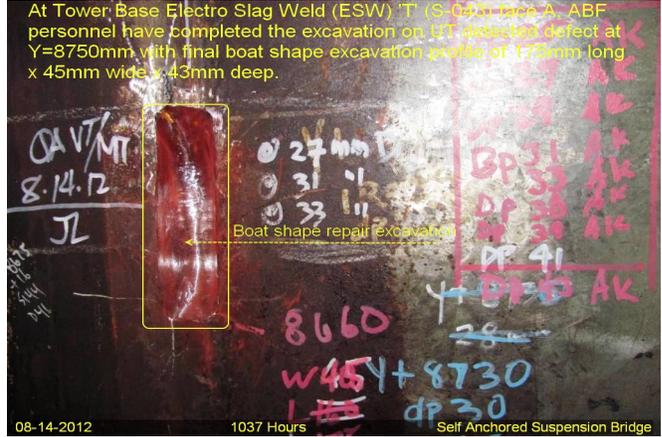
At Tower Base Electro Slag Weld (ESW), this QA observed ABF welder Han Wen Yu continuing to perform repair excavation at location 'T' face B (S-043) Y=8750mm due to Ultrasonic Testing (UT) detected defect. The repair excavation is being undertaken per Caltrans approved Request for Weld Repair RWR #201208-010. The welder was noted using carbon air arc gouging followed by grinding using a die grinder. The excavation was alternately gouged and ground then Magnetic Particle Testing (MT) tested by ABF QC Andrew Keach and this QA. The following excavation events were noted during the repair excavation;

At Tower Base Electro Slag Weld (ESW) 'T' (S-043) face A, ABF personnel have completed the excavation on UT detected defect at Y=8750mm with final boat shape excavation profile of 178mm long x 45mm wide x 43mm deep.
