**DEPARTMENT OF TRANSPORTATION**

Contract #: 04-0120F4Cty: SF/ALA Rte: 80 PM: 13.2/13.9File #: 1.28**WELDING INSPECTION REPORT****Resident Engineer:** Casey, William**Address:** 333 Burma Road**City:** Oakland, CA 94607**Report No:** WIR-028183**Date Inspected:** 15-Aug-2012**Project Name:** SAS Superstructure**OSM Arrival Time:** 700**Prime Contractor:** American Bridge/Fluor Enterprises, a JV**OSM Departure Time:** 1930**Contractor:** American Bridge/Fluor Enterprises, a JV**Location:** Job site**CWI Name:** Salvador Merino**CWI Present:** Yes No**Inspected CWI report:** Yes No N/A**Rod Oven in Use:** Yes No N/A**Electrode to specification:** Yes No N/A**Weld Procedures Followed:** Yes No N/A**Qualified Welders:** Yes No N/A**Verified Joint Fit-up:** Yes No N/A**Approved Drawings:** Yes No N/A**Approved WPS:** Yes No N/A**Delayed / Cancelled:** Yes No N/A**Bridge No:** 34-0006**Component:** OBG**Summary of Items Observed:**

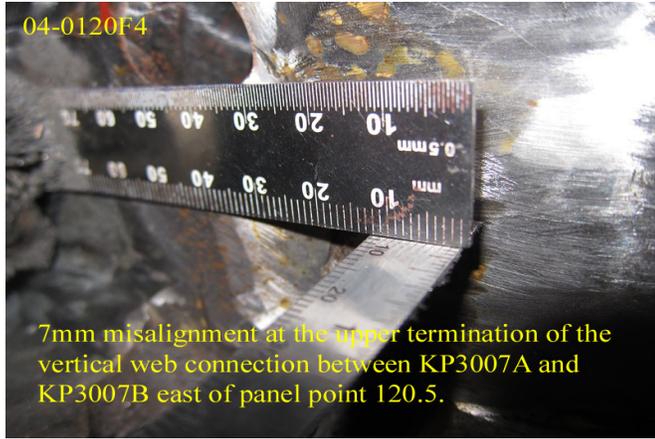
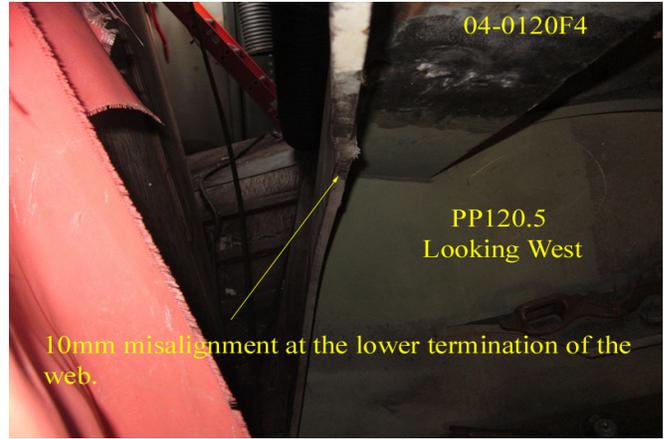
During the Quality Assurance (QA) random in-process visual inspection of the welding operations on the OBG 13 East, the QA inspector observed the K-plate web splice between KP3007A and KP3007B was welded with planar misalignment measured to be 10mm at the lower termination and 7mm at the upper termination of the vertical web. The K-plate web splice is located 585mm east of east of panel point 120.5 and is designated on the contract drawings as a Seismic Performance Critical Member (SPCM). The QA task leader was notified in writing of the

non-compliant issue for further discussion with the Caltrans Structural Materials Representative (SMR) and ABF Management.
