DEPARTMENT OF TRANSPORTATION

Contract #: 04-0120F4Cty: SF/ALA Rte: 80 PM: 13.2/13.9File #: 1.28**WELDING INSPECTION REPORT****Resident Engineer:** Casey, William**Address:** 333 Burma Road**City:** Oakland, CA 94607**Report No:** WIR-028184**Date Inspected:** 15-Aug-2012**Project Name:** SAS Superstructure**OSM Arrival Time:** 700**Prime Contractor:** American Bridge/Fluor Enterprises, a JV**OSM Departure Time:** 1930**Contractor:** American Bridge/Fluor Enterprises, a JV**Location:** Job Site**CWI Name:** As noted below**CWI Present:** Yes No**Inspected CWI report:** Yes No N/A**Rod Oven in Use:** Yes No N/A**Electrode to specification:** Yes No N/A**Weld Procedures Followed:** Yes No N/A**Qualified Welders:** Yes No N/A**Verified Joint Fit-up:** Yes No N/A**Approved Drawings:** Yes No N/A**Approved WPS:** Yes No N/A**Delayed / Cancelled:** Yes No N/A**Bridge No:** 34-0006**Component:** SAS OBG**Summary of Items Observed:**

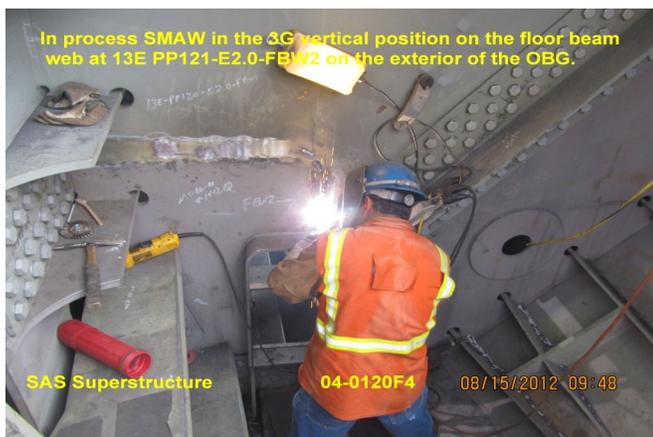
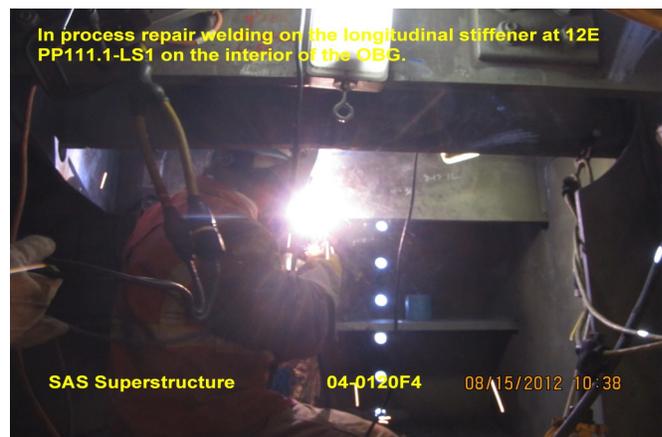
This QA Inspector made random observations of the first time repair of the Longitudinal Stiffener (LS) located at 12E PP111.1-LS1 on the interior of the OBG. QC Inspector Salvador Merino performed a Magnetic Particle (MT) test and inspection of the back-gouge and noted no indications. This QA Inspector observed QC monitor and verify the welder pre-heat the 35mm joint to +200°F. This QA Inspector made random observations of ABF/JV qualified welder Jim Quan Huang #1088 performing the Shielded Metal Arc Welding (SMAW) Process in the 3G vertical position utilizing E 9018-H4R electrodes. QC Inspector Fred Michels verified the temperature and recorded the parameters as acceptable and within the requirements of ABF-WPS-D1.5-1002-Repair. The welder was observed welding the height of the joint followed by grinding and blending of the work utilizing a small disc grinder. On a subsequent observation, this QA Inspector noted that the welding was performed in the vertical position utilizing the E9018-H4R low hydrogen electrodes. The 3.2mm electrodes were stored in electrically heated, thermostatically controlled oven after removal from the sealed containers. The exposure limits of the electrodes appeared to comply with the minimum storage oven temperature of 120 degrees Celsius as per the contract documents. The welding parameters and surface temperatures were verified by the QC inspector's utilizing a Fluke 337 clamp meter to measure the electrical welding parameters and Tempilstik Heat Indicators for verifying the preheat and inter-pass temperatures. At the time of the observation no issues were noted by the QA. On subsequent observations throughout the shift to monitor quality, it was noted that the work was completed on this date and appeared to be in general conformance with the contract documents. No RWR was required for this first time weld repair.
