**DEPARTMENT OF TRANSPORTATION**

Contract #: 04-0120F4Cty: SF/ALA Rte: 80 PM: 13.2/13.9File #: 1.28**WELDING INSPECTION REPORT****Resident Engineer:** Casey, William**Address:** 333 Burma Road**City:** Oakland, CA 94607**Report No:** WIR-028186**Date Inspected:** 14-Aug-2012**Project Name:** SAS Superstructure**OSM Arrival Time:** 700**Prime Contractor:** American Bridge/Fluor Enterprises, a JV**OSM Departure Time:** 1900**Contractor:** American Bridge/Fluor Enterprises, a JV**Location:** jobsite**CWI Name:** See Body of Report**CWI Present:** Yes No**Inspected CWI report:** Yes No N/A**Rod Oven in Use:** Yes No N/A**Electrode to specification:** Yes No N/A**Weld Procedures Followed:** Yes No N/A**Qualified Welders:** Yes No N/A**Verified Joint Fit-up:** Yes No N/A**Approved Drawings:** Yes No N/A**Approved WPS:** Yes No N/A**Delayed / Cancelled:** Yes No N/A**Bridge No:** 34-0006**Component:** OBG**Summary of Items Observed:**

# WELDING INSPECTION REPORT

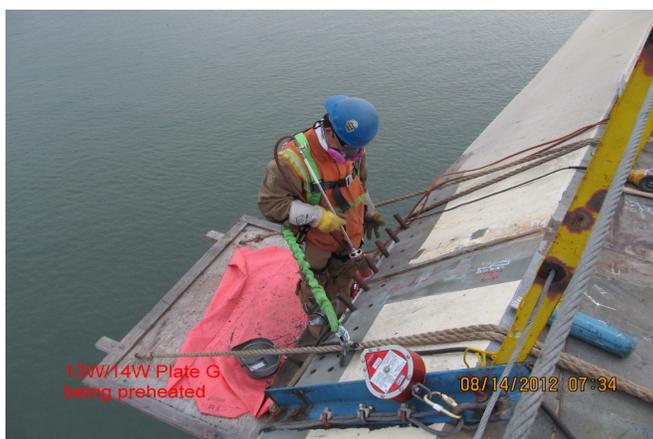
13W/14W Plate G

Due to the contractor choosing to weld prior to getting engineer approval for the poor fit up an Incident Report was issued on the above-mentioned welded splice. At the time of this report the joint exhibited a 3mm to 5mm offset with a maximum root opening of 20mm.

The QA inspector from time to time observed the in process Shield Metal Arc Welding being performed by ABF welding personnel Jim Quan Huang (9340) on 13W/14W Plate G vertical splice. The welder spent the shift depositing the fill passes with approximately 80% being completed at the end of the shift. QC inspector Fred Michels was noted to be present in order to monitor the progress and ensure the welding was within the established Welding Procedure Specification (WPS) noted as ABF-WPS-D15-1040-C and supporting Procedure Qualification

Records (PQR). Prior to initiating the welding at this location the QC inspector observed the preheat temperature, using a Raytek non-contact Thermometer, was sufficient and compliant to the above-mentioned WPS. Using a Tempil Stick, (temperature indicating crayon)the preheat and interpass temperature was then verified by this QA inspector to be greater than 150F and the parameters, using a Fluke brand Tong style meter, was verified to be 160 amps. See digital photo included in the body of this report for general information.
