Contract #: 04-0120F4Cty: SF/ALA Rte: 80 PM: 13.2/13.9File #: 1.28**WELDING INSPECTION REPORT****Resident Engineer:** Casey, William**Address:** 333 Burma Road**City:** Oakland, CA 94607**Report No:** WIR-028191**Date Inspected:** 15-Aug-2012**Project Name:** SAS Superstructure**OSM Arrival Time:** 700**Prime Contractor:** American Bridge/Fluor Enterprises, a JV**OSM Departure Time:** 1930**Contractor:** American Bridge/Fluor Enterprises, a JV**Location:** Job Site**CWI Name:** William Sherwood**CWI Present:** Yes No**Inspected CWI report:** Yes No N/A**Rod Oven in Use:** Yes No N/A**Electrode to specification:** Yes No N/A**Weld Procedures Followed:** Yes No N/A**Qualified Welders:** Yes No N/A**Verified Joint Fit-up:** Yes No N/A**Approved Drawings:** Yes No N/A**Approved WPS:** Yes No N/A**Delayed / Cancelled:** Yes No N/A**Bridge No:** 34-0006**Component:** SAS OBG**Summary of Items Observed:**

WELDING INSPECTION REPORT

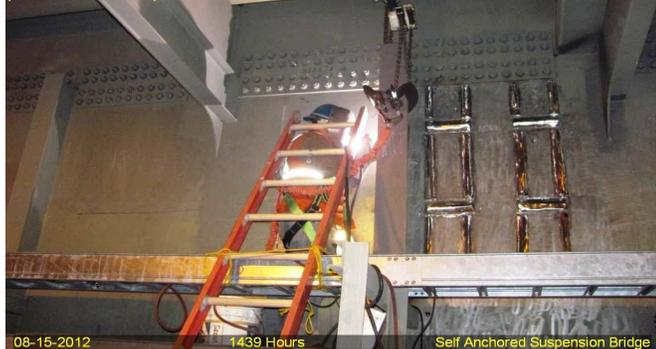
At OBG location 13W-PP121.5-W3 longitudinal diaphragm WT12 stiffener inside, this QA randomly observed ABF welder Gue Wu Chen perform fillet welding on the above mentioned stiffener. The welder was noted fillet welding in 3F (vertical) position using Shielded Metal Arc Welding (SMAW) with 3.2mm diameter E7018 H4R electrode implementing Welding Procedure Specification (WPS) ABF-D15-F1200A. The vertical WT12 stiffener web is being welded to the longitudinal diaphragm on both sides of the web. During welding, the welder was noted preheating the plates using propylene gas torch prior welding. ABF QC William Sherwood was noted monitoring the welding parameters with measured working current of 128 amperes during welding. At the end of the shift, fillet welding was completed on both sides of the WT stiffener web.

At OBG 13W-PP121.5-W3 longitudinal diaphragm (LD) vertical stiffener WT12, ABF welder Gue Wu Chen was observed performing 3F (vertical) position Shielded Metal Arc Welding (SMAW) fillet welding WT12 web plate to LD web plate.

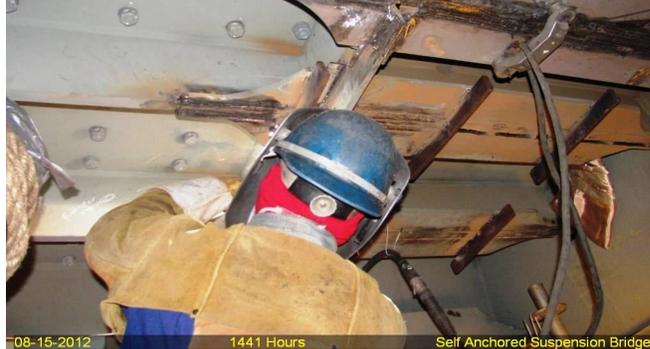
At OBG 13W-PP122.2-LS5 deck stiffener flange inside, QA randomly observed ABF/JV qualified welder Xiao Jian Wan continuing to perform PJP groove welding fill pass on the deck stiffener flange PJP T-joint. The welder was observed perform manual welding in the 4G (overhead) position utilizing a Shielded Metal Arc Welding (SMAW) with 3.2mm diameter E9018H4R electrode and implementing Caltrans approved Welding Procedure Specification (WPS) ABF-WPS-D15-1162-4. The stiffener flange plate has a bevel groove being welded PJP T-joint to the longitudinal stiffener LS5. The plates were preheated to more than 200 degree Fahrenheit using Miller Proheat 35 Induction Heating System. During welding, ABF Quality Control (QC) William Sherwood was

At OBG 13W-PP122.2-LS5 deck stiffener flange inside, ABF welder Xiao Jun Wan was observed performing 4G (overhead) position Shielded Metal Arc Welding (SMAW) welding root pass on the flange plate to LS5 CJP T-joint.

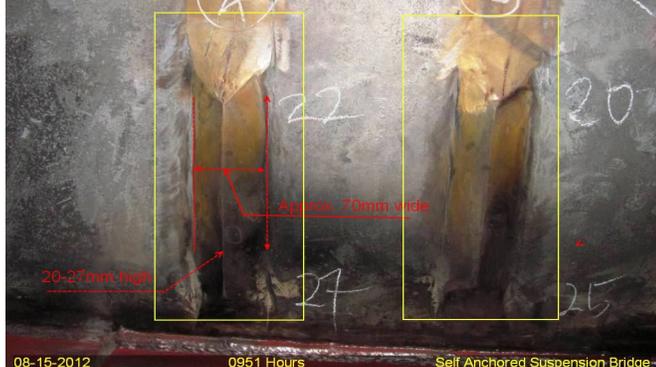
At location OBG 13W-PP121.5/122.5-W3, ABF personnel have requested this QA to perform Visual Test (VT) on the lifting lug bracket removal. These lifting lug brackets were welded to the longitudinal diaphragm (LD) that have been cut to 19.0mm from the LD then ground smooth to transition per ABF Request for Information (RFI) ABF-RFI-001151R01 dated March 31, 2008. During the QA verification, all the lifting lug brackets that were shown that were cut and ground to transitions were noted smooth but the required transition ratio of 3:1 per submitted RFI was not met. The results of the QA verification were verbally relayed to ABF Superintendent Scott Smith. This QA also informed Mr. Smith that the removal of the lifting lugs brackets needs further grinding to meet the requirements of the RFI.

At location OBG 13W-PP122.5-W3 lifting lug bracket removal from the longitudinal diaphragm (LD) web plate was noted not in conformance to the required slope ratio of 3:1.

At location OBG 13W-PP121.5/122.5-W3 lifting lug bracket removal, this QA has informed Mr. Scott Smith that the removal of the lifting lugs brackets did not meet the required 3:1 slope ratio and that it needs further grinding to meet the requirements of the approved RFI.

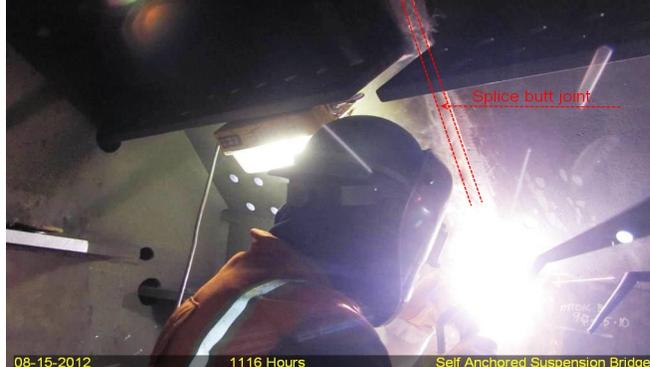
At OBG 13W/14W drop-in corner plate 'G' inside, QA randomly observed ABF/JV qualified welder Lin E. Yun perform back welding fill pass on the Complete Joint Penetration (CJP) splice butt joint. The welder was observed manually welding in the 3G (vertical) position utilizing a Shielded Metal Arc Welding (SMAW) with 3.2mm diameter E7018H4R electrode and implementing Caltrans approved Welding Procedure Specification (WPS) ABF-WPS-D15-1110A-1. The joint being welded has a single V-groove butt joint with steel backing bar that has been back gouged and ground smooth. ABF Quality Control (QC) William Sherwood was noted monitoring the welding parameters of the welder. QA randomly verified the welding parameter with measured working current of 120 amperes on the 3.2mm E7018H4R electrode which appears in conformance to the contract requirements. At the end of the shift, SMAW fill pass back welding was still continuing and should remain tomorrow.

At OBG 13W/14W edge plate 'G' inside, ABF welder Lin E. Yun was observed performing 3G (vertical) position Shielded Metal Arc Welding (SMAW) back welding fill pass on CJP splice butt joint.
