**DEPARTMENT OF TRANSPORTATION**

Contract #: 04-0120F4Cty: SF/ALA Rte: 80 PM: 13.2/13.9File #: 1.28**WELDING INSPECTION REPORT****Resident Engineer:** Casey, William**Address:** 333 Burma Road**City:** Oakland, CA 94607**Report No:** WIR-028200**Date Inspected:** 17-Aug-2012**Project Name:** SAS Superstructure**OSM Arrival Time:** 700**Prime Contractor:** American Bridge/Fluor Enterprises, a JV**OSM Departure Time:** 1930**Contractor:** American Bridge/Fluor Enterprises, a JV**Location:** Job site**CWI Name:** Salvador Merino**CWI Present:** Yes No**Inspected CWI report:** Yes No N/A**Rod Oven in Use:** Yes No N/A**Electrode to specification:** Yes No N/A**Weld Procedures Followed:** Yes No N/A**Qualified Welders:** Yes No N/A**Verified Joint Fit-up:** Yes No N/A**Approved Drawings:** Yes No N/A**Approved WPS:** Yes No N/A**Delayed / Cancelled:** Yes No N/A**Bridge No:** 34-0006**Component:** OBG**Summary of Items Observed:**

## WELDING INSPECTION REPORT

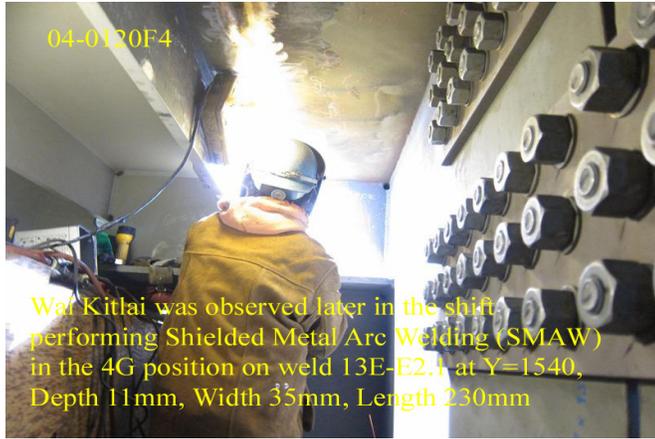
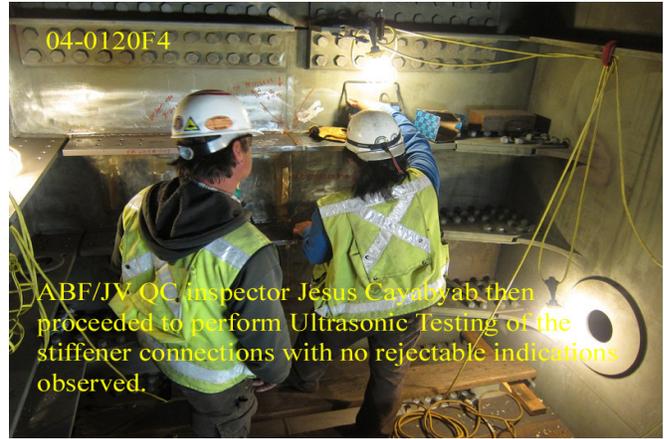
The QAI observed ABF/JV qualified welder Wai Kitlai #2953 performing Carbon Arc Gouging (CAG) for the repair of the deck panel drop-in splice designated as 13E-E2.1. The ABF/JV QC inspector Salvador Merino was observed performing magnetic particle testing (MT) in way of the repair excavations at the following location, Y=1540 Depth 11mm, Width 35mm, Length 230mm

The ABF welder Wai Kitlai was observed later in the shift performing Shielded Metal Arc Welding (SMAW) in the 4G position utilizing the Caltrans approved Welding Procedure Specifications ABF-WPS-D1.5-1004-Repair at the locations previously noted. The weld and surrounding area was brought to a temperature of 325°F by the use of inductions heaters and maintained throughout the welding process. Due to the first time repair at these locations approval for repair (RWR) of this weld was not required.
