Contract #: 04-0120F4Cty: SF/ALA Rte: 80 PM: 13.2/13.9File #: 1.28**WELDING INSPECTION REPORT**

**Report No:** WIR-028202  
**Date Inspected:** 16-Aug-2012

**Project Name:** SAS Superstructure  
**Prime Contractor:** American Bridge/Fluor Enterprises, a JV  
**Contractor:** American Bridge/Fluor Enterprises, a JV

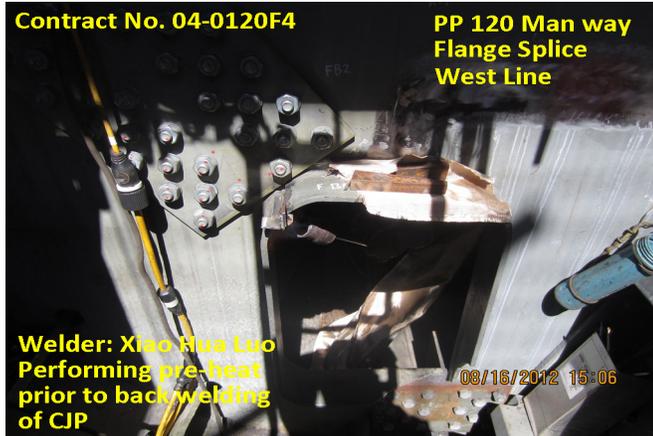
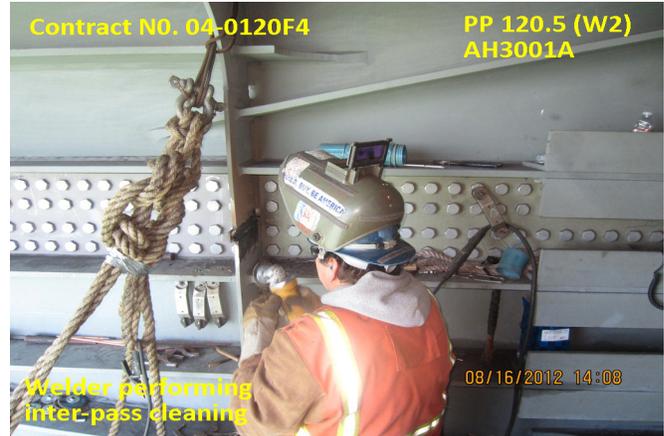
The QAI observed that welder 4671-Mike Jimenez, was welding multi-Pass welds at PP 120.5 (W2) / AH3001A in the horizontal (2G) position. This QAI observed these parameters as defined in Welding Procedure Specification WPS-ABF-WPS-D15-1040A. The QC inspector Steve Jenson verified the fit-up for this location and found it to be acceptable, this information was relayed to the QAI. The welder then continued pre-heat throughout the area during welding using a propane type weed burner at 40 degrees Celsius (150 degrees F) which was verified using a tempstik and infrared gun by the QC. The welder was using the Shielded Metal Arc Welding (SMAW) electrode E7018 for the Complete Joint Penetration (CJP) weld in the vertical (2G) position with 3.2 mm electrode with 138.5 amps. The welder utilized a power grinder and power wire wheel for the interpass cleaning. The QC inspector for this location was Steve Jenson and was observed verifying and documenting the welding parameters for this location, along with overseeing the welding operations. At the time METS observation was

The welder was grinding the starts and stops between weld layers to a bright metal. The location was still in process at the end of this QAI's shift.

The QAI observed that welder 1291-Xiao Hua Luo, was welding multi-Pass welds at PP 120.0 (W2) / FBW1 to FBW2 (Man Way Flange Splice) in the horizontal (2G) and flat (1G) position. This QAI observed these parameters as defined in Welding Procedure Specification WPS-ABF-WPS-D15-1040A (2G) and WPS-ABF-WPS-D15-1040C (1G). The QC inspector Steve Jenson verified the fit-up for this location and found it to be acceptable, this information was relayed to the QAI. The welder then continued pre-heat throughout the area during welding using a propane type weed burner at 40 degrees Celsius (150 degrees F) which was verified using a tempstik and infrared gun by the QC. The welder was using the Shielded Metal Arc Welding (SMAW) electrode E7018 for the Complete Joint Penetration (CJP) weld in the vertical (2G) position with 3.2 mm electrode with 125.3 amps. The welder utilized a power grinder and power wire wheel for the interpass cleaning. The QC inspector for this location was Steve Jenson and was observed verifying and documenting the welding parameters for this location, along with overseeing the welding operations. At the time METS observation was performed. No issues were noted by the QAI
