DEPARTMENT OF TRANSPORTATION

Contract #: 04-0120F4Cty: SF/ALA Rte: 80 PM: 13.2/13.9File #: 1.28**WELDING INSPECTION REPORT****Resident Engineer:** Casey, William**Address:** 333 Burma Road**City:** Oakland, CA 94607**Report No:** WIR-028237**Date Inspected:** 18-Aug-2012**Project Name:** SAS Superstructure**OSM Arrival Time:** 700**Prime Contractor:** American Bridge/Fluor Enterprises, a JV**OSM Departure Time:** 1530**Contractor:** American Bridge/Fluor Enterprises, a JV**Location:** jobsite

Welding 12E-PP116.5-E5 Deck Access Hole Face B

Weld Repairs 2W-13.5-5W Longitudinal Stiffener (LS-1) .

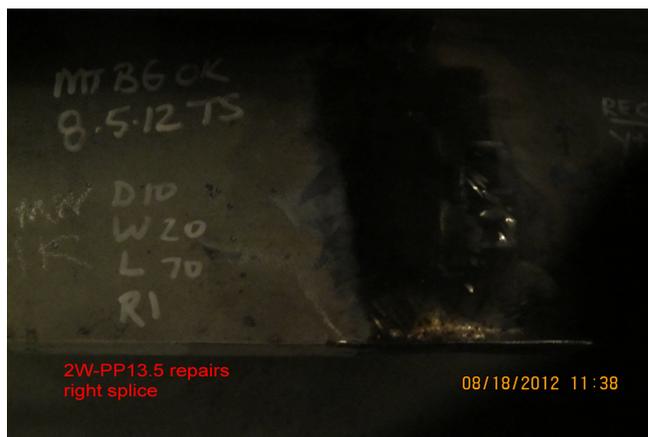
Repairs 2W-13.5-5W Deck Access Hole Longitudinal Stiffener

The QA inspector at random observed first time repairs (no RWR required) being performed by ABF welding personnel Roby Smith on Deck Access Hole 2W-PP13.5-5W Longitudinal Stiffener LS-1 at the following locations:

Y=100mm, D=10mm, W=20mm, L=70mm

Y=150mm, D=10mm, W=15mm, L=25mm

Y=80mm, D=6mm, W=15mm, L=25mm

This QA Inspector observed Roby Smith using the Carbon Arc Gouging process to remove defects at the above-mentioned locations on the LS-1 Longitudinal Stiffener. The locations and depth of the defects had been marked on the steel by the Ultrasonic Technician at the conclusion of his testing. At the end of gouging operations Mr. Smith ground the excavations to a bright clean metal condition in preparation of Visual and Magnetic Particle Testing.

Prior to welding Quality Control Technician William Sherwood performed Visual and Magnetic Particle Testing on the above excavations. This Quality Assurance Inspector verified the results of the test by doing duplicate testing to the excavations. No indications were noted.

The welder spent the remainder of the shift depositing the root passes and fill passes with approximately 100% being completed at the end of the shift. QC inspector William Sherwood was noted to be present in order to monitor the progress and ensure the welding was within the established Welding Procedure Specification (WPS) noted as ABF-WPS-D15-1110-A and supporting Procedure Qualification Records (PQR). Prior to initiating the welding at this location the QC inspector observed the preheat temperature, using a Raytek non-contact Thermometer, was sufficient and compliant to the above-mentioned WPS. Using a Tempil Stick, (temperature indicating crayon) the preheat and interpass temperature was then verified by this QA inspector to be greater than 150F and the parameters, using a Fluke brand Tong style meter, was verified to be 151 amps. See digital photo included in the body of this report for general information.
