Contract #: 04-0120F4Cty: SF/ALA Rte: 80 PM: 13.2/13.9File #: 1.28**WELDING INSPECTION REPORT****Resident Engineer:** Casey, William**Address:** 333 Burma Road**City:** Oakland, CA 94607**Report No:** WIR-028242**Date Inspected:** 22-Aug-2012**Project Name:** SAS Superstructure**OSM Arrival Time:** 700**Prime Contractor:** American Bridge/Fluor Enterprises, a JV**OSM Departure Time:** 1530**Contractor:** American Bridge/Fluor Enterprises, a JV**Location:** jobsite

Welding 12E-116.5-E5 Deck Access Hole

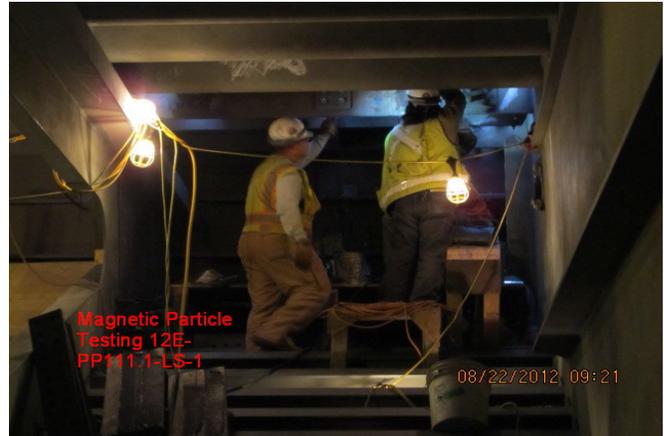
The QA inspector at random observed non-critical repair (no RWR required) being performed by ABF welding personnel Jin Huang at 12E-PP111.1 on Longitudinal Stiffener LS-1.

This QA Inspector observed Jin Huang using a grinder to remove defects at the above-mentioned location on Longitudinal stiffener LS-1. The locations and depth of the defects had been marked on the steel by the Ultrasonic Technician at the conclusion of his testing. At the end of gouging operations Mr. Lia ground the excavations to a bright clean metal condition in preparation of Visual and Magnetic Particle Testing.

Prior to welding Quality Control Technician Sal Merino performed Visual and Magnetic Particle Testing on the above excavations. This Quality Assurance Inspector verified the results of the test by doing duplicate testing to the excavations. No indications were noted.

The welder spent the remainder of the shift depositing the root passes and fill passes with approximately 100% being completed at the end of the shift. QC inspector Sal Merino was noted to be present in order to monitor the progress and ensure the welding was within the established Welding Procedure Specification (WPS) noted as ABF-WPS-D15-1002 and supporting Procedure Qualification Records (PQR). Prior to initiating the welding at this location the QC inspector observed the preheat temperature, using a Raytek non-contact Thermometer, was sufficient and compliant to the above-mentioned WPS. Using a Tempil Stick, (temperature indicating crayon) the preheat and interpass temperature was then verified by this QA inspector to be greater than 150F and the parameters, using a Fluke brand Tong style meter, was verified to be 166 amps.
