DEPARTMENT OF TRANSPORTATION

Contract #: 04-0120F4Cty: SF/ALA Rte: 80 PM: 13.2/13.9File #: 1.28**WELDING INSPECTION REPORT****Resident Engineer:** Casey, William**Address:** 333 Burma Road**City:** Oakland, CA 94607**Report No:** WIR-028245**Date Inspected:** 26-Aug-2012**Project Name:** SAS Superstructure**OSM Arrival Time:** 700**Prime Contractor:** American Bridge/Fluor Enterprises, a JV**OSM Departure Time:** 1500**Contractor:** American Bridge/Fluor Enterprises, a JV**Location:** jobsite**CWI Name:** Pat Swain**CWI Present:** Yes No**Inspected CWI report:** Yes No N/A**Rod Oven in Use:** Yes No N/A**Electrode to specification:** Yes No N/A**Weld Procedures Followed:** Yes No N/A**Qualified Welders:** Yes No N/A**Verified Joint Fit-up:** Yes No N/A**Approved Drawings:** Yes No N/A**Approved WPS:** Yes No N/A**Delayed / Cancelled:** Yes No N/A**Bridge No:** 34-0006**Component:** OBG**Summary of Items Observed:**

1. Weld Repair 12/13W-C1 Y=1740

2. Grinding of Weld Repair 12W-PP111.1-C1

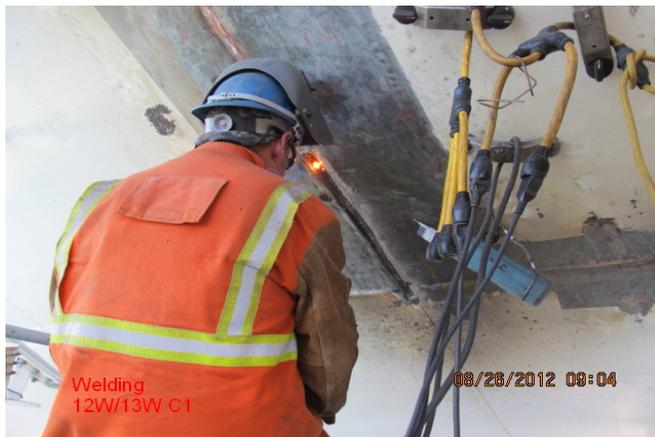
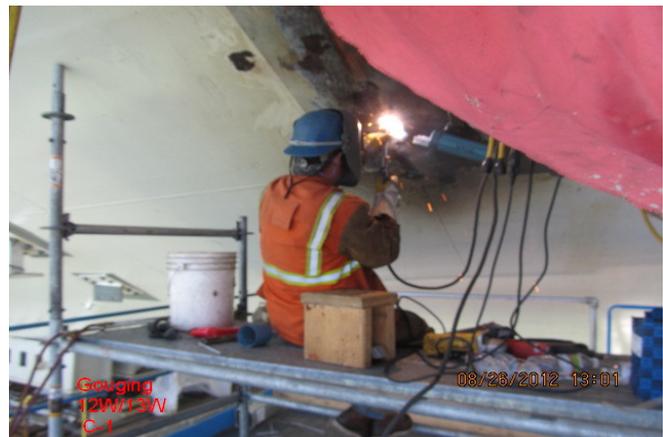
Grinding of repairs 12W-PP111.1-C1

This Quality Assurance Inspector observed the repairs, on the above-mentioned splice being ground flush in preparation for Inspection and testing. At the conclusion of grinding it was noted that some areas had been over ground leaving concaved areas that exceed the allowable amount per applicable specification. Some areas were noted to be in excess of 4mm deep. QC was aware of the issue and was working to have the problem corrected. No corrective action has been taken at the time of this report.
