**DEPARTMENT OF TRANSPORTATION**

Quality Assurance and Source Inspection

Contract #: 04-0120F4Cty: SF/ALA Rte: 80 PM: 13.2/13.9File #: 1.28**WELDING INSPECTION REPORT****Resident Engineer:** Casey, William**Address:** 333 Burma Road**City:** Oakland, CA 94607**Report No:** WIR-028246**Date Inspected:** 21-Aug-2012**Project Name:** SAS Superstructure**OSM Arrival Time:** 700**Prime Contractor:** American Bridge/Fluor Enterprises, a JV**OSM Departure Time:** 1930**Contractor:** American Bridge/Fluor Enterprises, a JV**Location:** Job Site

# WELDING INSPECTION REPORT

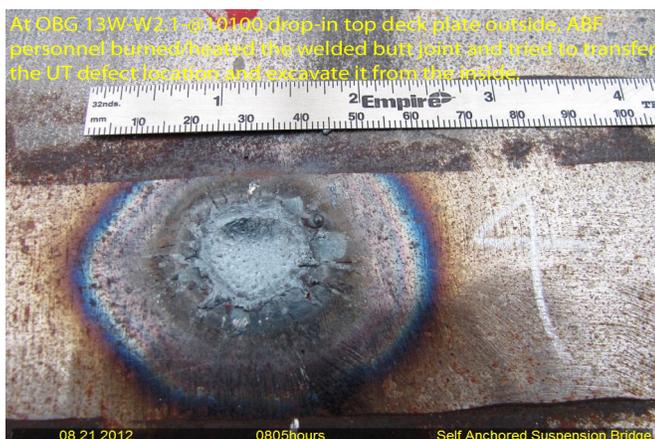
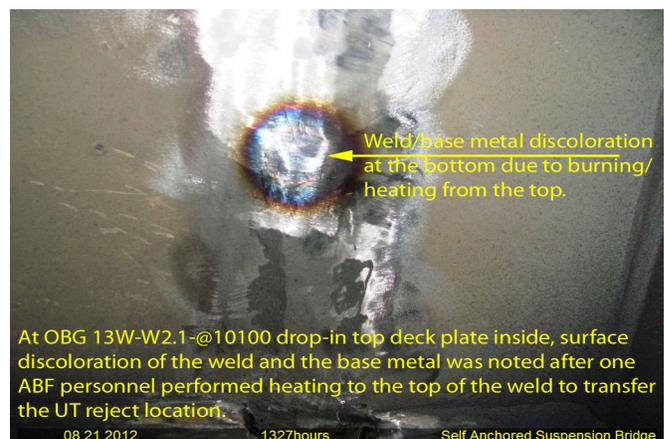
At OBG 13W, this QA together with fellow QA Robert De Armond have just completed inspection from the inside of the OBG when we came out the box and saw one ABF personnel/apprentice Joshua Washington just completed the burning/heating of four (4) locations on the weld 13W-W2.1-@10100 to apparently transfer the Ultrasonic Testing (UT) reject location to the bottom side of the welded joint for more accuracy. The ABF personnel has used oxy-propylene gas torch to perform the heating/burning of the weld. This was done at Y locations of the joint Y=2480mm, Y=5180mm, Y=7910mm and Y=9250mm. When the ABF personnel was asked what he was doing, he replied saying he knows what he was doing and this is per instruction from somebody. When asked again who was that somebody he said that is a top secret that he cannot divulge. Due to severity of the incident, it was immediately relayed to Lead QA Danny Reyes who also talked to Lead ABF QC Bonifacio Daquinag.

At OBG 13W-W2.8 @ 12570 drop-in top deck plate inside, QA randomly observed ABF/JV qualified welder Rick Clayborn continuing to perform CJP groove welding repair from location Y=4200mm to Y=5000mm. The repair was having boat shape excavation profile of 750mm long x 35mm wide x 13mm deep and it is being repaired per Request for Weld Repair RWR# 201208-001. The welder was observed welding in the 4G (overhead) position utilizing Shielded Metal Arc Welding (SMAW) with 3.2mm diameter E7018H4R electrode implementing welding procedure ABF-WPS-D15-1004-Repairs. During the shift, ABF QC Barry Drake was noted monitoring the welder

At OBG 13W-WK-WP1 K-plate, ABF welder Lin E Yun was observed continuing to perform repair welding. Prior to perform the repair, the welder was noted excavating the UT detected defects using carbon air arc gouging then ground smooth the groove of the excavation. ABF QC Bernie Docena was noted performing the Magnetic Particle Testing (MT) on the defect removal with no relevant defect noted during the test. The repair was located at Y=430 and was having boat shape excavation profile of 100mm long x 30mm wide x 11mm deep. After the completion of the MT, welder Lin E Yun was observed welding in the 3G (vertical) position utilizing Shielded Metal Arc Welding (SMAW) with 3.2mm diameter E7018H4R electrode implementing welding procedure ABF-WPS-D15-1000-Repairs. During the shift, ABF QC Bernie Docena was noted monitoring the welder with measured working current of 120 amperes on the 3.2mm E7018H4R electrode. During the shift, repair welding at location mentioned above was completed and the welder has moved to another weld location but the same K-plate, 13W-WK-SK1. The welder was noted adding more weld to cover due to ABF QC visual test (VT) reject. The welder was noted using the same process but implementing different Caltrans approved procedure ABF-WPS-D15-1072. The welder performed the 2G (horizontal) SMAW welding cover pass until the end of the shift wherein he was not able to complete the weld joint.

1. 13W-PP121.5-W2.5 BF1 – drop-in floor beam flange weld cover QA verified.
2. 13W-PP121.5-W2.5 BF2 – drop-in floor beam flange weld cover QA verified.
3. 13W-PP124.65-W3 stiffener 'A' – longitudinal diaphragm (LD) stiffener butt joint weld cover QA verified.
4. 13W-WK-S1 – K-plate stiffener butt joint weld cover QA verified.
