**DEPARTMENT OF TRANSPORTATION**

Contract #: 04-0120F4Cty: SF/ALA Rte: 80 PM: 13.2/13.9File #: 1.28**WELDING INSPECTION REPORT****Resident Engineer:** Casey, William**Address:** 333 Burma Road**City:** Oakland, CA 94607**Report No:** WIR-028248**Date Inspected:** 23-Aug-2012**Project Name:** SAS Superstructure**OSM Arrival Time:** 700**Prime Contractor:** American Bridge/Fluor Enterprises, a JV**OSM Departure Time:** 1930**Contractor:** American Bridge/Fluor Enterprises, a JV**Location:** Job Site**CWI Name:** Scott Kourtum**CWI Present:** Yes No**Inspected CWI report:** Yes No N/A**Rod Oven in Use:** Yes No N/A**Electrode to specification:** Yes No N/A**Weld Procedures Followed:** Yes No N/A**Qualified Welders:** Yes No N/A**Verified Joint Fit-up:** Yes No N/A**Approved Drawings:** Yes No N/A**Approved WPS:** Yes No N/A**Delayed / Cancelled:** Yes No N/A**Bridge No:** 34-0006**Component:** SAS OBG**Summary of Items Observed:**

Caltrans Office of Structural Material (OSM) Quality Assurance Inspector (QAI) Joselito Lizardo was present at the Self Anchored Suspension (SAS) job site as requested to perform observations on the welding of components for the San Francisco Oakland Bay B

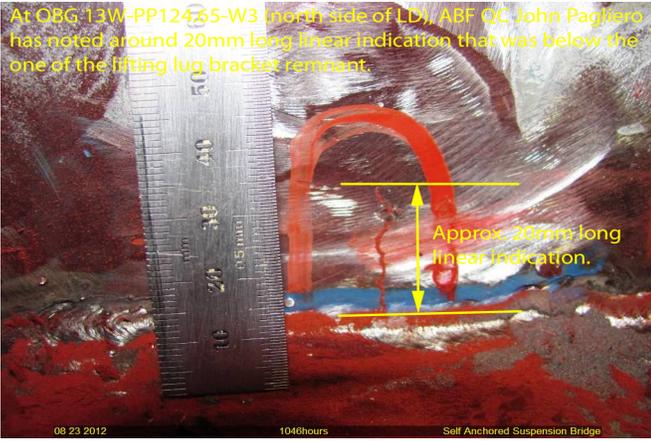
At the request of ABF personnel, this QA has performed visual inspection and Magnetic Particle Testing (MT) on the lifting lug bracket removal at 13W-PP124.65-W3 (north side) that was ground smooth to 3:1 slope per RFI ABF-RFI-001151R01 dated March 31, 2008. During the verification, all four bracket remnants that were ground were in compliance to the ABF-RFI-001151R01 dated March 31, 2008 required slope of 3:1 ratio and the MT performed on these remnants revealed three (3) were in compliance whereas one has linear indication that still needs to be fixed. The results of the verification were relayed to ABF QC Scott Kourtum and ABF foreman Ric Robles.
