DEPARTMENT OF TRANSPORTATION

Contract #: 04-0120F4Cty: SF/ALA Rte: 80 PM: 13.2/13.9File #: 1.28**WELDING INSPECTION REPORT****Resident Engineer:** Casey, William**Address:** 333 Burma Road**City:** Oakland, CA 94607**Report No:** WIR-028249**Date Inspected:** 24-Aug-2012**Project Name:** SAS Superstructure**OSM Arrival Time:** 700**Prime Contractor:** American Bridge/Fluor Enterprises, a JV**OSM Departure Time:** 1930**Contractor:** American Bridge/Fluor Enterprises, a JV**Location:** Job Site**CWI Name:** Scott Kourtum**CWI Present:** Yes No**Inspected CWI report:** Yes No N/A**Rod Oven in Use:** Yes No N/A**Electrode to specification:** Yes No N/A**Weld Procedures Followed:** Yes No N/A**Qualified Welders:** Yes No N/A**Verified Joint Fit-up:** Yes No N/A**Approved Drawings:** Yes No N/A**Approved WPS:** Yes No N/A**Delayed / Cancelled:** Yes No N/A**Bridge No:** 34-0006**Component:** SAS OBG**Summary of Items Observed:**

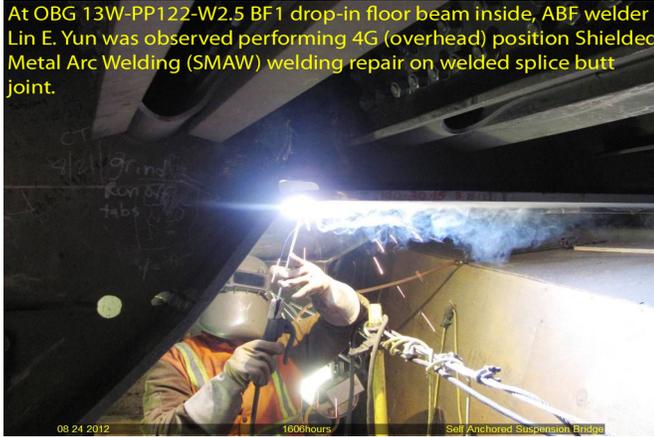
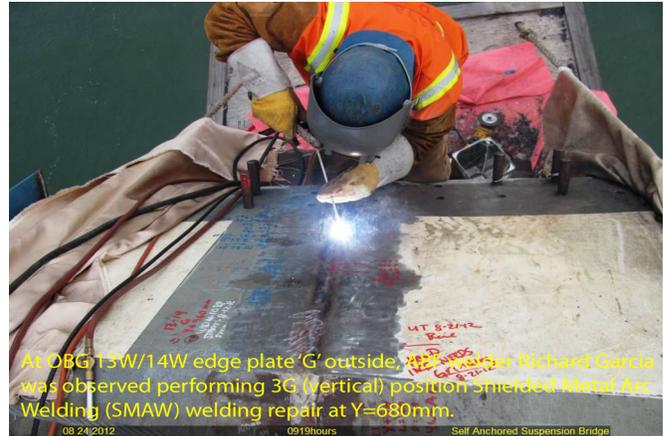
At OBG 13W-PP122-W2.5 BF1 drop-in floor beam inside, ABF welder Lin E. Yun was observed performing 4G (overhead) position Shielded Metal Arc Welding (SMAW) welding repair on welded splice butt joint.

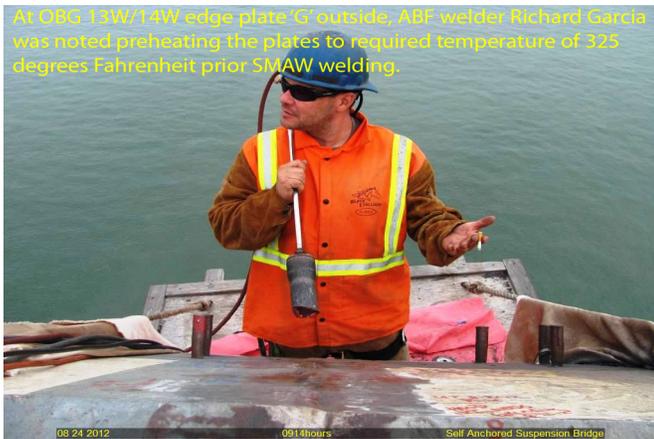
At OBG 13W/14W edge plate 'G' outside, ABF-welder Richard Garcia was noted preheating the plates to required temperature of 325 degrees Fahrenheit prior SMAW welding.
