DEPARTMENT OF TRANSPORTATION

Contract #: 04-0120F4Cty: SF/ALA Rte: 80 PM: 13.2/13.9File #: 1.28**WELDING INSPECTION REPORT****Resident Engineer:** Casey, William**Address:** 333 Burma Road**City:** Oakland, CA 94607**Report No:** WIR-028258**Date Inspected:** 25-Aug-2012**Project Name:** SAS Superstructure**OSM Arrival Time:** 700**Prime Contractor:** American Bridge/Fluor Enterprises, a JV**OSM Departure Time:** 1530**Contractor:** American Bridge/Fluor Enterprises, a JV**Location:** Job Site

WELDING INSPECTION REPORT

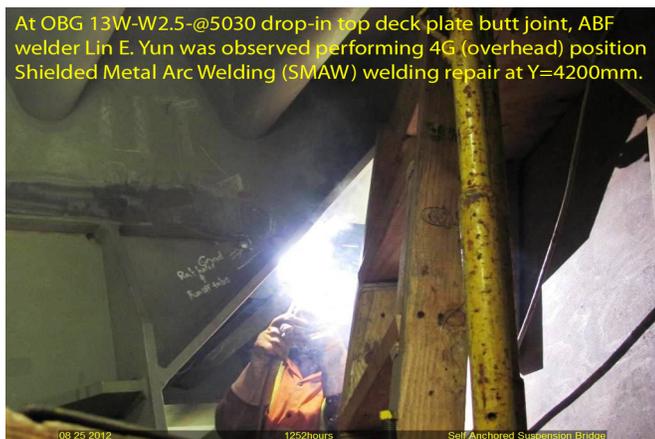
At OBG 13W-W2.5-@5030mm outside, ABF welder Lin E Yun was observed continuing to perform repair welding. The welder has excavated UT detected defect using carbon air arc gouging then ground smooth the groove of the excavation. ABF QC Scott Kourtum was noted performing the Magnetic Particle Testing (MT) on the defect removal with no relevant defect noted during the test. The second time repair which was located at Y=4220 was excavated at the wrong location Y=3590mm. This erroneous excavation was brought to the attention of ABF QC Scott Kourtum and Lead QA Danny Reyes. Since the wrongly excavated repair location was a first time repair, it was decided by both parties, QA and QC to proceed with the repair. During welding repair, the welder was observed welding in the 4G (overhead) position utilizing Shielded Metal Arc Welding (SMAW) with 3.2mm diameter E7018H4R electrode implementing welding procedure ABF-WPS-D15-1004-Repairs. The repair area was preheated to required temperature of >325°F using Miller Proheat 35 Induction Heating System during welding and 450°F PWHT after welding for one hour as required. During the shift, ABF QC Scott Kourtum was noted monitoring the welder with measured working current of 130 amperes on 3.2mm E7018H4R electrode. During the shift, repair welding at location mentioned above was completed. The welder has moved to another location after welding above mentioned repair.

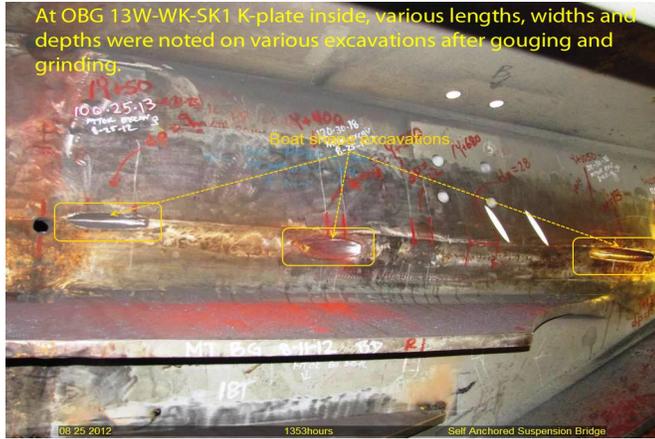
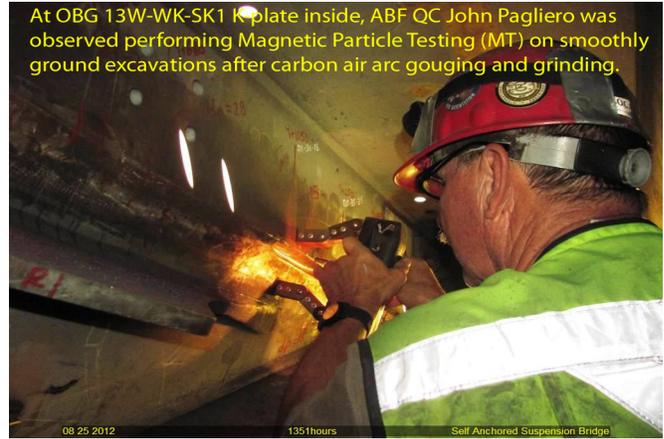
At OBG 13W-WK-SK1 K-plate inside, ABF welder Richard Garcia was observed continuing to perform repair welding. Prior to perform the repair, the welder was noted individually excavating the UT detected defects using carbon air arc gouging then ground smooth the groove of the excavation. ABF QC John Pagliero was noted performing the Magnetic Particle Testing (MT) on the defects removal with no relevant defects noted during the test. After the completion of the MT, welder Richard Garcia was observed welding in the 2G (horizontal) position utilizing Shielded Metal Arc Welding (SMAW) with 3.2mm diameter E7018H4R electrode. The welder preheated the repair area and its vicinity to more than 200°F during welding. During the shift, ABF QV John Pagliero was noted monitoring the welder with measured working current of 125 amperes on the 3.2mm E7018H4R electrode. The following four (4) first time repairs were noted excavated and welded during the shift;

1. 50mm 100mm 25mm 13mm Completed.
2. 400mm 120mm 30mm 18mm Excavated.
3. 1050mm 210mm 30mm 18mm Excavated.
4. 1250mm 120mm 35mm 24mm Excavated.
