DEPARTMENT OF TRANSPORTATION

Contract #: 04-0120F4Cty: SF/ALA Rte: 80 PM: 13.2/13.9File #: 1.28**WELDING INSPECTION REPORT****Resident Engineer:** Casey, William**Address:** 333 Burma Road**City:** Oakland, CA 94607**Report No:** WIR-028261**Date Inspected:** 20-Aug-2012**Project Name:** SAS Superstructure**OSM Arrival Time:** 700**Prime Contractor:** American Bridge/Fluor Enterprises, a JV**OSM Departure Time:** 1700**Contractor:** American Bridge/Fluor Enterprises, a JV**Location:** Job Site**CWI Name:** As noted below**CWI Present:** Yes No**Inspected CWI report:** Yes No N/A**Rod Oven in Use:** Yes No N/A**Electrode to specification:** Yes No N/A**Weld Procedures Followed:** Yes No N/A**Qualified Welders:** Yes No N/A**Verified Joint Fit-up:** Yes No N/A**Approved Drawings:** Yes No N/A**Approved WPS:** Yes No N/A**Delayed / Cancelled:** Yes No N/A**Bridge No:** 34-0006**Component:** SAS OBG**Summary of Items Observed:**

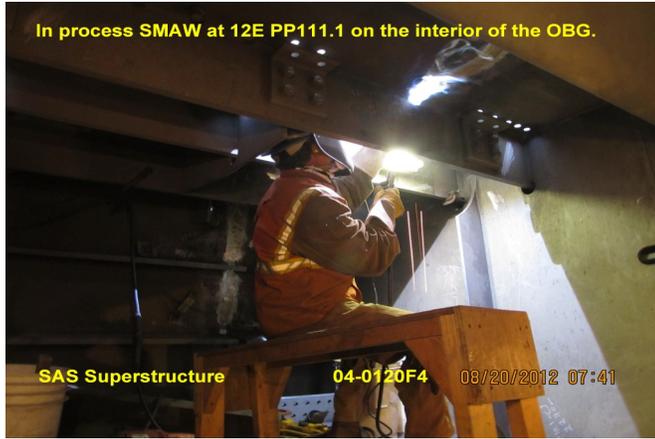
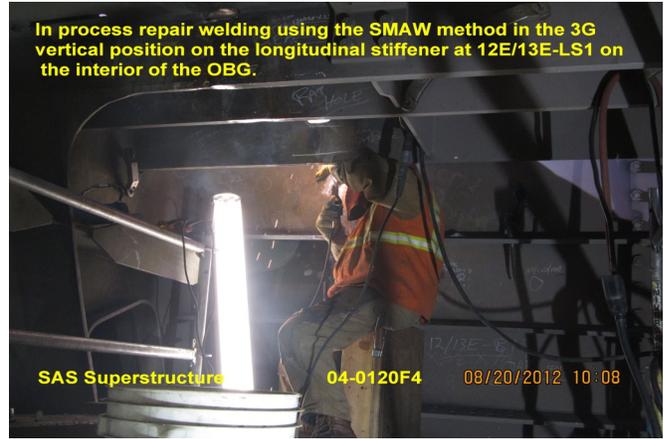
This QA Inspector randomly observed ABF welder Mike Jimenez #4671 perform carbon air arc gouging of Ultrasonic rejectable indications on the Longitudinal Stiffener (LS) at 12E PP111.1-LS1 on the interior of the OBG. The welder ground the weld joint smooth after the gouging and it was tested by ABF QC using the Magnetic Particle Testing (MT). The welder was observed continuing to perform 3G (vertical) Shielded Metal Arc Welding (SMAW) Complete Joint Penetration (CJP) welding to fill the stiffener splice butt joint. The stiffener plate being welded are made of high strength plate material HPS 485W and has a thickness of 30mm. The welder was noted using E9018H4R with 3.2mm diameter electrode implementing Caltrans approved Welding Procedure Specification (WPS) ABF-WPS-D1.5-1002-Repair. The splice joint was preheated to greater than 200 degrees Fahrenheit. The QA Inspector noted the ABF QC Salvador Merino was on site monitoring the in process preheat and welding parameters and measured working current during welding was 120 amps on a 3.2mm E9018H4R electrode. QC was also closely monitoring the issuance of E9018H4R electrodes due to its limited exposure time allowed. The welder completed LS1 and the work at this location appeared to be in general conformance with the contract documents. No RWR was required for this first time weld repair.

This QA Inspector randomly observed QC Inspector Jesse Cayabyab at 12E-E2.1-C1.1 on the interior of the OBG performing Ultrasonic Testing (UT). The QC Inspector was observed scanning from each side of the weld and the scanning pattern as described in D1.5 6.24. The QC Inspector was noted as identifying rejectable indications and the work at this location is ongoing and appeared to be in general conformance with the contract documents and SE-UT-D1.5-CT-100-Revision 4.

This QA Inspector randomly observed ABF certified welder Jin Quan Huang #1088 continuing to perform 4G (overhead position) Shielded Metal Arc Welding (SMAW) welding fill pass on the CJP transverse joint on 12E PP111.1 on the interior of the OBG. The welder was utilizing 3.2mm diameter E7018H4R on the fill pass implementing Caltrans approved Welding Procedure Specification (WPS) ABF-WPS-D15-1040C-Revision 0. The joint was preheated to more than 150 degree Fahrenheit using propylene gas torch prior welding. Welding parameters were monitored by ABF/QC Salvador Merino. QA noted the welding working current of 135 amperes on the 3.2 diameter E7018H4R electrode. This QA Inspector made subsequent observations throughout the shift to monitor quality and noted that the work at this location was in progress and appeared to be in general conformance with the contract specifications.

This QA Inspector randomly observed SMAW in the 2G horizontal position on the Floor Beam Web plate at 13E PP120. ABF/JV qualified welder Chris Bowles #9317 was observed pre-heating the joint prior to welding and utilized 3.2mm E7018-H4R electrodes drawing amperage of 126. QC Inspector Salvador Merino was present to monitor the welding and the parameters as they pertain to ABF-WPS-D1.5-1004-Repair. Between passes the welder was observed cleaning the work using a small disc grinder as QC measured the inter-pass temperatures with Tempilstik Heat Indicators. On a subsequent observation, it was noted that the welder was continuing the in process welding. This QA Inspector noted that the 3.2mm electrodes were stored in electrically heated thermostatically controlled oven after removal from the sealed containers. The exposure limits of the electrodes appeared to comply with the minimum storage oven temperature of 120 degrees Celsius as per the contract documents. The welding parameters and surface temperatures were verified by the QC inspector's utilizing a Fluke 337 clamp meter to measure the electrical welding parameters. Upon completion of the welding, thermal heat blankets were placed over the sites for one (1) hour at 450-650°F. At the time of the observations no issues were noted by the QA. RWR-201208-054 was referenced throughout this procedure.
